National Transportation Safety Board Aviation Accident Factual Report

Location:	Mount Pleasant, TX	Accident Number:	CEN20TA025
Date & Time:	11/25/2019, 1610 CST	Registration:	N15412
Aircraft:	Piper PA34	Aircraft Damage:	Substantial
Defining Event:	Hard landing	Injuries:	2 None
Flight Conducted Under:	Part 91: General Aviation - Instructional

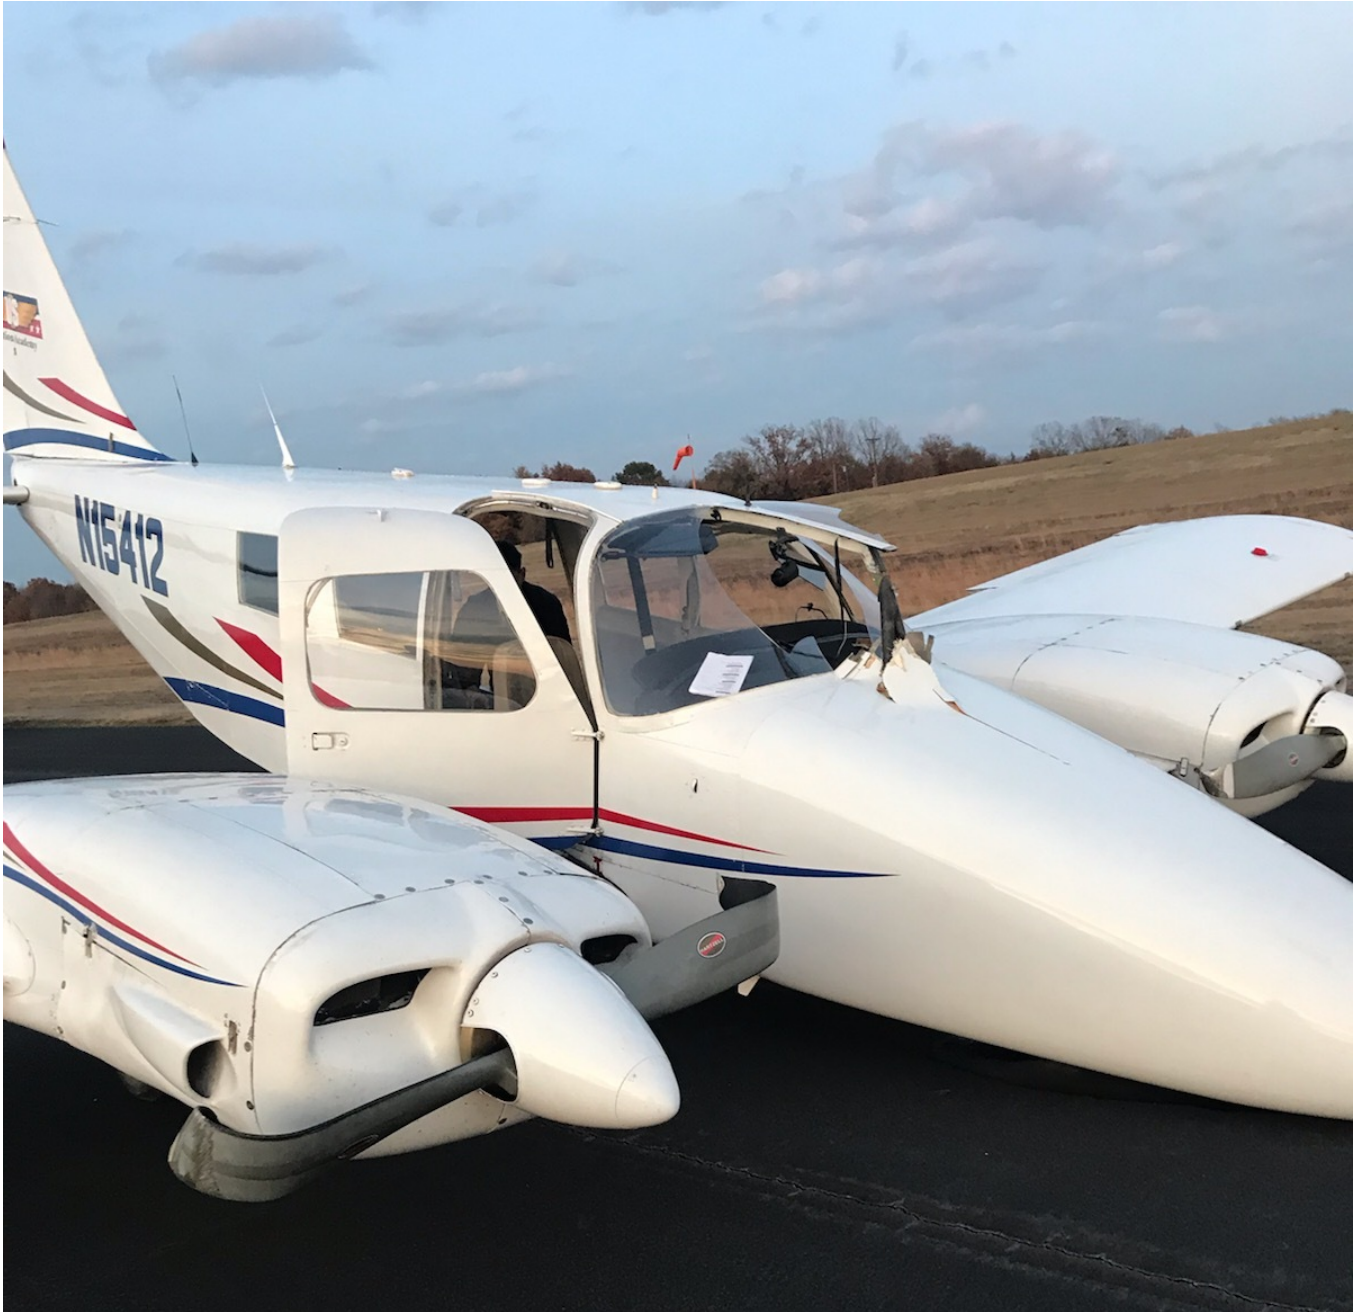
Another witness, who is a pilot and has his airplane hangared at OSA, observed the approach and landing. He stated that the airplane was very fast on final approach and landed fairly flat on the first landing attempt. The airplane bounced into the air about 10 to 15 ft then landed on the nose gear. The airplane bounced a final time and came down directly on the nose gear. The airplane hit the runway hard and the nose strut collapsed upward into the fuselage (Figure 1).

Figure 1 – Airplane with nose gear strut through the fuselage and windscreen

A postaccident examination of the damage to the nose landing gear revealed that the lower truss of the nose gear mounting structure was fractured. The nose gear mount assembly separated from the airframe but remained attached to the windscreen trim strip. The mount was displaced upward and punctured through the top of the fuselage and fractured the windscreen. The nose landing gear strut was intact and did not show signs of damage or failure.
