National Transportation Safety Board Aviation Accident Preliminary Report

Location:	Mullin, TX	Accident Number:	CEN20LA055
Date & Time:	01/04/2020, 1600 CST	Registration:	N5573M
Aircraft:	Aero Commander 100	Injuries:	2 None
Flight Conducted Under:	Part 91: General Aviation - Instructional

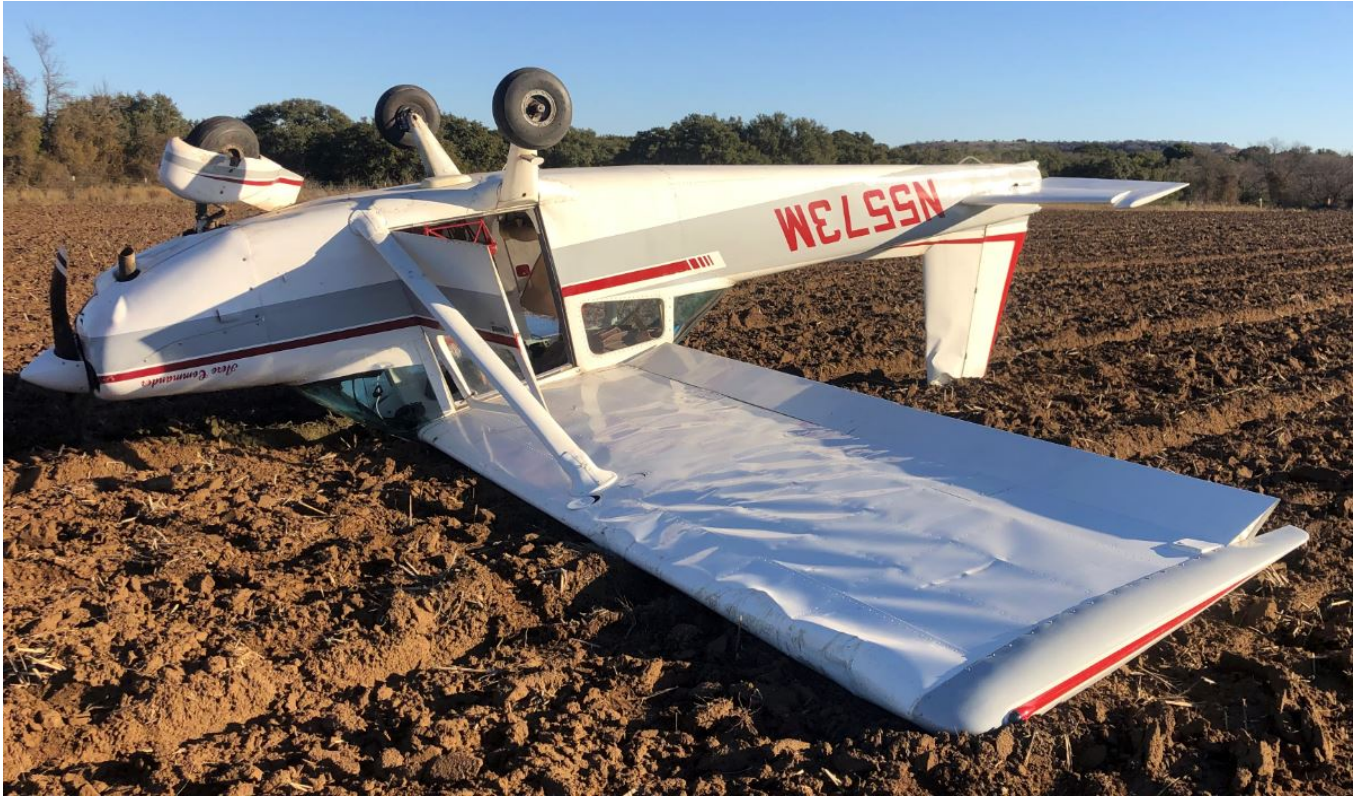
came to rest upside down as shown below in figure 1. The CFI executed an emergency shutdown and both occupants egressed from the airplane without further incident.

Figure 1 - View of the airplane after it came to rest (courtesy of the student pilot).

The airplane sustained substantial damage to the fuselage, both wings, and the empennage. The airplane was recovered from the accident site for a future examination of the airframe and engine.
