# National Transportation Safety Board Aviation Accident Preliminary Report

<b>Location:</b>	Billings, MT	<b>Accident Number:</b>	WPR20FA063
<b>Date &amp; Time:</b>	01/11/2020, 1801 MST	<b>Registration:</b>	N736YU
<b>Aircraft:</b>	Cessna TR182	<b>Injuries:</b>	4 Fatal
<b>Flight Conducted Under:</b>	Part 91: General Aviation - Personal

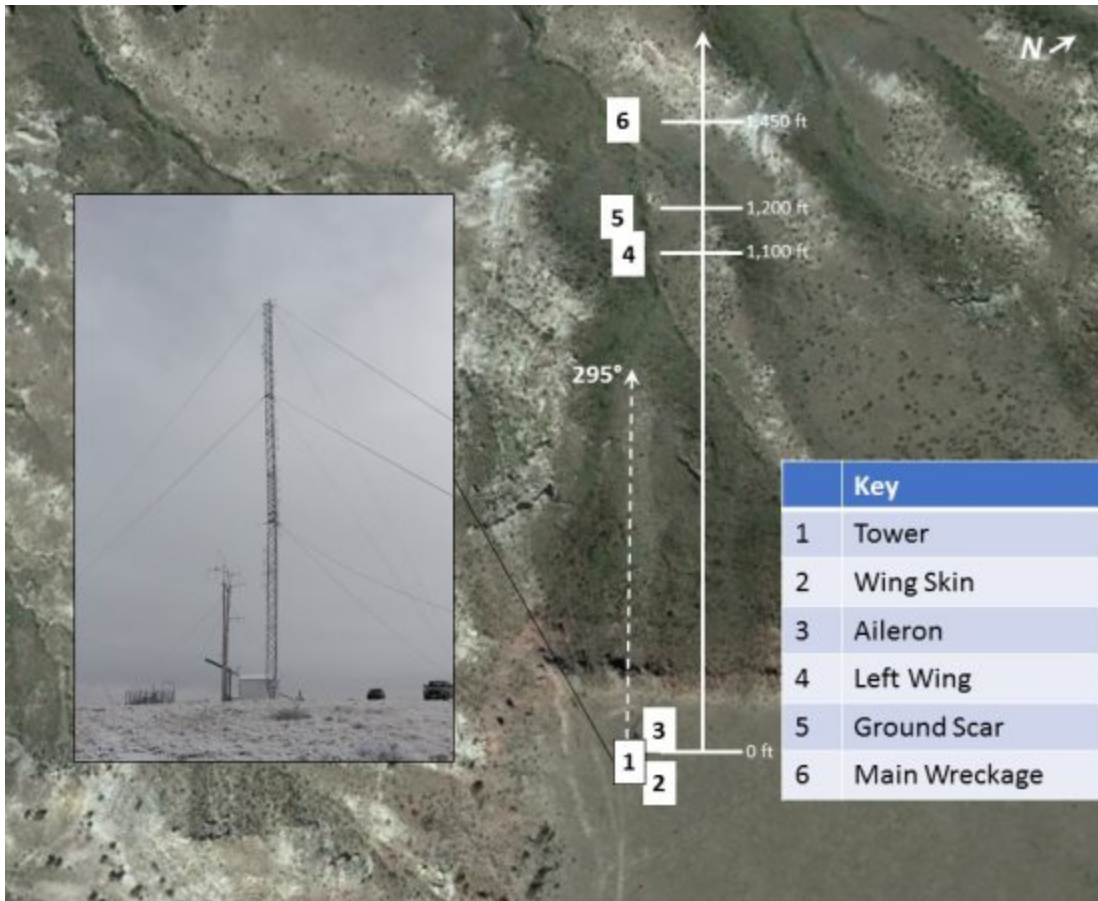
Figure 1: Wreckage Diagram

The airplane was located in mountainous terrain at an elevation of about 4,252 ft mean sea level. All major sections of the airplane were accounted for at the accident site. The initial impact point (IIP) was marked by several bent cross members and a broken guy wire about 65 ft high on an approximate 185 foot-tall radio tower. Several sections of the outboard left wing were located about 100 ft north of the tower and two pieces displayed longitudinal signatures consistent with impacting a wire. The remaining section of left wing was found in the debris path about 350 ft from the main wreckage. Several airframe and engine fragments were distributed along the energy path, which was oriented on a heading of about 295° magnetic. A 5 foot-long intermediate ground scar was located about 250 ft from the main wreckage, which was found about 1,450 ft northwest of the IIP in a coulee and comprised of the right wing, fuselage, empennage, and engine.
