National Transportation Safety Board Aviation Accident Preliminary Report

Location:	Pineville, LA	Accident Number:	CEN20LA199
Date & Time:	05/31/2020, 1330 CDT	Registration:	N6461J
Aircraft:	PIPER PA28	Injuries:	2 Fatal, 1 Serious
Flight Conducted Under:	Part 91: General Aviation - Personal

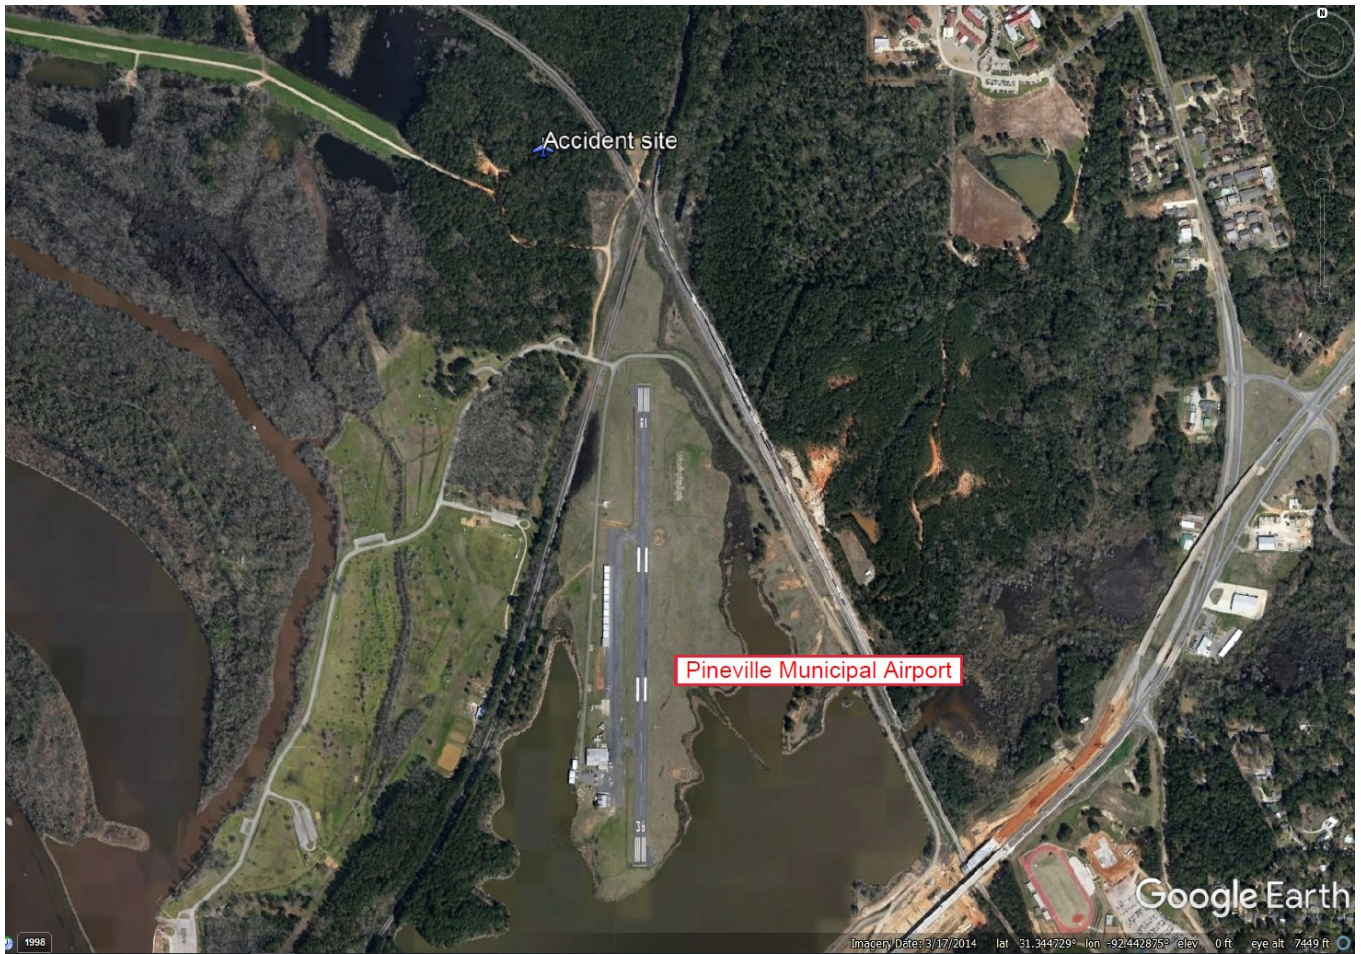
There were no radio or distress calls heard from the pilot. The accident site was located in a heavily wooded area, about 1.5 miles from the departure end of runway 36 at 2LO. Figure 1 depicts the accident site in relation to the departure end of runway 36 and the airport. Local authorities rescued the surviving passenger and secured the accident site. After initial on-site examinations, the airplane wreckage was transported to a secure facility for further examinations.

Figure 1. Accident Site in Proximity to Runway 36 at Pineville Municipal Airport
