# National Transportation Safety Board Aviation Accident Preliminary Report

<b>Location:</b>	Keokuk, IA	<b>Accident Number:</b>	CEN20LA276
<b>Date &amp; Time:</b>	07/12/2020, 1110 CDT	<b>Registration:</b>	N3104S
<b>Aircraft:</b>	Rockwell S2R R1340	<b>Injuries:</b>	1 None
<b>Flight Conducted Under:</b>	Part 91: General Aviation - Ferry

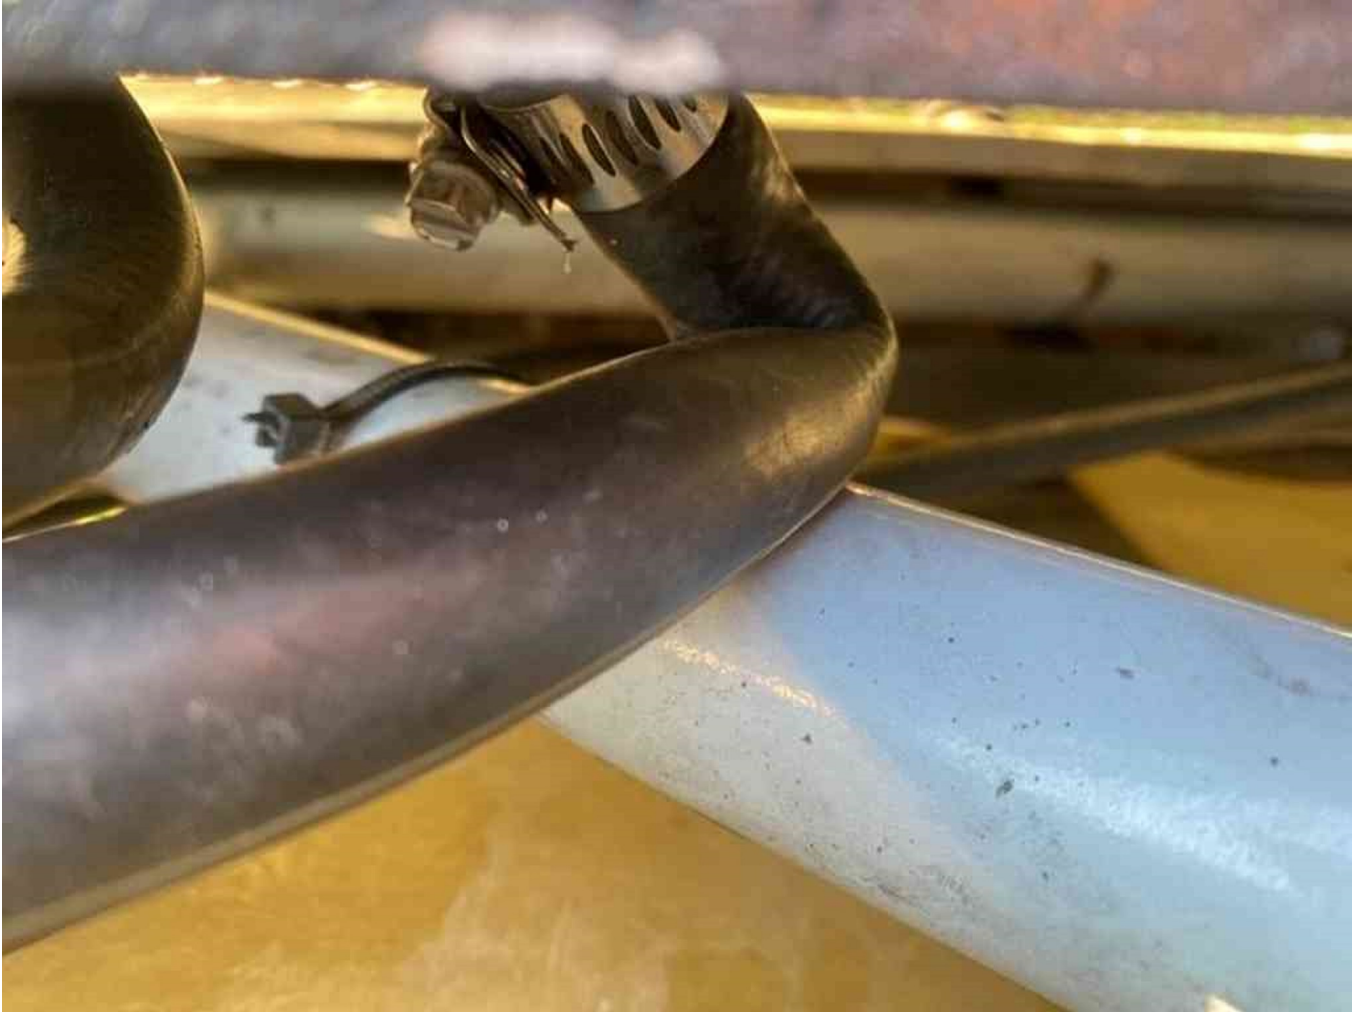
Examination of the airplane after the accident revealed that a fuel vent line in the right wing was creased across a structural beam. The creased fuel vent was not consistent with impact damage, and restricted air from entering the fuel tank. Further examination of the vent line revealed that the installation right wing's vent line was not correct and the left wing's vent was installed properly.

Figure 1. Creased Fuel Vent Right Wing
