National Transportation Safety Board Aviation Accident Preliminary Report

Location:	Burns Flat, OK	Accident Number:	CEN20LA292
Date & Time:	07/18/2020, 2245 CDT	Registration:	N3412C
Aircraft:	Beech A23-24	Injuries:	4 None
Flight Conducted Under:	Part 91: General Aviation - Personal

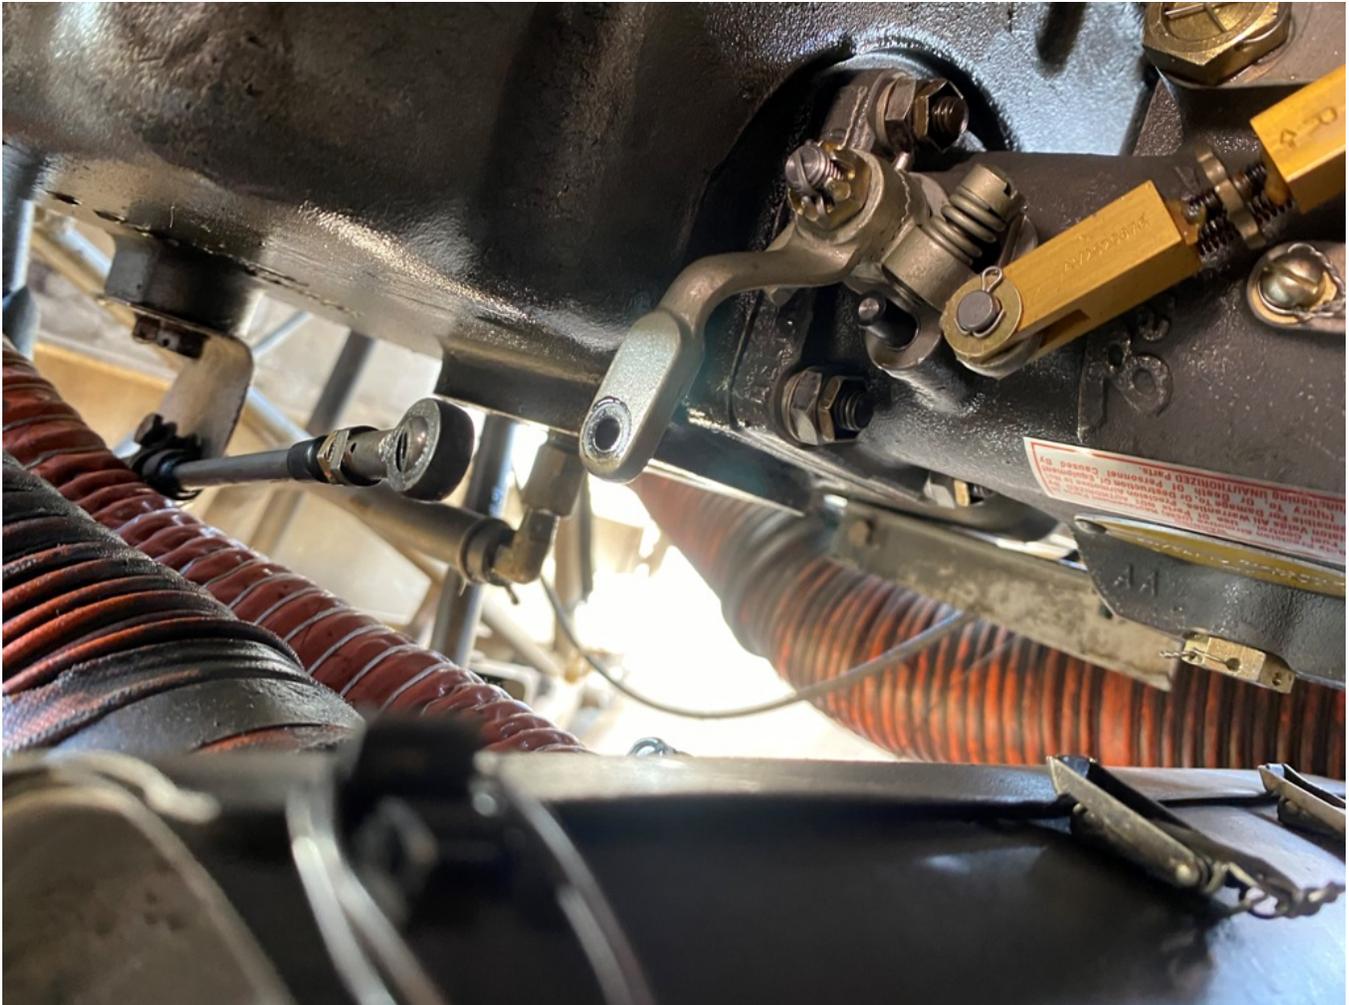
The airplane was examined at the accident site by a Federal Aviation Administration airworthiness inspector. Both wing fuel tanks contained about 25 gallons of 100 low-lead aviation fuel. The throttle control was very loose when moved by hand in the cockpit. A visual inspection of the fuel servo revealed that the throttle linkage was not connected to the throttle control rod-end. The retaining bolt, washer, and self-locking nut were not located during the investigation.

Figure 1. Throttle control rod-end found disconnected from the fuel servo throttle linkage.

The airplane had accumulated 8.72 hours since the last annual inspection that was completed on October 22, 2019. The inspection authorized (IA) mechanic who had completed the annual inspection stated that the fuel servo had been removed from the engine and overhauled in conjunction with the annual inspection. The IA mechanic stated that he personally reinstalled the overhauled fuel servo on the engine, while another individual moved the throttle and mixture controls in the cockpit. The IA mechanic stated that it is his standard practice to connect both the throttle and mixture controls to the fuel servo at the same time. The IA mechanic stated that he likely reused the bolt and washer to connect the throttle control rod-end to the fuel servo throttle linkage, and that it is possible that he also reused the self-locking steel nut. However, he would not have reused the self-locking nut if it had fully engaged the bolt threads by hand. The IA mechanic stated that he used two wrenches to secure the self-locking nut and that he did not use a torque wrench. A review of the Beech A23-24 Maintenance Manual revealed no specific assembly instructions on how to physically connect the throttle control rod-end to the fuel servo throttle linkage. The Beech A23-24 Illustrated Parts Catalog specified that the throttle control rod-end be attached to the fuel servo throttle linkage with a 169-910021 bolt, AN960-10 washer, and MS20365-1032 self-locking nut.
