National Transportation Safety Board Aviation Accident Preliminary Report

Location:	Brandon, MN	Accident Number:	CEN20LA343
Date & Time:	08/15/2020, 1307 CDT	Registration:	N2510H
Aircraft:	Piper PA18	Injuries:	2 Minor
Flight Conducted Under:	Part 91: General Aviation - Personal

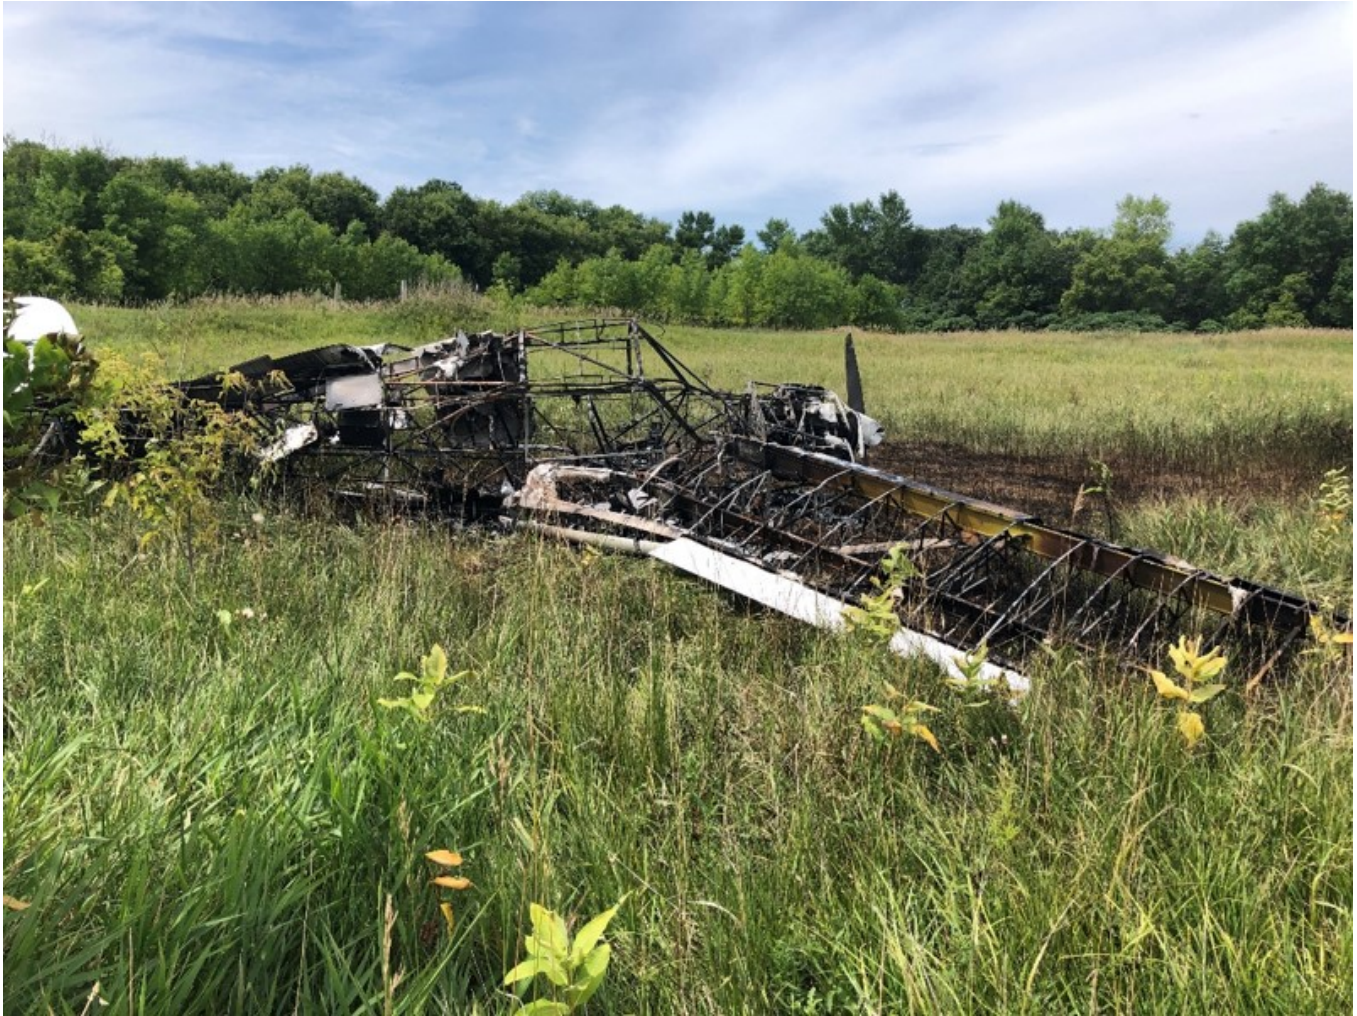
Figure 1. Airplane Wreckage after Post Crash Fire.

Examination of the accident site revealed that the airplane struck the steel post about 4-ft above the ground. The airplane came to rest about 150 ft from the impact with the post. Evidence at the site showed that the airplane rotated about 90° to the right before it struck the ground. Although a post impact fire consumed most of the airplane, all flight control continuities were confirmed. Due to the extensive fire damage, the engine could not be rotated and a detailed examination was not possible.
