NATIONAL TRANSPORTATION SAFETY BOARD

SAFETY STUDY

THE PERFORMANCE AND USE OF
CHILD RESTRAINT SYSTEMS, SEATBELTS,
AND AIR BAGS FOR CHILDREN
IN PASSENGER VEHICLES

VOLUME 2: CASE SUMMARIES

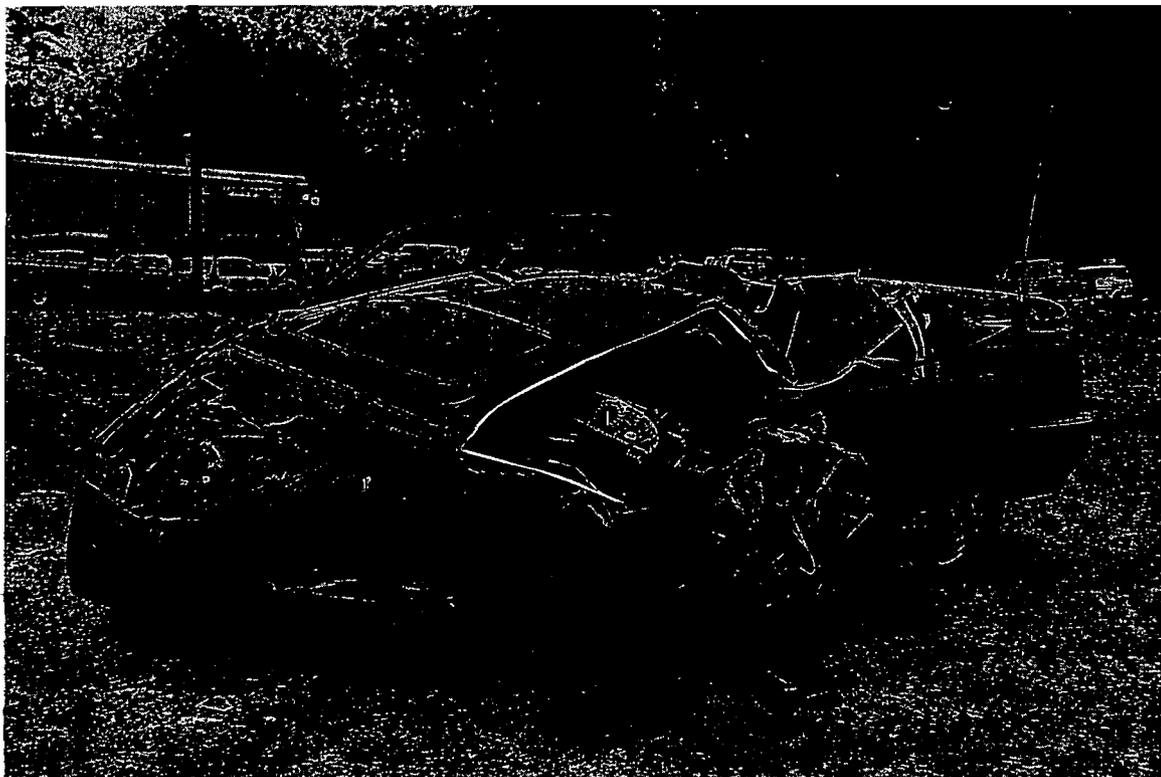
Collision Diagram

A 1991 Honda Accord was struck head-on by a 1990 Chevrolet pickup truck that crossed the center-line of a 4-lane roadway. After impact, the pickup crossed back to the right side of the roadway and was struck by a 1985 Chevrolet Citation. The restrained driver of the Honda received fatal injuries and the restrained left rear passenger received moderate injuries. A 3-week-old infant, seated in a Rock n' Ride infant seat at the right rear position, was found on the floorboard under the driver's legs at final rest. He was not injured. The two unrestrained occupants of the pickup were seriously injured. The driver of the Chevrolet was not injured.

Occupant Location	Injuries	AIS	Probable Source
Center Front	Abrasions lower right jaw	1	Not Determined
	Abrasions right arm	1	Not Determined
	Occipital skull fracture with brain hemorrhage and infarction	4	Instrument panel
	Loss of consciousness with neurological deficit 6-24 hours	5	Instrument panel

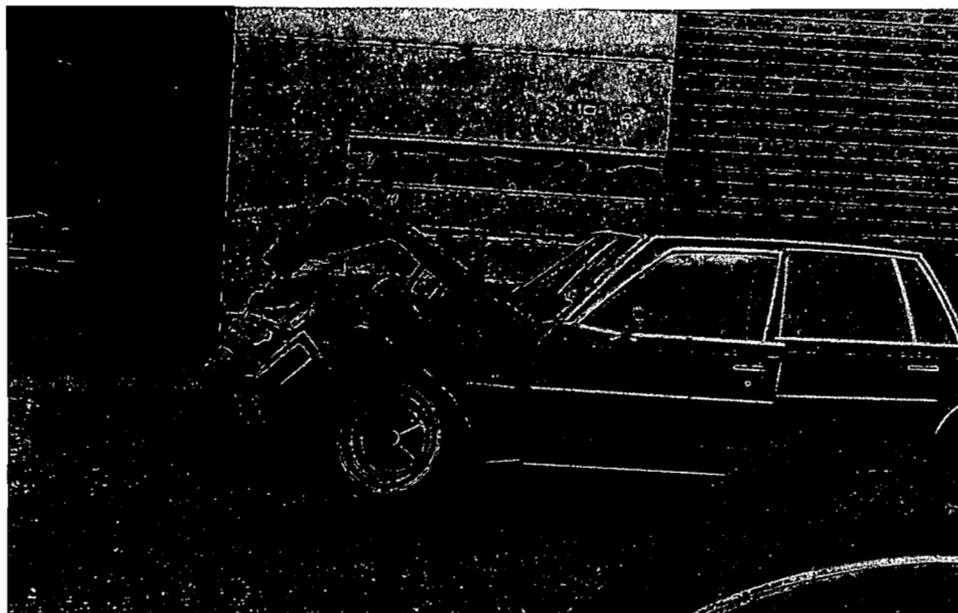
Collision Diagram

The truck tractor combination unit was traveling southbound in a heavy rain storm when it jackknifed across the median and collided with the northbound case vehicle. The combination unit was nearly stopped at impact. The front of the Buick contacted the right side of the truck tractor. Both outboard front occupants were restrained by their lap/shoulder belts. The driver received minor injuries and the passenger received moderate injuries. The infant passenger was seated in the front center in a rear facing Evenflo Joyride infant seat. The child restraint system was secured with the lapbelt. The infant's child restraint harness was loosely secured and the harness clip was positioned at navel level instead of armpit level as called for in the manufacturer's instructions. The infant received a fractured skull and died the following day.

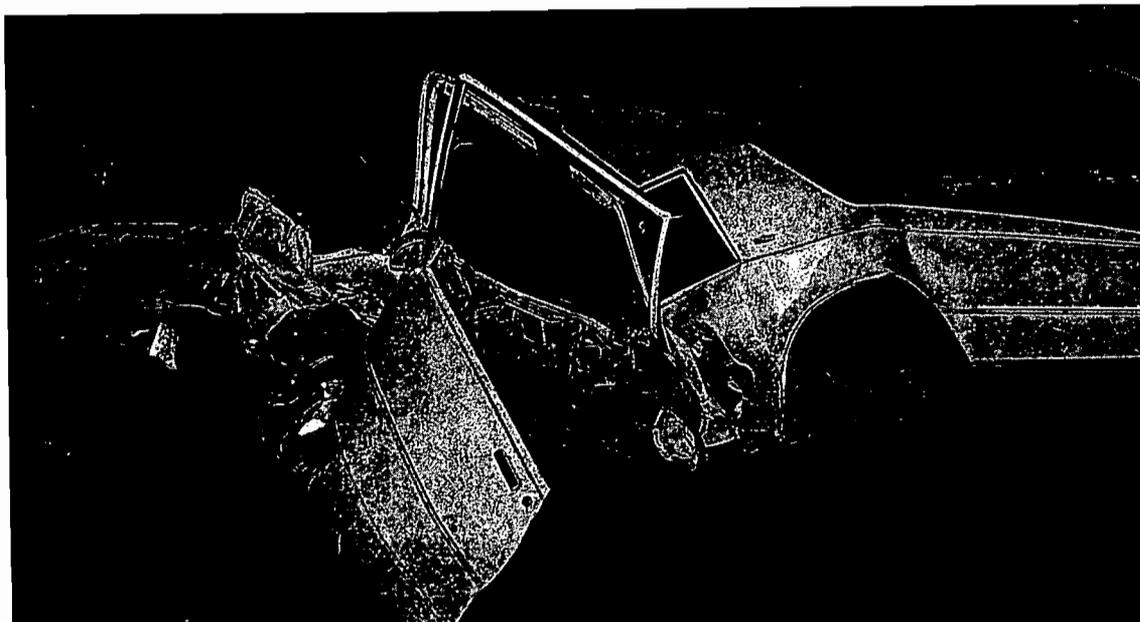
Collision Diagram

The Chevrolet was westbound when an eastbound 1989 Toyota crossed the center line and crashed head-on into the Chevrolet. The driver of the Chevrolet was restrained by a lap/shoulder belt and was killed. A female passenger was also restrained by a lap/shoulder belt and sustained serious injuries. A 2-year-old male seated in the left rear was restrained by a Gerry Guardian, convertible, forward-facing, child restraint system (CRS). The shoulder straps of the CRS were improperly routed through the metal adjuster allowing the left shoulder strap to pull free during the accident. The 2-year-old was partially ejected from the CRS and died several days later in the hospital. The 5-year-old female seated in the middle was restrained by a lapbelt and was also killed. The 6-year-old female, seated in the right rear seat, was also restrained by a lapbelt and sustained serious injuries. All four occupants of the Toyota were killed.

Occupant Location	Injuries	AIS	Probable Source
Vehicle 1			
Left Rear	Severe cerebral edema	5	Collapsed left "B" pillar
	Fracture left femur	3	Collapsed left side wall
	Fracture right clavicle	2	Right shoulder strap of CRD
	Fracture left tibia, fibula	2	Collapsed left firewall
	Fracture right radius	2	Unknown
	Abrasion, contusion left forehead		Collapsed left "B" pillar
Middle Rear	Child sustained fatal injuries. No medical examination or autopsy performed.	9	Unknown
Right Rear	Brain swelling	3	Back of front seat
	Fracture left tibia	2	Unknown
	Laceration left forehead	1	Back of front seat
	Abrasions abdomen	1	Lap belt
	Contusions pelvic area	1	Lap belt

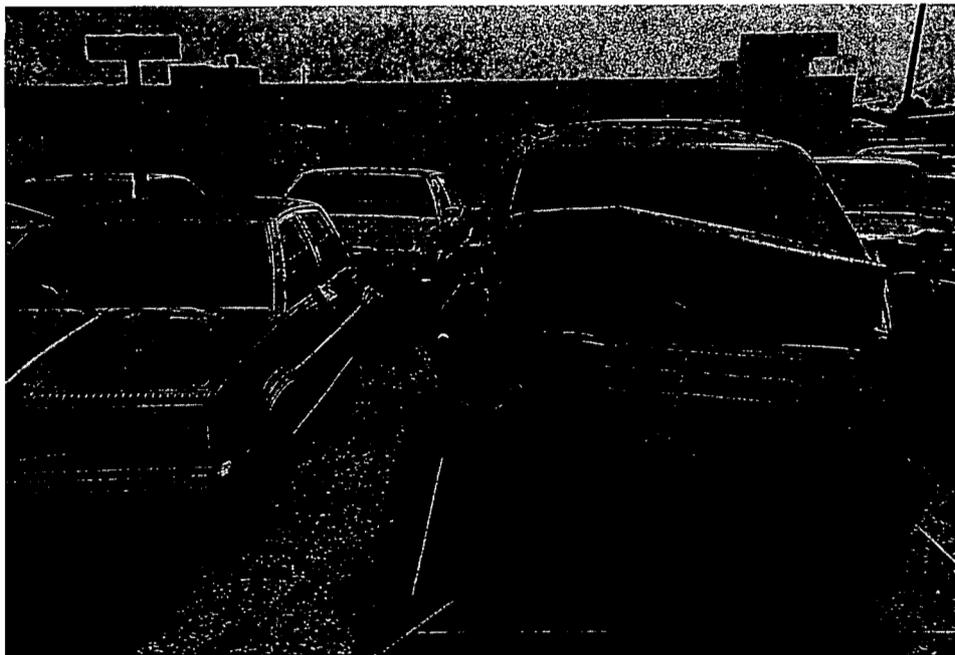
Collision Diagram

A Dodge Caravan collided head-on with a concrete bridge column. The driver, restrained with a lap/shoulder belt, received minor injuries when he struck the A-pillar, steering wheel, and knee bolster. The 27-year-old female, restrained with a lapbelt, received moderate injuries when her head struck a side window and her feet slid under the driver's seat. The 3-year-old female passenger, also restrained by a lapbelt, received minor injuries when her face struck her knees. The 6-year-old female passenger, improperly restrained by a lap belt, received minor injuries. She was lying down on the seat with the lapbelt worn loosely around her waist. She was injured when she was thrown forward into the seat in front of her and then back onto her seat, sustaining multiple lacerations and contusions on her head and face from contact with an arm rest on the driver side of the vehicle.

Occupant Location	Injuries	AIS	Probable Source
Vehicle 1			
Right side of center bench seat	Abrasions, chin	1	Knees
	Broken tooth, top jaw	1	Knees
Center of rear bench seat	Abrasions, abdomen	1	Lap belt
	Abrasions, right forearm	1	Back of center seat
	Abrasions, right leg	1	Back of center seat
	Lacerations, face	1	Armrest driver side
	Lacerations, scalp	1	Armrest driver side
	Lacerations, right leg	1	Back of center seat.

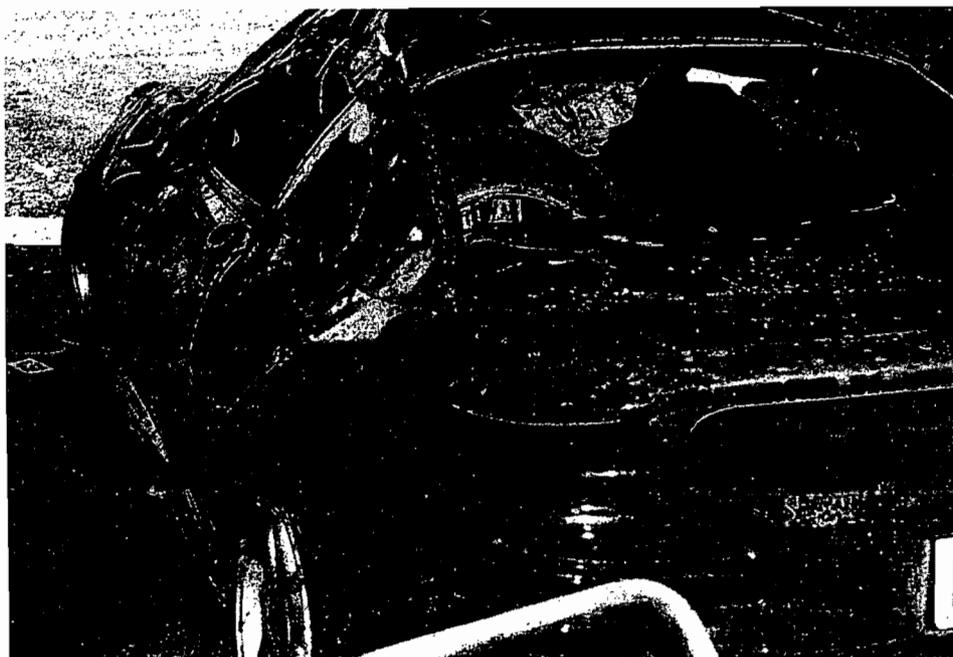
Rollover

A Ford Mustang was traveling westbound on a 65 mph interstate roadway when the fatigued driver lost control of the vehicle and skidded into the highway median. The vehicle overturned while sliding sideways, crossed over the two eastbound lanes of travel, and came to rest along the south side of the roadway. The driver was restrained with the lap/shoulder belt, and remained in the vehicle. A 1-year-old female, seated behind the driver in a forward facing infant seat, remained in the child restraint system. The unrestrained adult occupying the right front bucket seat was ejected. An unrestrained 4-year-old male passenger was ejected from the right rear seat, and came to rest on the pavement of the roadway.

Occupant Location	Injuries	AIS	Probable Source
Left Rear	facial bruises	1	Rear of driver's seat
Right Rear	two broken legs	2	Ejection/ground contact

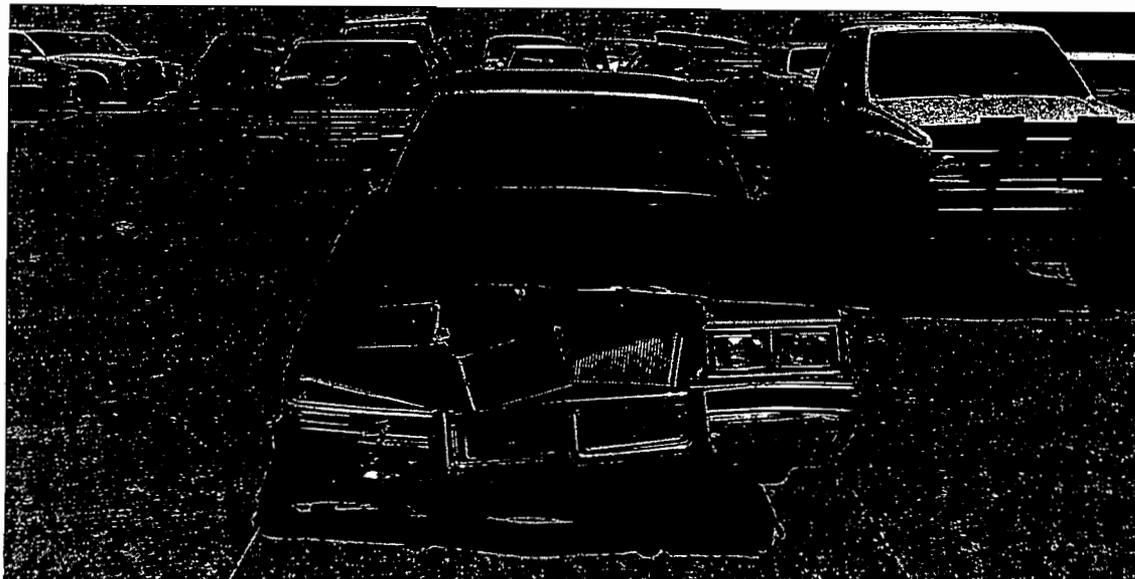
Collision Diagram

A Pontiac Grand Prix struck the rear end of the stopped Chevrolet pickup truck. The driver of the Pontiac was restrained by a lap/shoulder belt. A 9-month-old male, restrained in a Kolcraft Quikstep child restraint system, was in the right front seating position. The child seat was secured on the vehicle seat by a lap/shoulder belt. The only injury sustained by the driver of the Pontiac was an abrasion to the left side of her neck, caused by the rubbing of the seat belt. The child was not injured. The occupants of the Chevrolet were wearing their lap/shoulder belts. They were not injured.

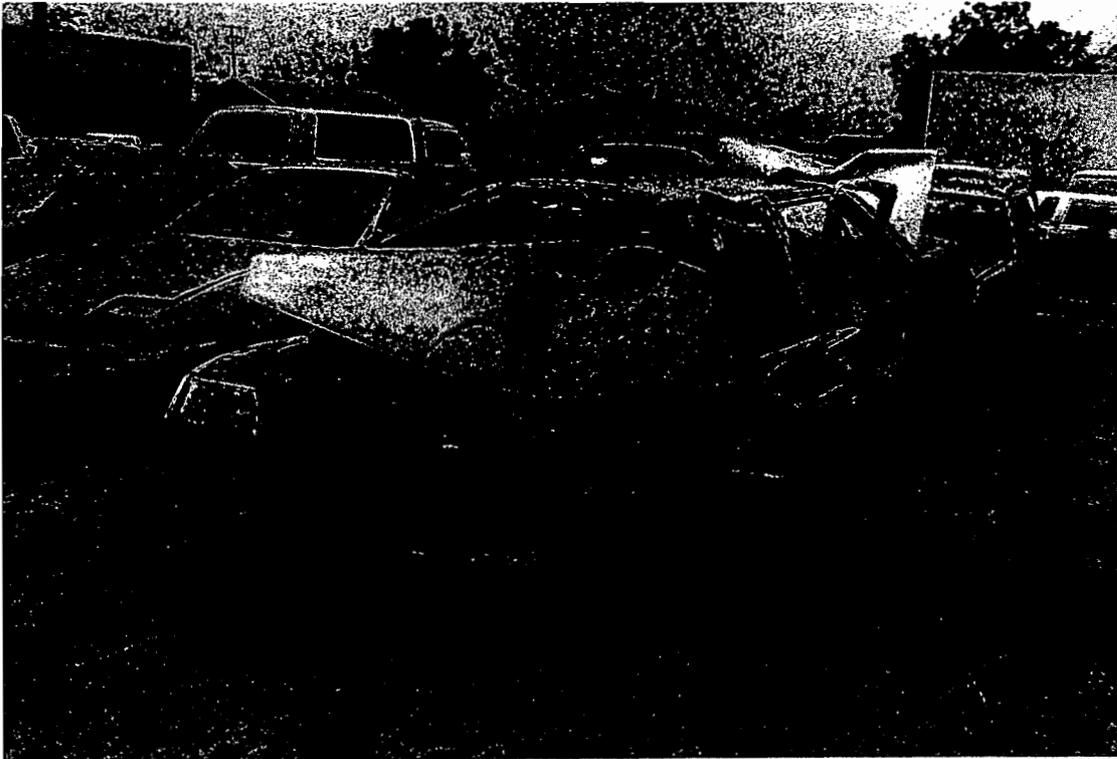
Collision Diagram

A Dodge Colt, crossed into the opposite lane of traffic and struck the front of a Chevrolet step van. Although both front bucket seats and both rear outboard positions of the Dodge Colt were equipped with lap/shoulder belts, none of the four occupants were restrained. The 26-year-old female driver died of multiple traumatic injuries. The right front bucket seat was being shared by two female children, ages 4 and 6. The 6-year-old received minor facial lacerations and the 4-year-old had moderate lacerations. A 7-year-old boy, believed to be laying down in the back seat, sustained a cervical spine fracture and a cerebral contusion. The lapbelted driver of the step van sustained minor injuries. The unrestrained passenger in the step van, seated on a "stool type" seat several feet behind the driver, sustained minor injuries.

Occupant Location	Injuries	AIS	Probable Source
Vehicle 1			
Right Front (near driver)	Facial laceration below lip	1	Dash
Right Front (near door)	Deep laceration over left eye	2	Windshield
	Facial abrasions		Dash and Windshield
Rear seat (laying down)	Cervical Spine Fracture (C-2)	2	Unknown
	Cerebral Contusion	3	Unknown
	Abrasions on right shoulder		Unknown
	and knee

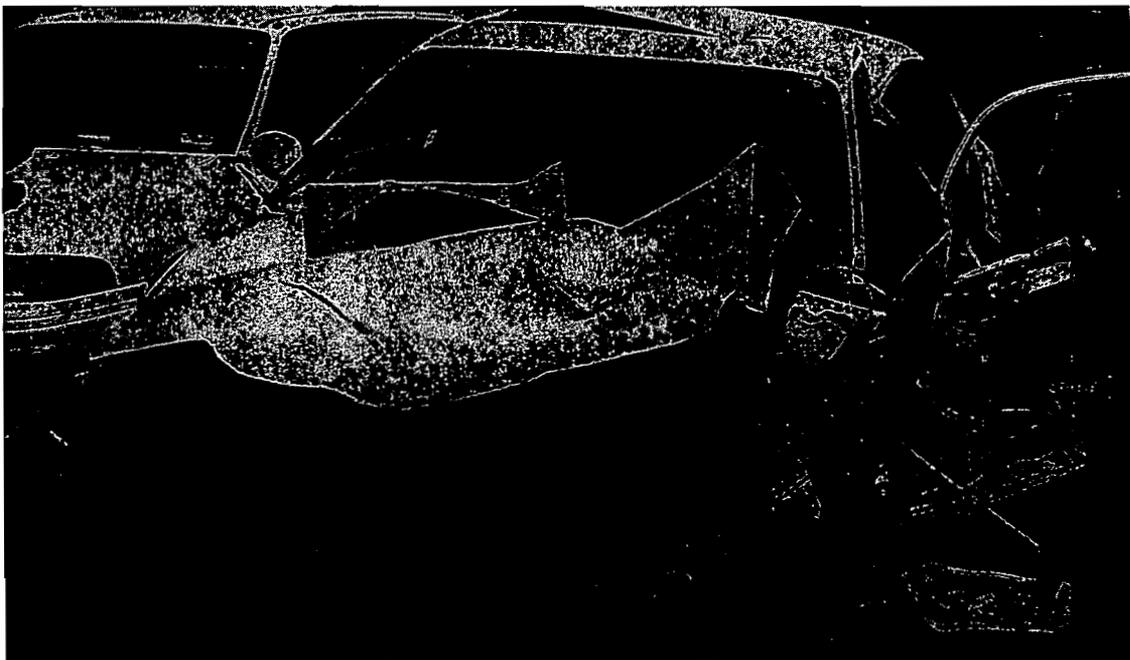
A Mazda 626 was struck head-on by a 1973 Chevrolet Nova. The 34-year-old female driver of the Mazda was unrestrained, but received protection from an airbag that deployed upon impact. A 27-year-old female right front passenger was restrained by a lap/shoulder belt. An 8-year-old male seated in the left rear and a 9-year-old female seated in the rear center position were unrestrained. It could not be determined if the 5-year-old male seated in the right rear was restrained. Both rear outboard positions were equipped with lap/shoulder belts and the rear center position was equipped with a lapbelt. All five occupants of the Mazda were transported to local hospitals. The driver sustained serious injuries, which included a comminuted fracture of the left femur and the fracture of both ankles. The right front adult passenger sustained a fractured right clavicle and multiple bruises and abrasions on various parts of the body. The male child riding in the left rear sustained serious injuries. The female child riding in the rear center position sustained minor injury. The male child riding in the right rear position suffered a broken right clavicle. The unrestrained driver of the Chevrolet died of multiple traumatic injuries.

Occupant Location	Injuries	AIS	Probable Source
Vehicle 1 Left rear seat	Contusion of left lung	3	Back of driver seat and/or B-pillar
	Brain Concussion (NFS)	2	Back of driver seat and/or B-pillar
	Right Mandibular Fracture	2	Back of driver seat and/or B-pillar
Center rear seat	Multiple abrasions and contusions on various parts of the body.	1	Back of front seats and/or console area
Right rear seat	Fractured right clavicle	2	Unknown

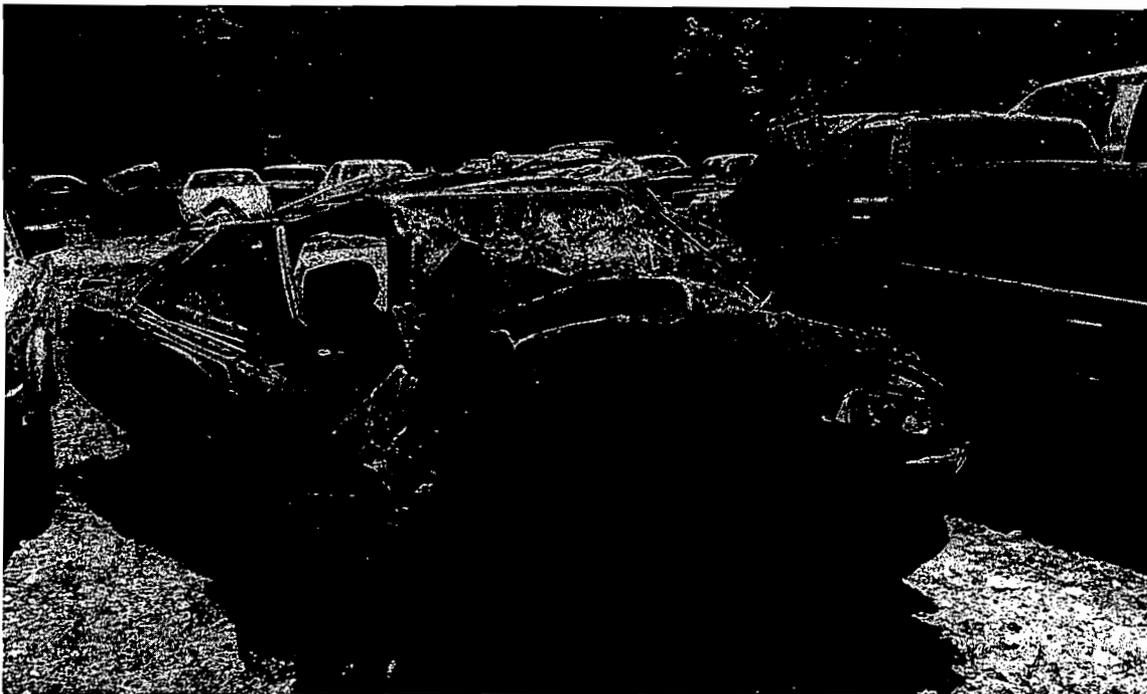
A Geo Prism struck a rock head-wall after it ran off the right side of the 4-lane roadway. The driver of the Prism lost control of the vehicle when she attempted to avoid a collision with a Pontiac that entered the roadway ahead of her. The Prism struck the right rear corner of the Pontiac, continued movement forward and to the right, crossed the shoulder, and collided head-on into the rock wall. The driver of the Prism, restrained with only a motorized shoulder belt, received serious injuries that were later fatal. A 4-month-old female, seated in an infant seat in the right front passenger seat, sustained serious injuries that were also fatal.

Occupant Location	Injuries	AIS	Probable Source
Vehicle 1 Right Front	Skull Fracture (basilar) (Occipital bone)	3	Lower Dashboard

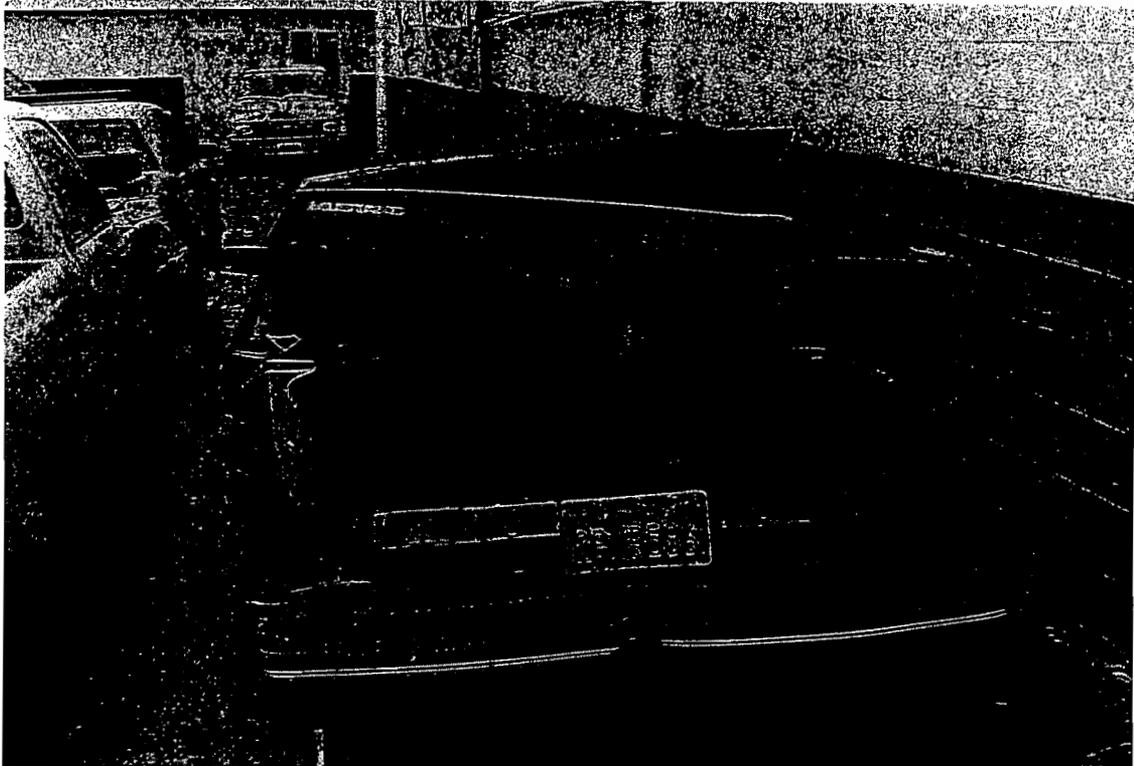
A Ford Mustang was stopped and was struck in the rear by a 1986 Chevrolet Camaro. The driver of the Ford was wearing his lap/shoulder belt, and the male passenger in the right rear seat was wearing his lapbelt (only belt available). The 3-year-old male child was restrained in a Fisher-Price convertible child seat in the right front. The child seat was secured to the vehicle's seat by a lap/shoulder belt. The child seat was forward facing. The driver of the Ford complained of pain to his back, neck and left arm. The right rear passenger sustained a contusion to his forehead. The child sustained a laceration to his forehead. The driver of the Camaro was wearing his lap/shoulder seat belt. He sustained a broken right foot and a laceration to his nose.

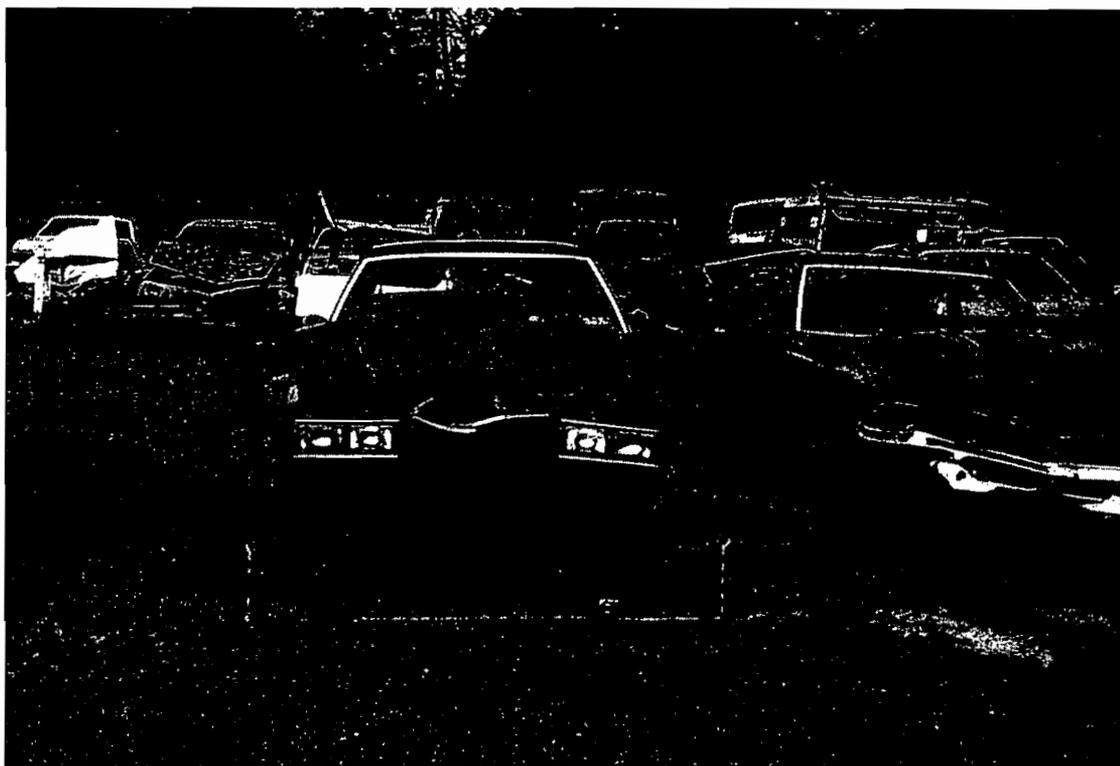
Collision Diagram

The Pontiac ran off the right side of the road, then struck and knocked down a wooden utility pole. The driver was unrestrained and sustained moderate injuries. The rear seat was occupied by an adult and 2 child passengers, ages 4 and 2. An adult female was seated in the middle and the children were seated on either side. The adult was unrestrained and it was undetermined whether or not the two children were restrained. The 2-year-old child and 4-year-old child both sustained minor injuries.

Occupant Location	Injuries	AIS	Probable Source
Left rear	Contusions, abrasions of the right orbital	1	Back of front seat or child's knees
Right rear	Abrasions in pelvic area	1	Unknown

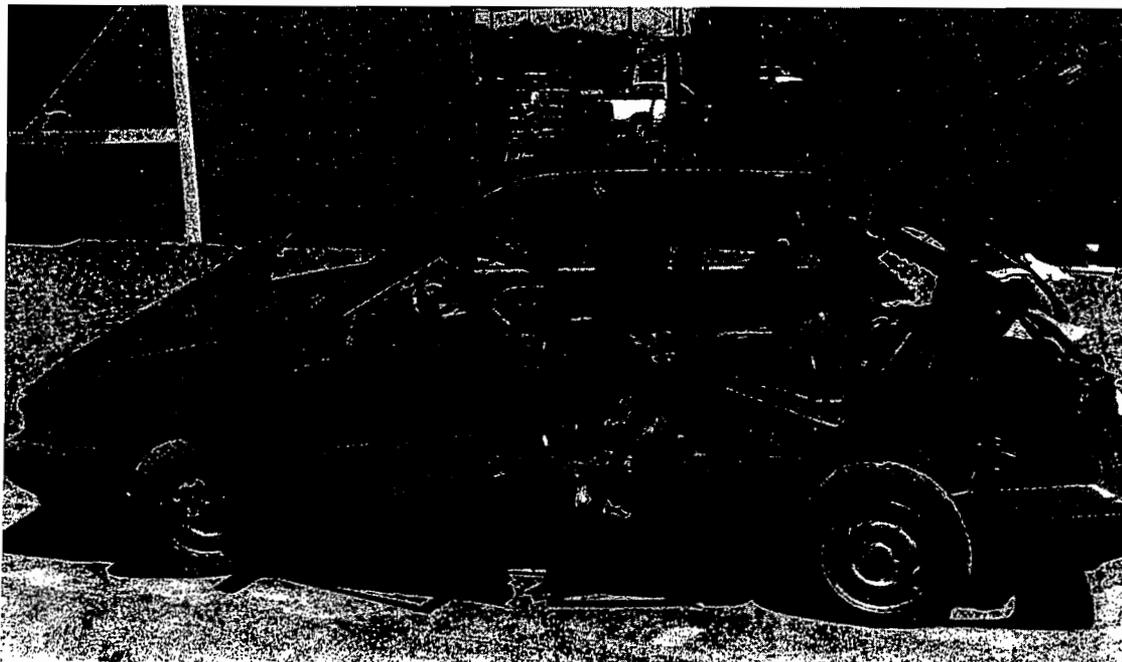
A Hyundai was northbound crossing through an intersection. An Oldsmobile was westbound crossing through the same intersection. The intersection is controlled by traffic signals. One of the vehicles entered against the red light. The Oldsmobile struck the Hyundai on the left side, at the driver's door. Both vehicles spun around, counterclockwise. Only one of the occupants of the Hyundai, the male right front passenger, was wearing seat belts. The 30-year-old female driver received fatal injuries. The 32-year-old male in the right front seat received serious injuries. The 7-year-old male passenger in the left rear seat received fatal injuries. The 5-year-old male passenger in the right rear seat received minor injuries. The driver of the Oldsmobile was wearing his lap/shoulder belt and received minor injuries.

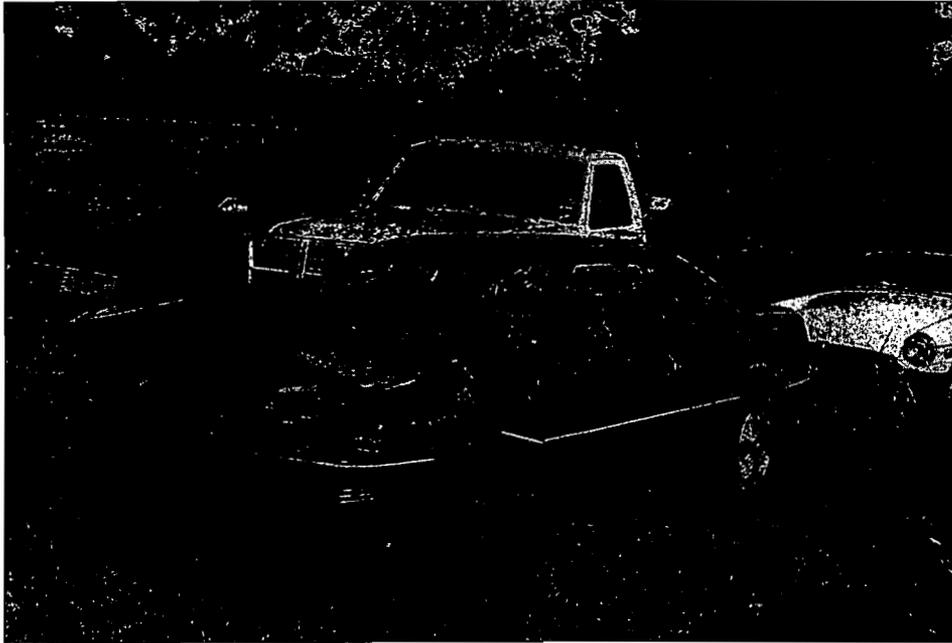
A Pontiac Sunbird collided front first into a dirt embankment. The collision forces separated the driver's shoulder belt and she struck the steering wheel, receiving a closed head injury, fractured thoracic vertebra, fractured sternum, and a fractured tibia and fibula. Laboratory tests showed that the shoulder strap met required strength standards and failed from overload stress. The 22-month-old child seated in a Fisher-Price child restraint system in the right front seat received moderate injuries. The child seat was not installed according to the instructions from Fisher-Price and from the Pontiac owner's manual.

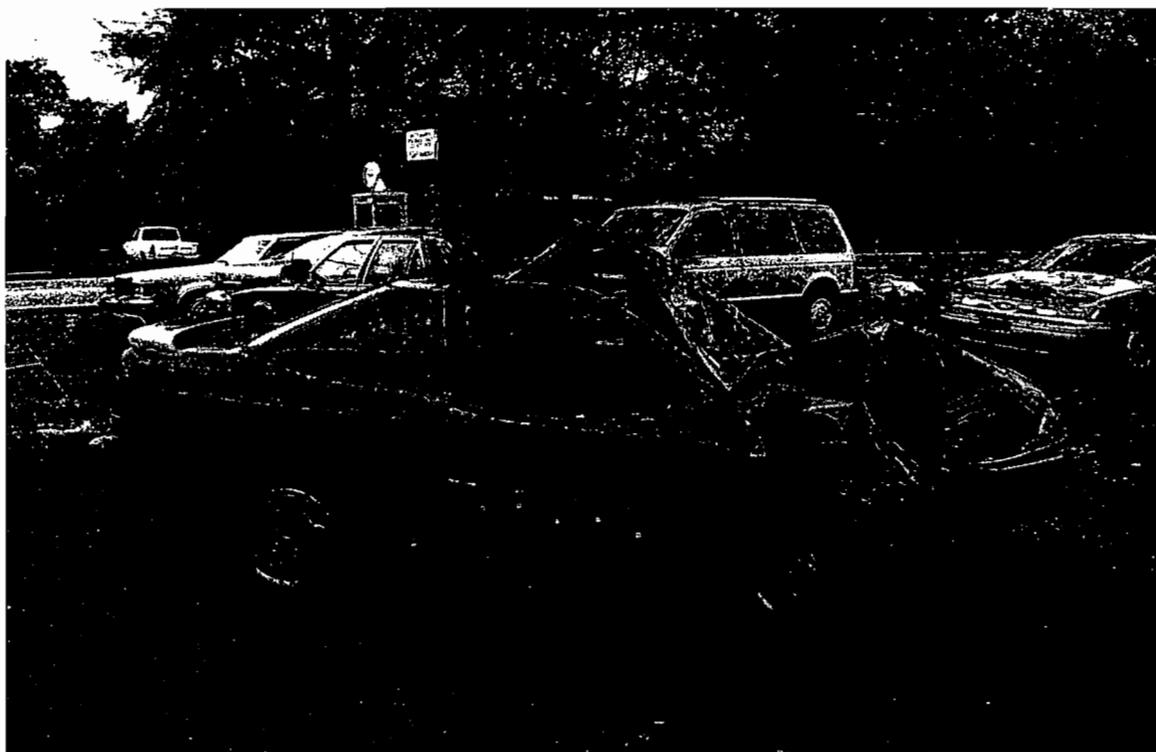
The Hyundai Scoupe was occupied by a 22-year-old female driver and a 1-year-old male when it ran off the right side of the road and struck a wooden utility pole. The driver was unrestrained and sustained serious injuries. The 1-year-old male in the right front passenger seat was lying down on a pillow, against a reclined seat, restrained by a lapbelt, and sustained moderate injuries. Both seating positions were equipped with detachable motorized shoulder belts that had been disconnected.

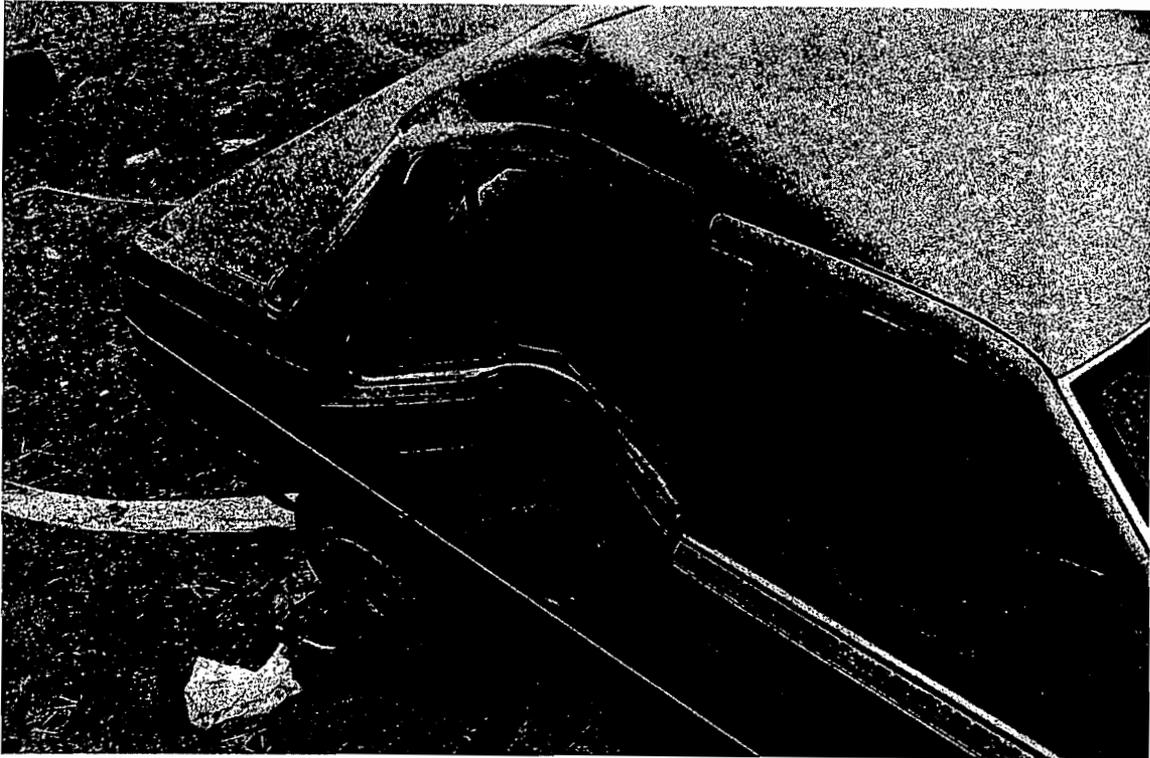
Collision Diagram

A Honda Civic skidded on a wet surface roadway, rotated clockwise 90 degrees off the left side of the roadway, and its right rear door crashed into a 12-inch-diameter tree. The driver, and two female child passengers, a 1-year-old and a 6-year-old, in the rear seat, were not restrained. All occupants of the Honda sustained minor injuries.

Occupant Location	Injuries	AIS	Probable Source
Left rear	Abrasion, left hand	1	Unknown
Right rear	Laceration, forehead	1	Interior side panel/window glass
	Abrasions, face	1	Interior side panel/window glass

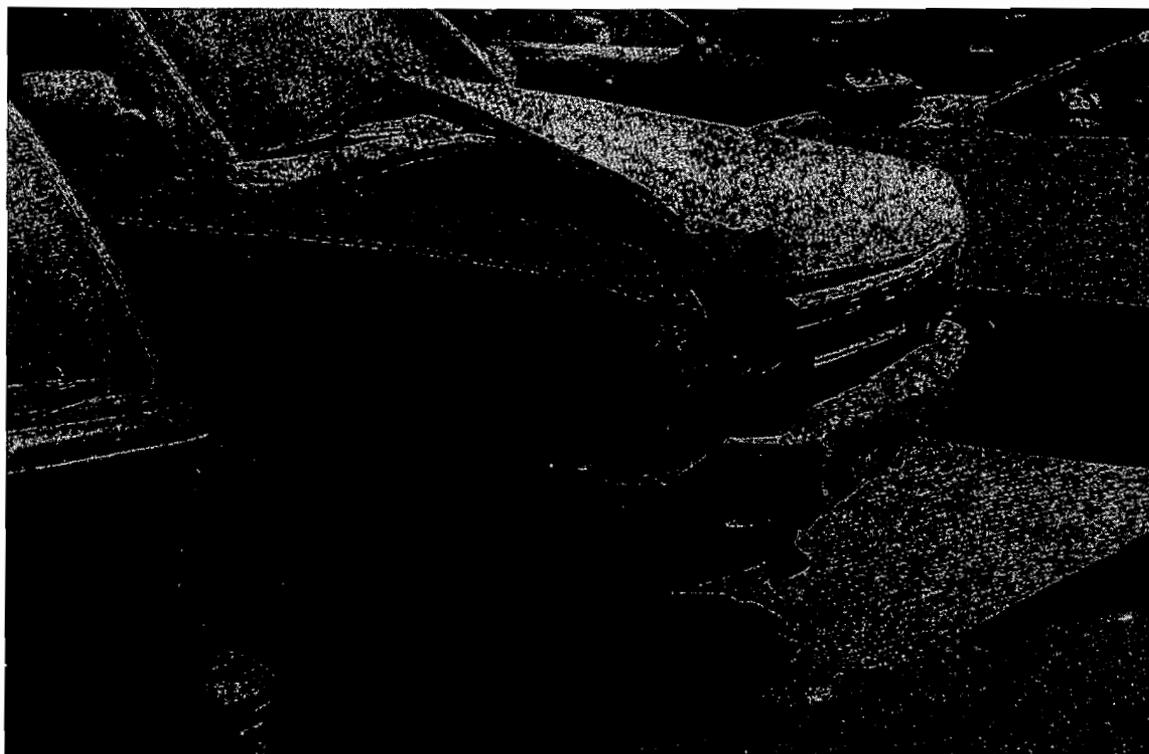
The front of the Dodge pickup struck the right side of an Oldsmobile Cutlass when it turned left into its path at an intersection. The pickup driver was restrained by the lap/shoulder belt. The adult in the right front seat, the 4-year-old and 5-year-old females in the front center, and the 7-year-old male in the rear of the pickup were not restrained. The 4-year-old female received moderate injuries, and the other pickup occupants received minor injuries. The driver of the Oldsmobile was restrained and received minor injuries.

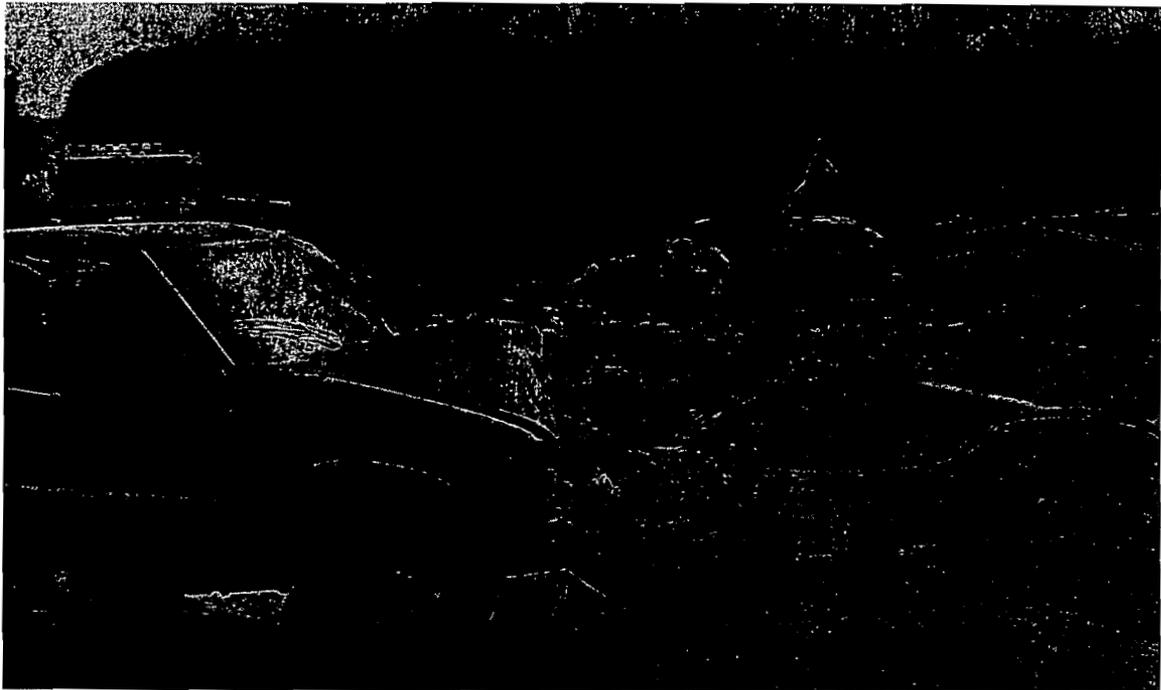
The Honda Accord was traveling northbound when a southbound Chevrolet pickup truck crossed the double yellow center line of the two lane roadway and struck the Honda head on. The Chevrolet overrode the left front of the Honda, rolled 360 degrees about its longitudinal axis and came to rest on its wheel on the southbound lane shoulder. The Honda rotated about 85 degrees about its vertical axis in a counter clockwise direction and came to rest on its wheels on the right edge of the northbound lane. The driver of the Chevrolet was fatally injured, while the driver of the Honda and the lap belted 3-year-old female passenger at the rear center seat position sustained serious injuries. The left rear passenger of the Honda sustained a moderate injury while the other two passengers were not injured; they all were lap/shoulder belted.

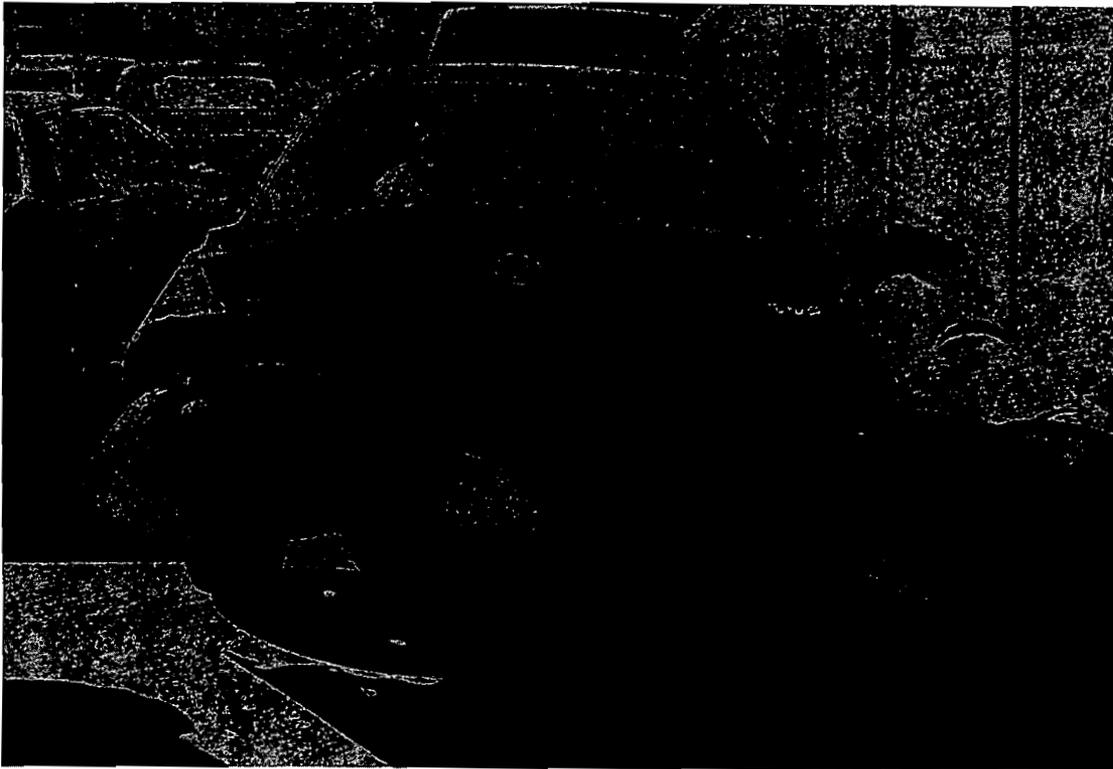
The Ford Fairmont was stopped ahead of the Toyota at a red light. The Ford Escort failed to stop and struck the Toyota in the rear. The 24-year-old driver of the Toyota and the 8-year-old male in the right front seat were wearing lap/shoulder belts and were not injured. The 7-year-old male in the right rear seat was wearing a lap belt, and struck his head on the back of the right front seat. The 21-year-old driver of the Escort and the two adults (20-year-old female in the left rear seat and 30-year-old female in the right rear seat) were wearing their lap/shoulder seat belts. The 30-year-old female was wearing the shoulder belt under her right arm. A 33-month-old male riding in a forward facing child restraint system was not injured.

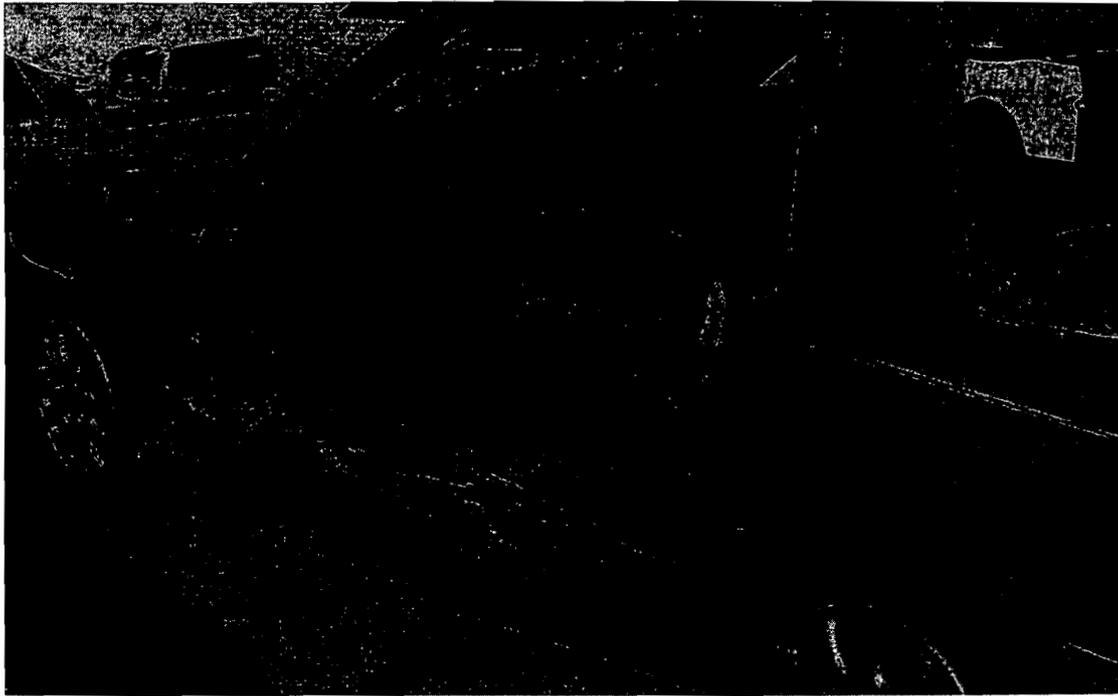
The Nissan 200SX was struck broadside, on the left side at the driver door location, by the front of a Mazda pickup truck. Both vehicles received heavy damage. There were four occupants in the Nissan. The 25-year-old female driver and 37-year-old female right front passenger were restrained with lap/shoulder belts and were treated for minor injury. Two 4-year-old children riding in the back seat were unrestrained and uninjured. There is no restraint or injury information available for the two adult males in the Mazda, as they fled the scene after the accident.

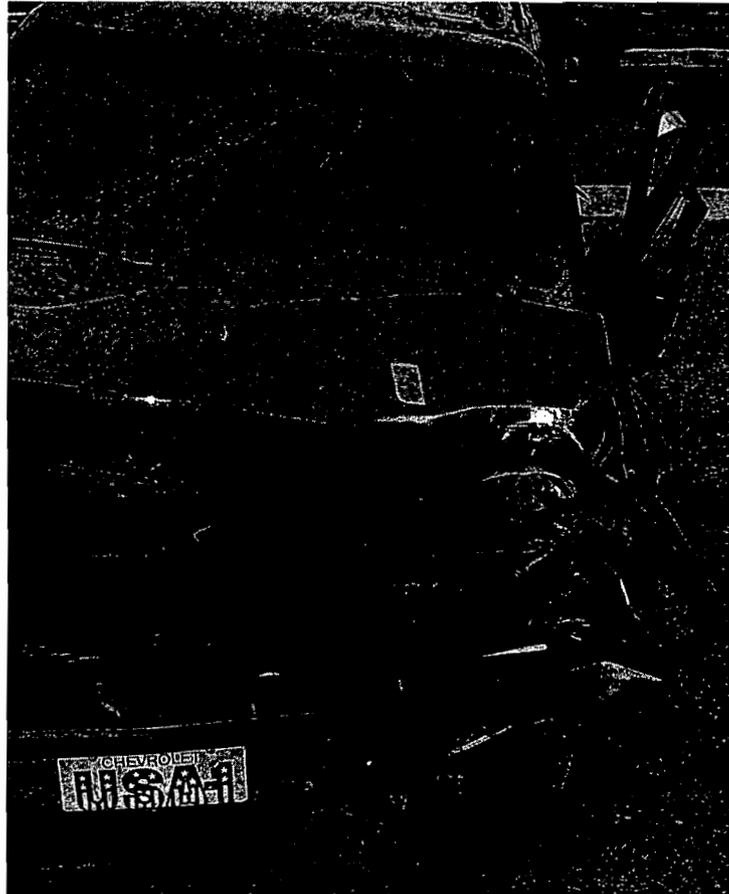
Collision Diagram

A Chevrolet Blazer was eastbound. The vehicle was occupied by a 28-year-old female driver and a 4-year-old female seated in the right front seat. The Chevrolet failed to negotiate a right turn and crashed into a wooden utility pole. The driver was unrestrained and sustained minor injuries. The 4-year-old female in the right front passenger seat was restrained by the lapbelt portion of a lap/shoulder belt and sustained moderate injuries.

Occupant Location	Injuries	AIS	Probable Source
Vehicle 1 Front, right	Kidney Contusion	2	Lapbelt
	Contusions, abrasions upper pelvic area	1	Lapbelt
	Forehead abrasion	1	Dashboard
	Contusions and abrasions to nose	1	Dashboard

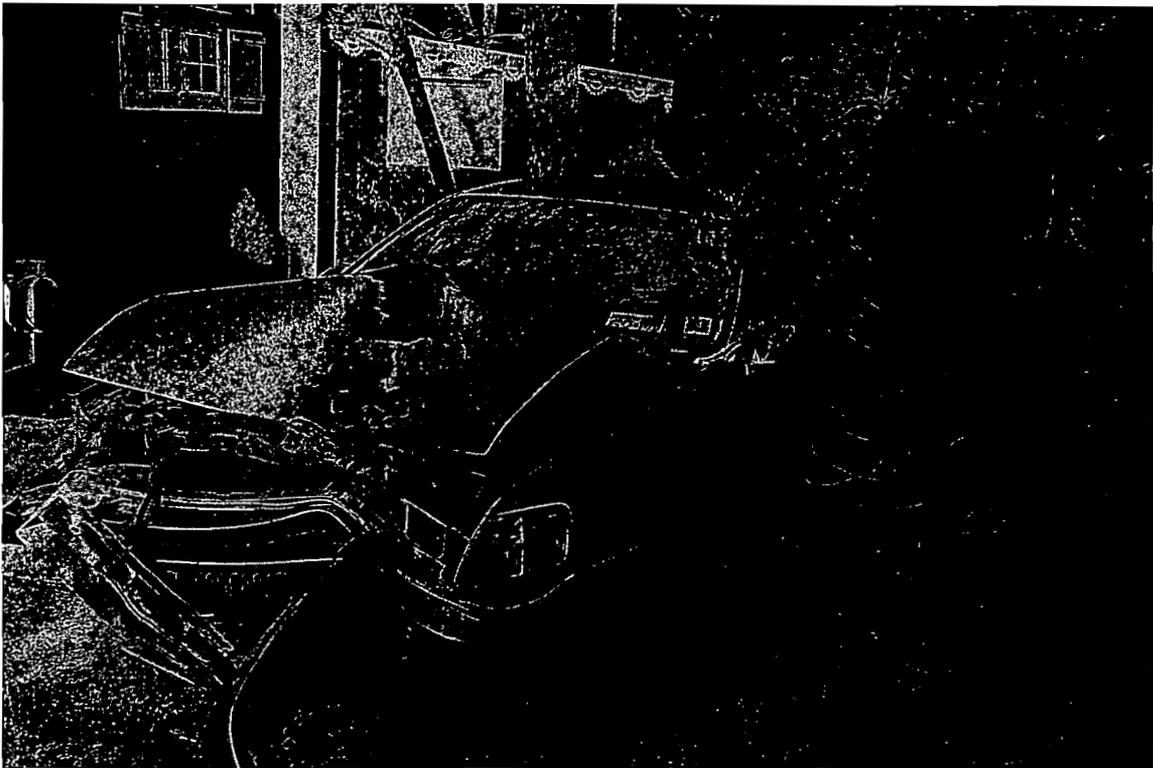
Collision Diagram

The Mercury was westbound when it drifted over the center line, crossed both eastbound lanes, crashed into and knocked down a wooden utility pole. A 1-year-old female seated in the right rear was restrained by an Evenflo Ultara, convertible, forward facing, child restraint system and was uninjured. A 12-year-old male seated in the left rear was not restrained by the available lapbelt and sustained minor injuries. The driver and front seat passengers were not restrained and sustained minor injuries.

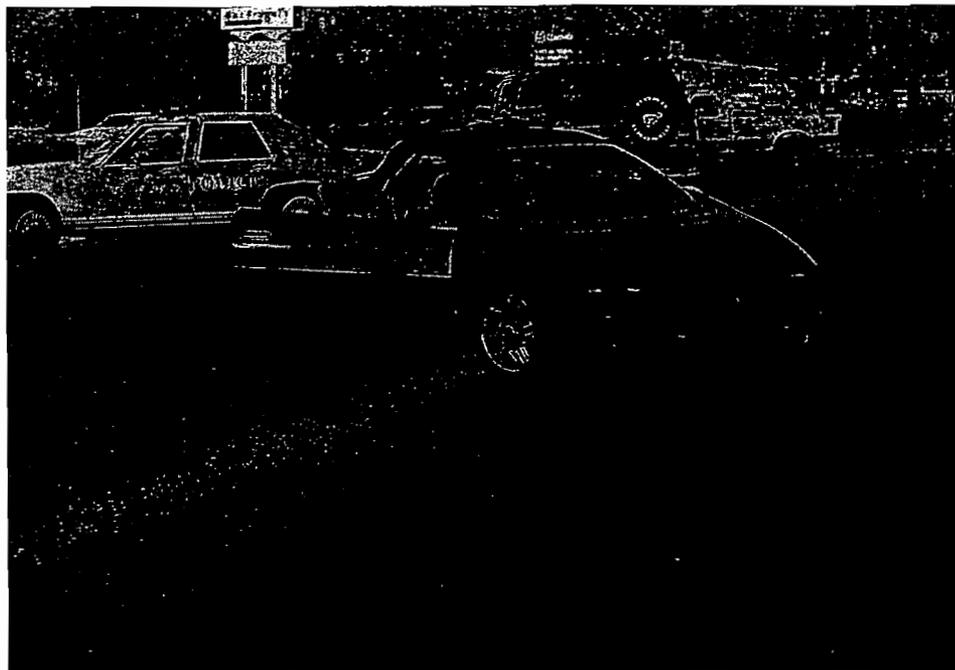
Collision Diagram

Accident Number: WRH-96-FH-01
Date: October 10, 1995
Location: N. Salt Lake, Utah
Vehicle 1: 1994 Chevrolet Camaro
Delta V: 9 to 15 mph (estimated)

A Chevrolet Camaro convertible had entered a parking lot when the vehicle overrode a curb, striking the front crossmember. Both driver and passenger air bags deployed. The 42 year-old female driver sustained abrasions on the face and neck from the air bag. The 5-year-old male in the right front seat sustained fatal injuries from the air bag, including a broken neck and crushed spinal cord. Based on the vehicle's diagnostic electronic monitoring of the driver belt system it was determined the driver was not wearing the lap/shoulder belt. The 5-year-old male is believed to have been wearing only the lap portion of the lap/shoulder belt.

Occupant Location	Injuries	AIS	Probable Source
Right front passenger	Crushed spinal cord with C-1 to C-3 fractures and dislocation	6	Impact with air bag door and air bag
	Brain contusions	3	Impact with air bag door, air bag, and seatback
	Stretching laceration of inferior vena cava	3	Being partially held down by the lap belt while being forced upward and rearward by the air bag
	Fracture of coronal suture	2	Impact with air bag door and air bag
	Subgaleal hemorrhage on left side of scalp	2	Impact with air bag door and air bag
	Subgaleal hemorrhage on right occiput	2	Impact with air bag door and air bag
	Intrathymic hemorrhage	2	Impact with air bag
	Severe facial abrasions	2	Impact with air bag
	Linear contusion from left ear and extending to right forehead	1	Impact with air bag door
