# Cell-level IIISC, Nail Penetration, Hot Pad and ARC Tests for LVP65

CORPORATE RESEARCH

PROJECT: 13CA50802 (Extend)

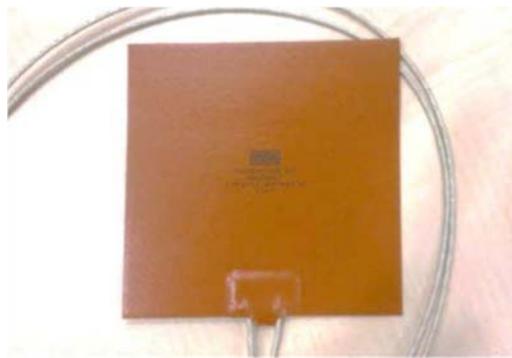
1. A 250W hot pad is attached to one side of LVP65 cell.
2. The test sample is to be setup inside a test chamber (Figure 15). The hot pad is under the test cell. Sample is to be conditioned at specified temperature for at least 2 hours but no more than 6 hours before test.
3. Connect the cell to MACCOR 4000 series system if an electrical load is required.
4. During the test, cell voltage and the temperature on the cell case are monitored and recorded.
5. Turn on the hot pad to heat the sample up to 160°C and turn off the power if no event occurs. Turn on the power again when the temperature decreases down to 150°C. Then wait until thermal runaway occurs.

Figure 14. The hot pad (250W) used in HP test

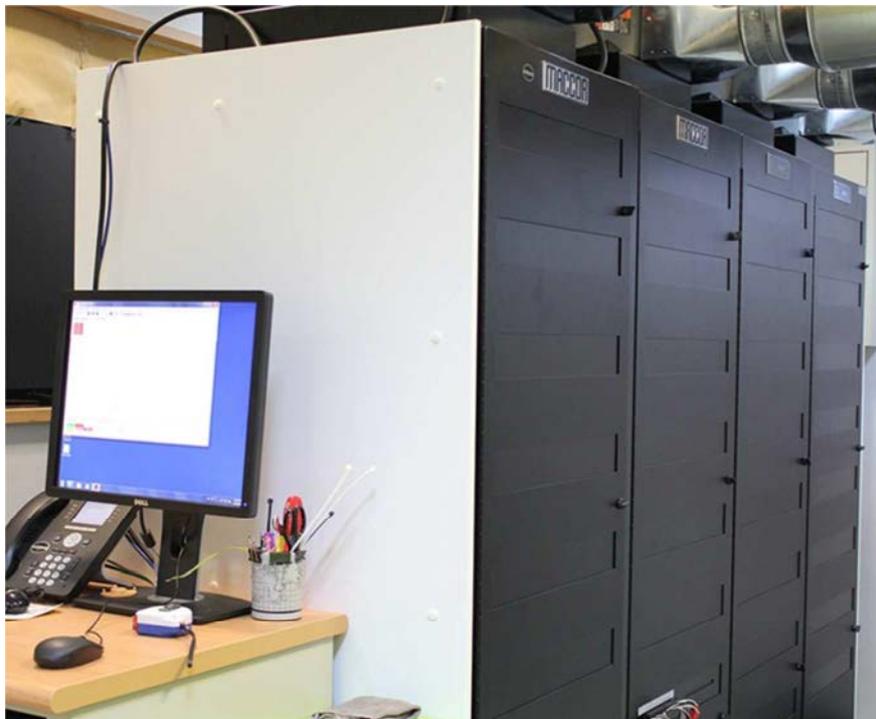
- Press Equipment: same as IIISC test
- MACCOR 4000 Series System: 10V/10A maximum rating (Figure 16)

**Figure 16. MACCOR 4000 battery conditioning system**

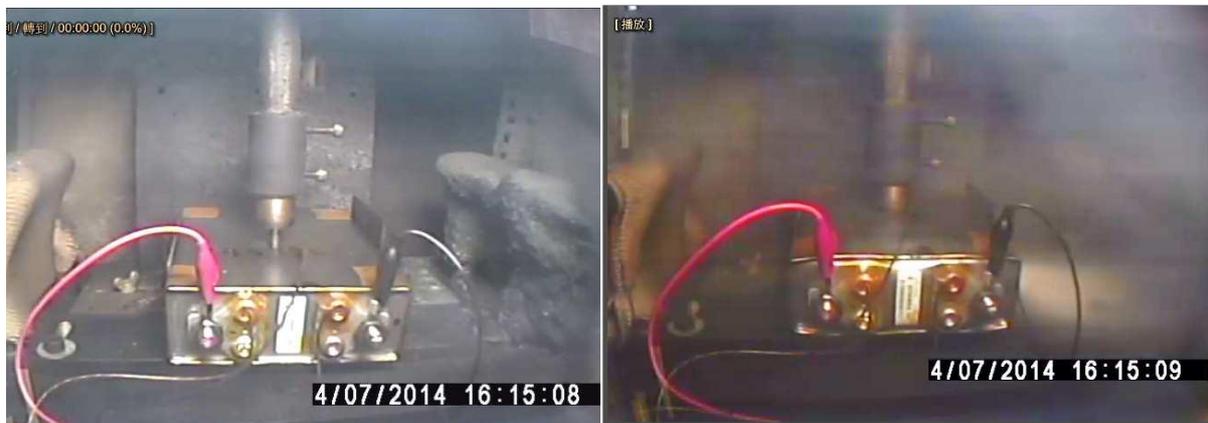
Some images are captured in Figure 22 from the video of IIIS test of sample 149-2. We can see the test cell swelling right after the ISC is triggered and the cell venting can also be observed.

Figure 22. Failure Mode observed in IIISC test (Sample: 149-1)

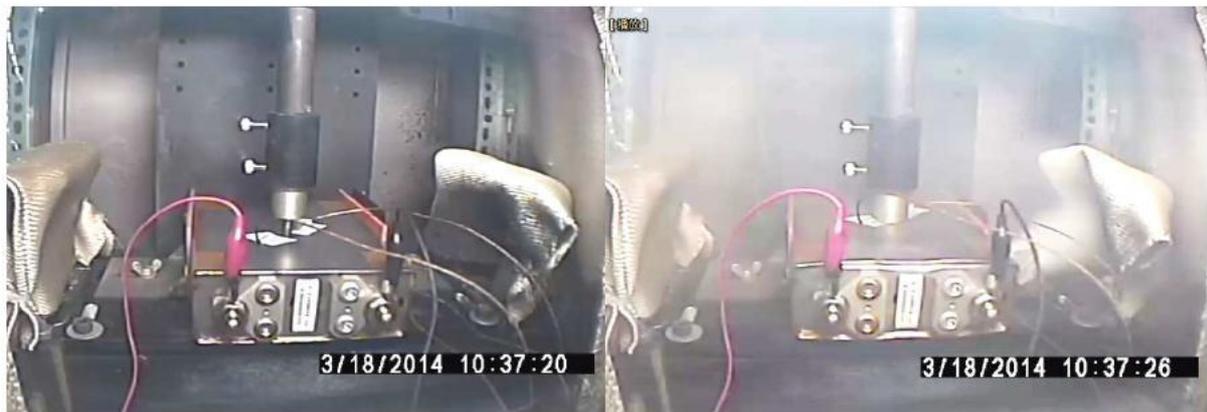
Figure 28. Failure Mode observed in IIISC test (Sample: 241-1)

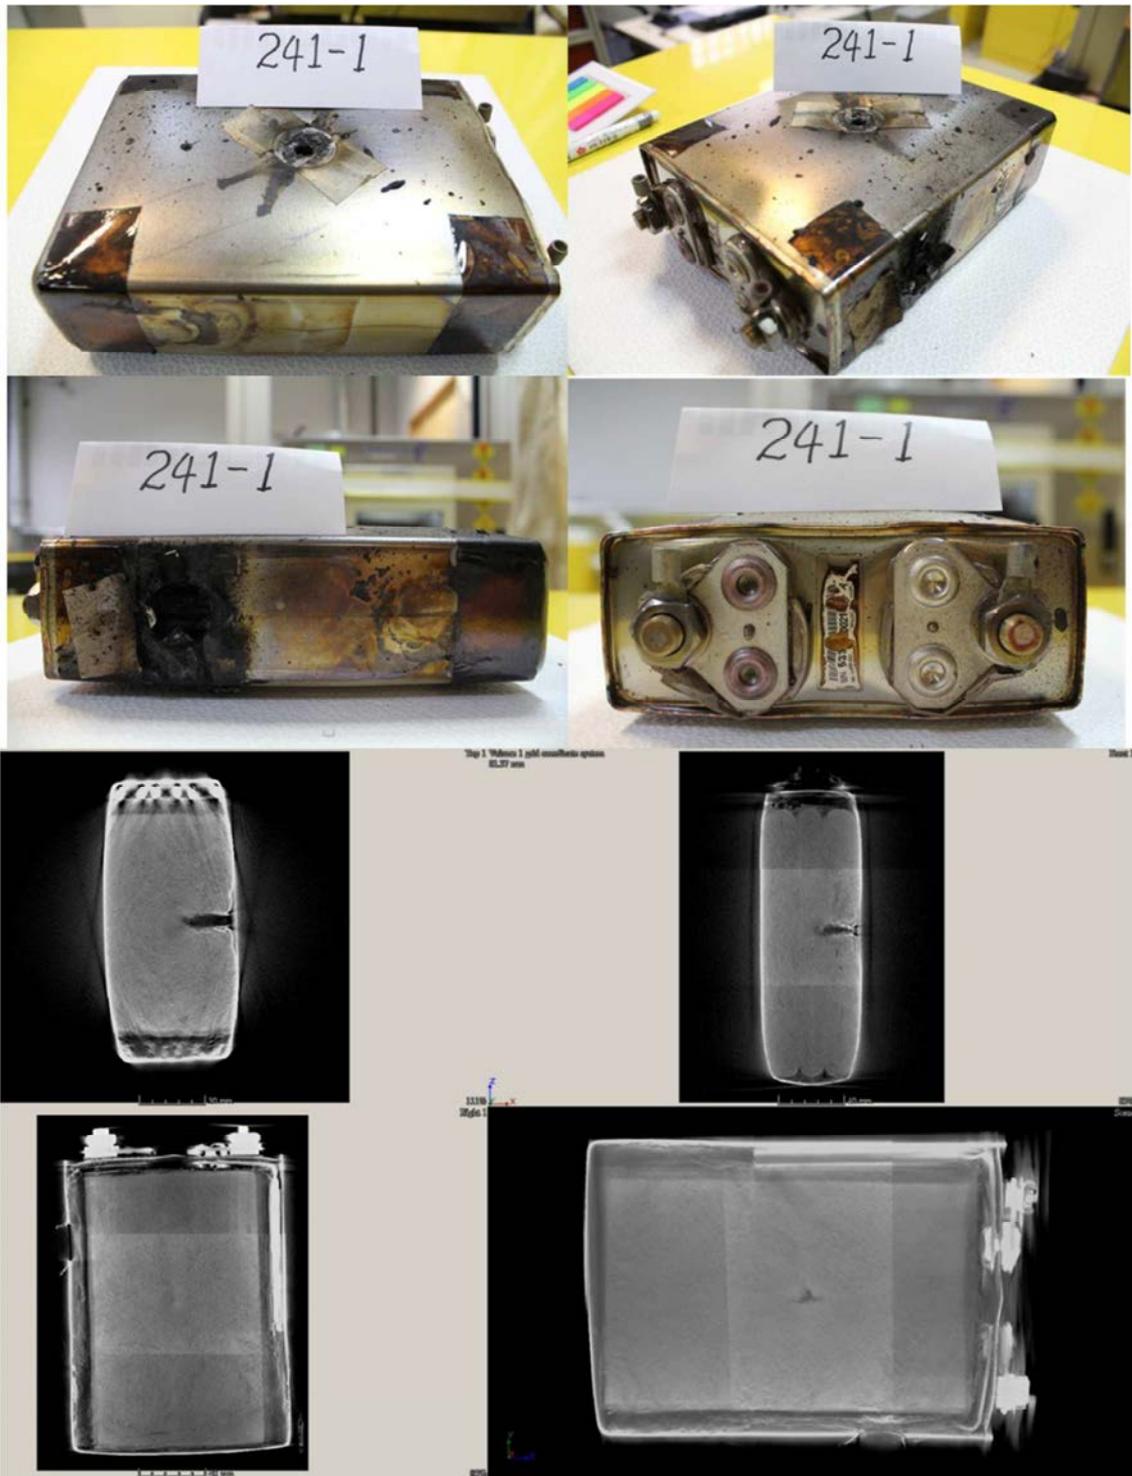
The pictures of tested sample 241-1 and the CT scan images are shown in Figure 30. This sample is swollen after the ISC test and W1 is penetrated by the indenter because the indenter was kept at the location after the ISC was triggered. According to the appearance of tested sample, the vent plate is burned and the insulation material (i.e. [REDACTED] between the rivet and terminals is melted and deformed.

Figure 30. Appearance of tested sample and CT scan after IIISC test (Sample: 241-1)

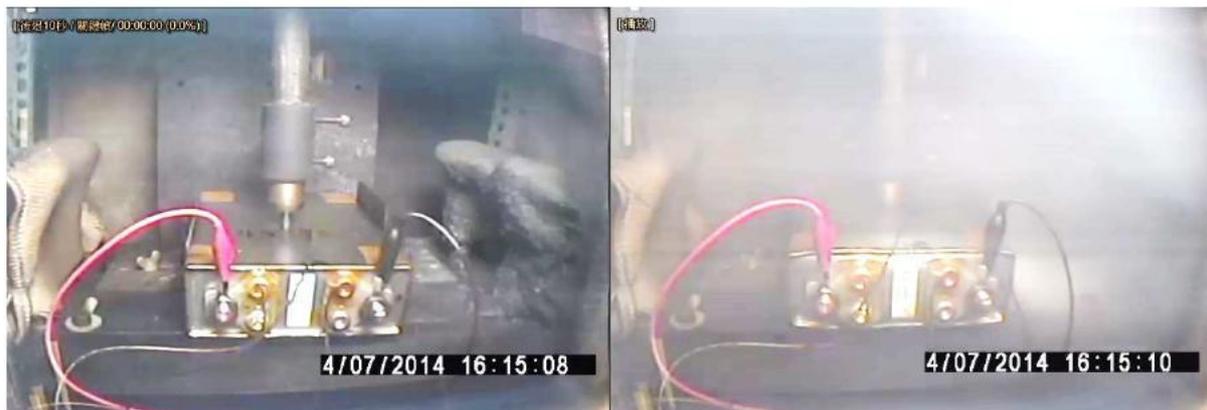
Figure 34. Failure mode observed in IIISC test (Sample: 149-2)

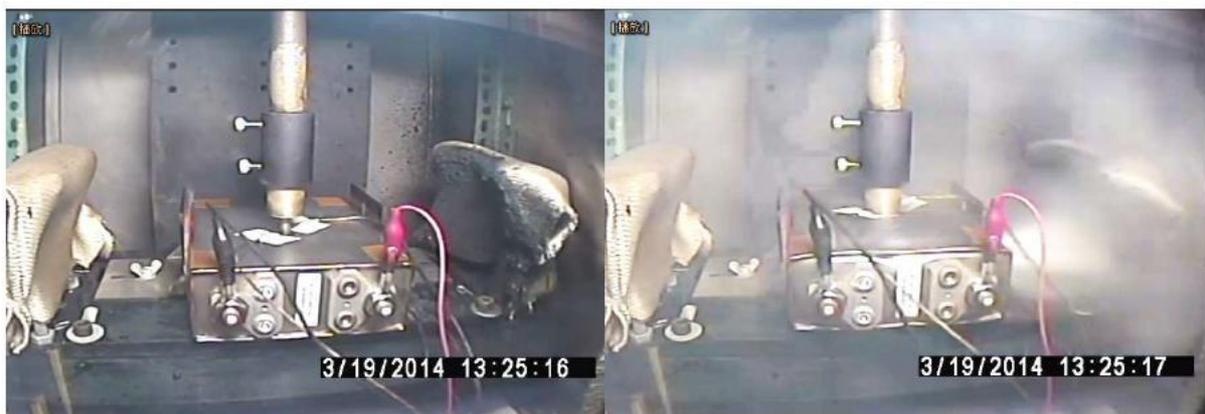
Figure 37 to Figure 42 show the detailed data profiles, status of open fuse, appearance of tested sample and the CT scan images of sample 241-2, which is the second test for IIISC under 70°C. The cell behavior is also very similar to the IIISC at 25°C but the overheating rate is faster. Besides, the open fuse can be observed at both W1 and W2. Under a higher test temperature, the IIISC test can cause more fuses to open. It's likely that the W2 got an ISC due to the overheating propagated from W1 before the trigger of material decomposition chain reaction in W2.

Figure 40. Failure mode observed in IIISC test (Sample: 241-2)

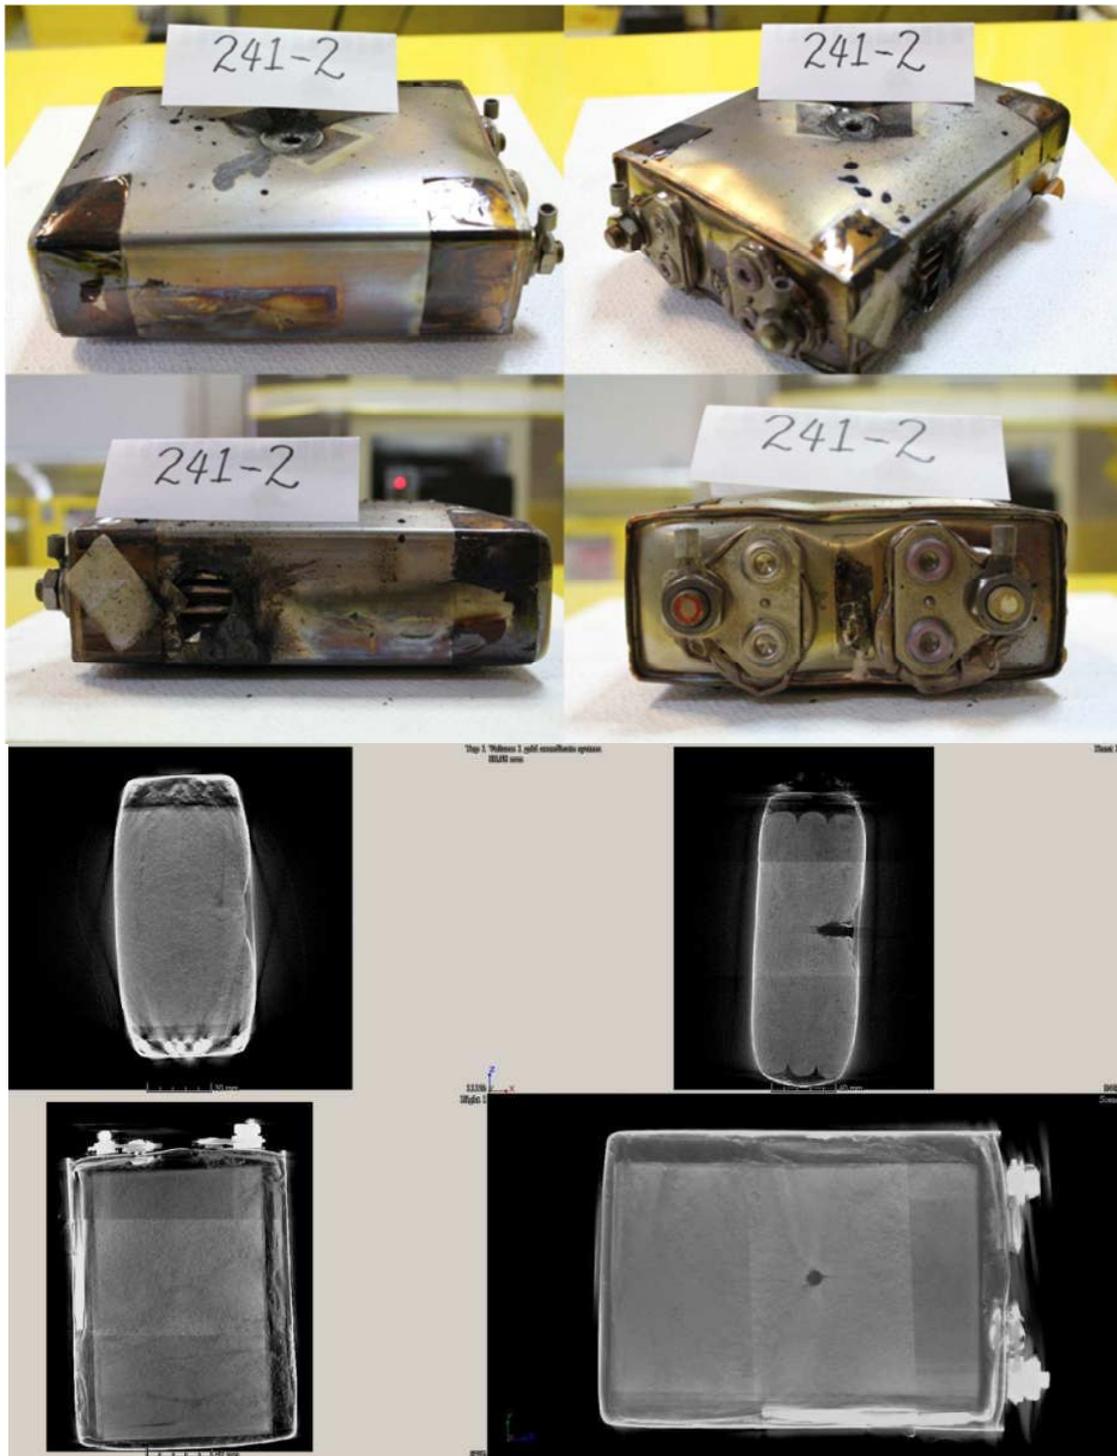
Figure 42 Appearance of tested sample and CT scan after IIISC test (Sample: 241-2)

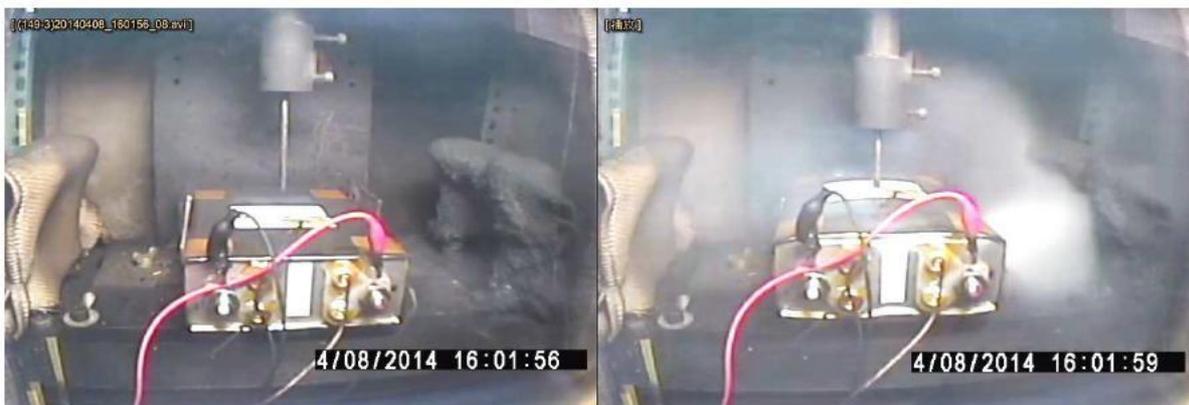
Figure 46. Failure mode observed in side-penetrated NP test (Sample: 149-3)

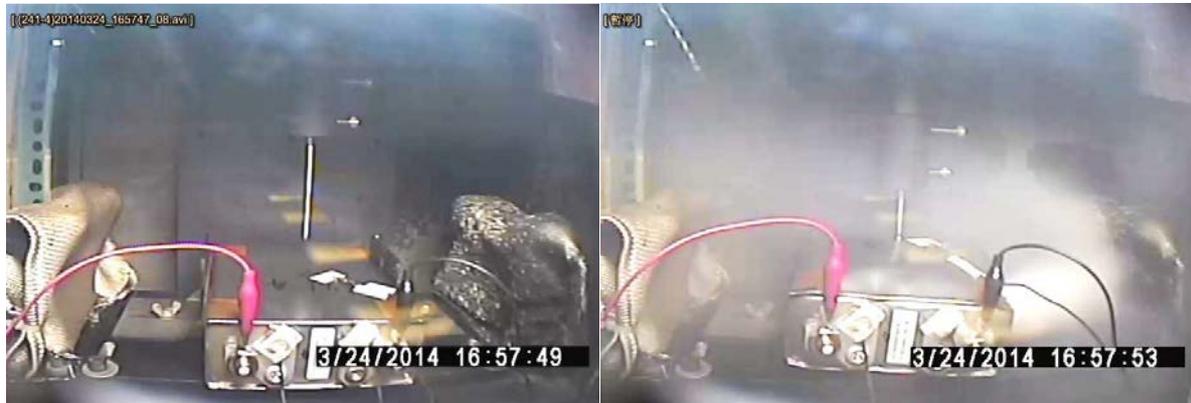
Figure 49 to Figure 52 are the cell voltage versus load data profiles, status of open fuse, appearance of tested sample and the CT scan images of sample 241-4. The test results are similar to previous test sample (149-3) and open fuse is also observed in W1 only.

Figure 51. Failure mode observed in side-penetrated NP test (Sample: 241-4)

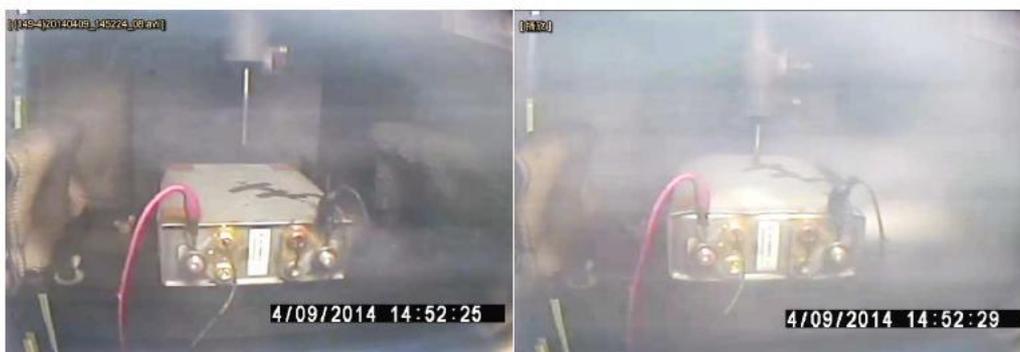
The cell voltage versus load profile is shown in Figure 54. In this test, we can observe the increase in load when the cell got voltage drop due to the trigger of ISC. Figure 55 shows that there are fuses open in both W1 and W2. Similar to other samples, the test cell also got swelling and venting after the occurrence of ISC. The failure mode, the appearance and the CT scan images of the tested sample, 149-4, are shown in Figure 56 and Figure 57.

Figure 56 Failure Mode observed in side-penetrated NP test (Sample: 149-4)

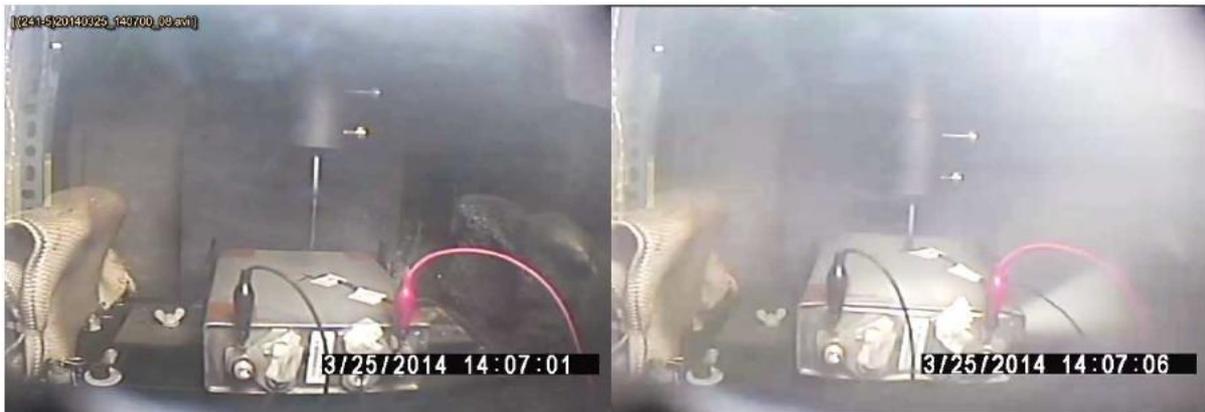
Figure 58 to Figure 62 show the detailed data profiles, status of open fuse, appearance of tested sample and the CT scan images of sample 241-5, which is the second test sample for side-penetrated NP under 70°C. The cell behavior is also very similar to other samples in side-penetrated NP tests. In this case, the open fuse can be observed in W1 only.

Figure 61. Failure mode observed in side-penetrated NP test (Sample: 241-5)

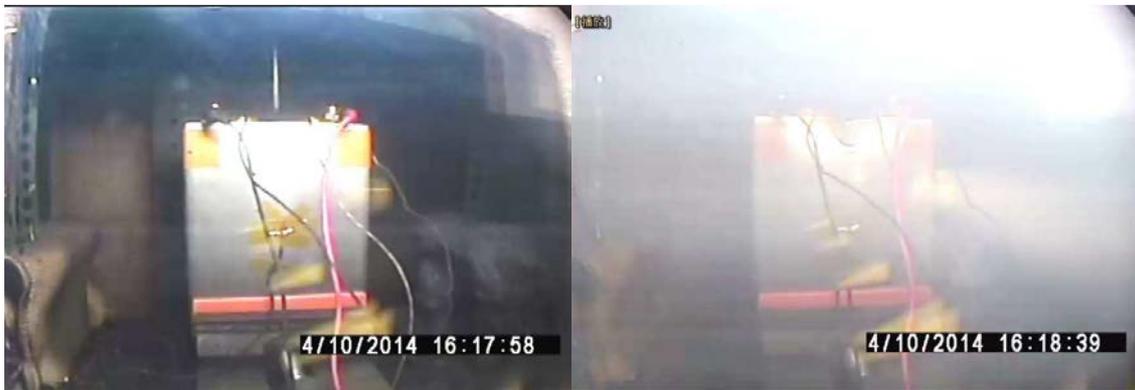
In Figure 66 and Figure 67, we can see the failure mode, the appearance and CT scan images of tested sample, 149-5, after the top-penetrated NP test under 25 °C. Similar to the cases introduced previously, the cell vents and also has deformation and swelling after the test.

**Figure 66. Failure mode observed in top-penetrated NP test (Sample: 149-5)**

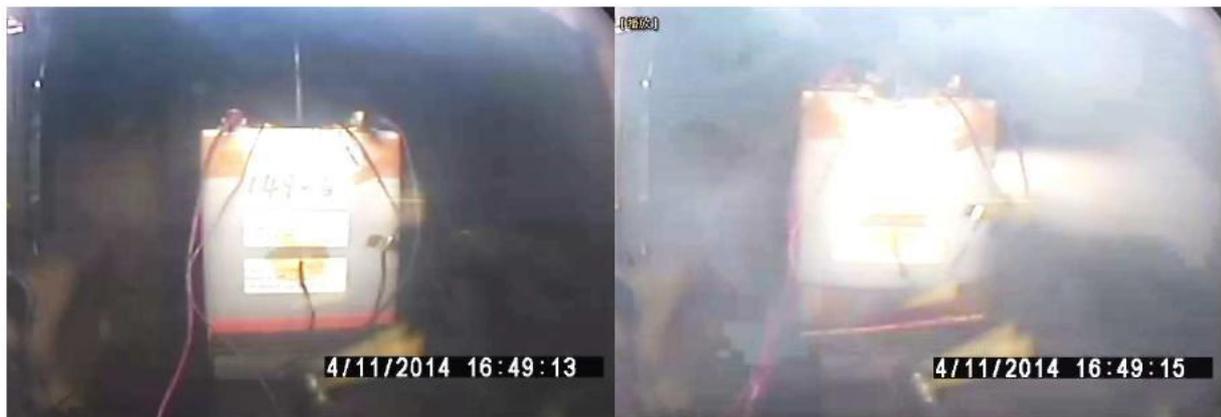
Figure 76. Failure Mode observed in top-penetrated NP test (Sample: 149-6)

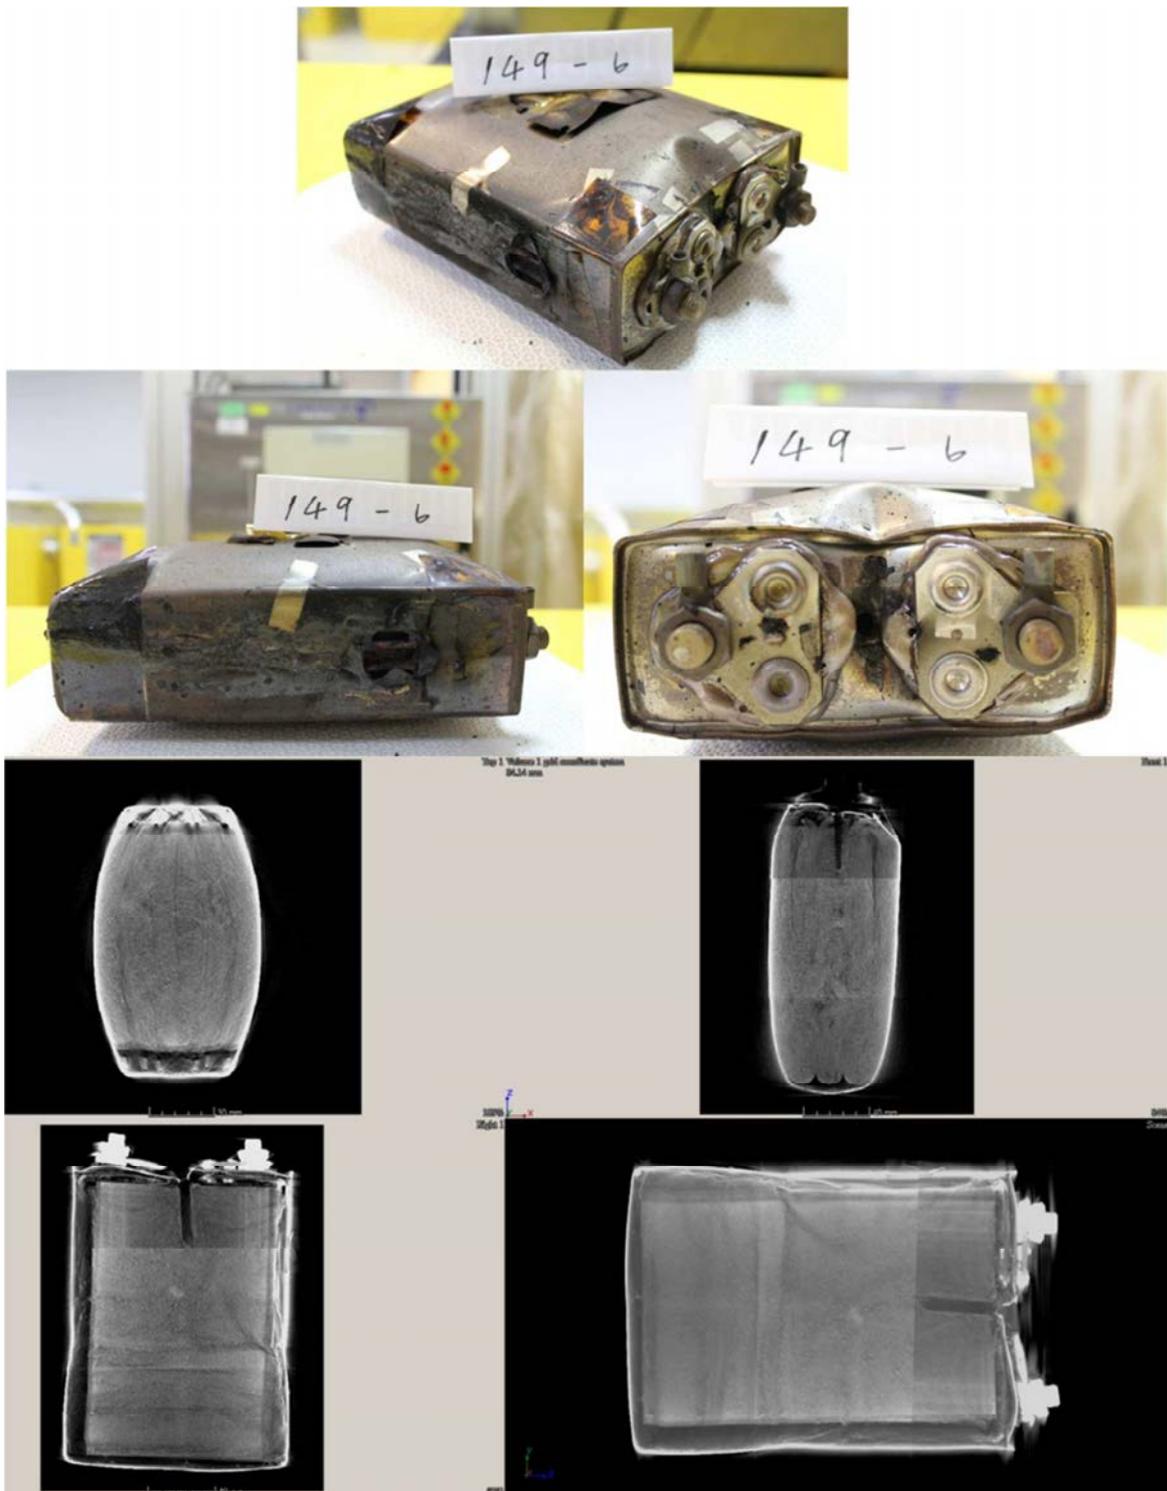
Figure 77. Appearance of tested sample and CT scan after top-penetrated NP test (Sample: 149-6)

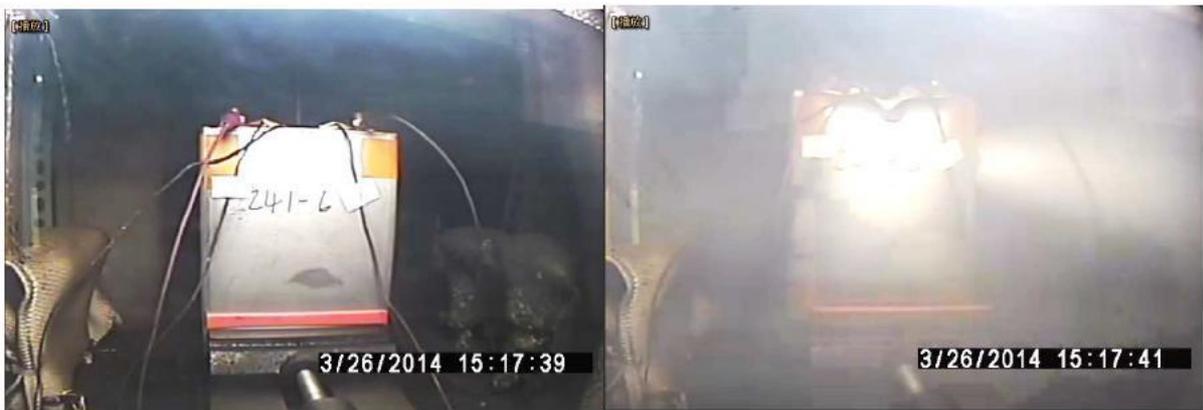
Figure 81. Failure mode observed in top-penetrated NP test (Sample: 241-6)

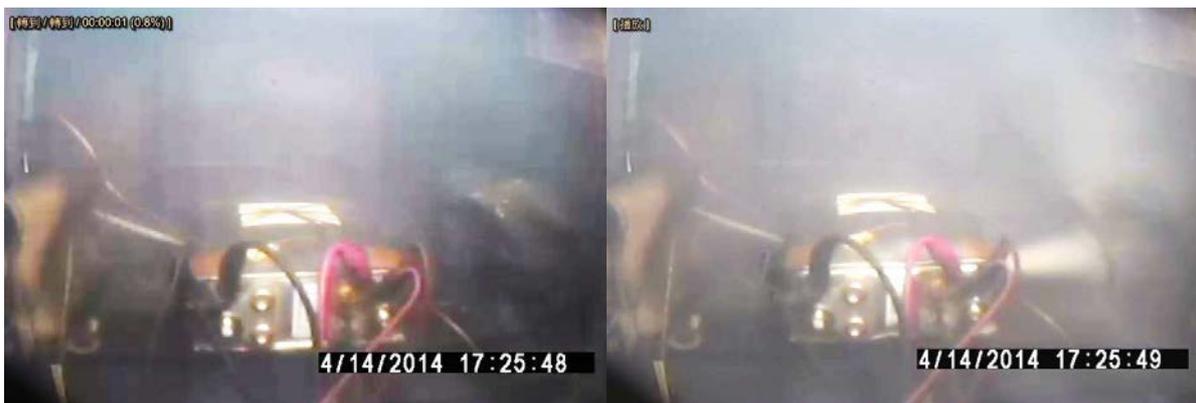
Figure 85 is the failure mode captured from the video during test. Figure 86 shows the appearance of tested samples and CT scan images 149-7.

Figure 85. Failure Mode observed in HP test (Sample: 149-7)

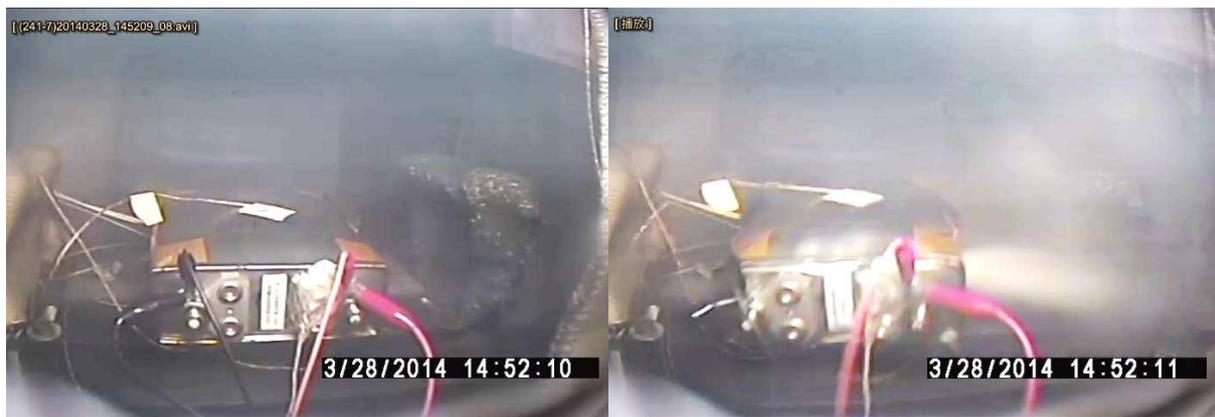
Figure 89. Failure Mode observed in HP test (Sample: 241-7)

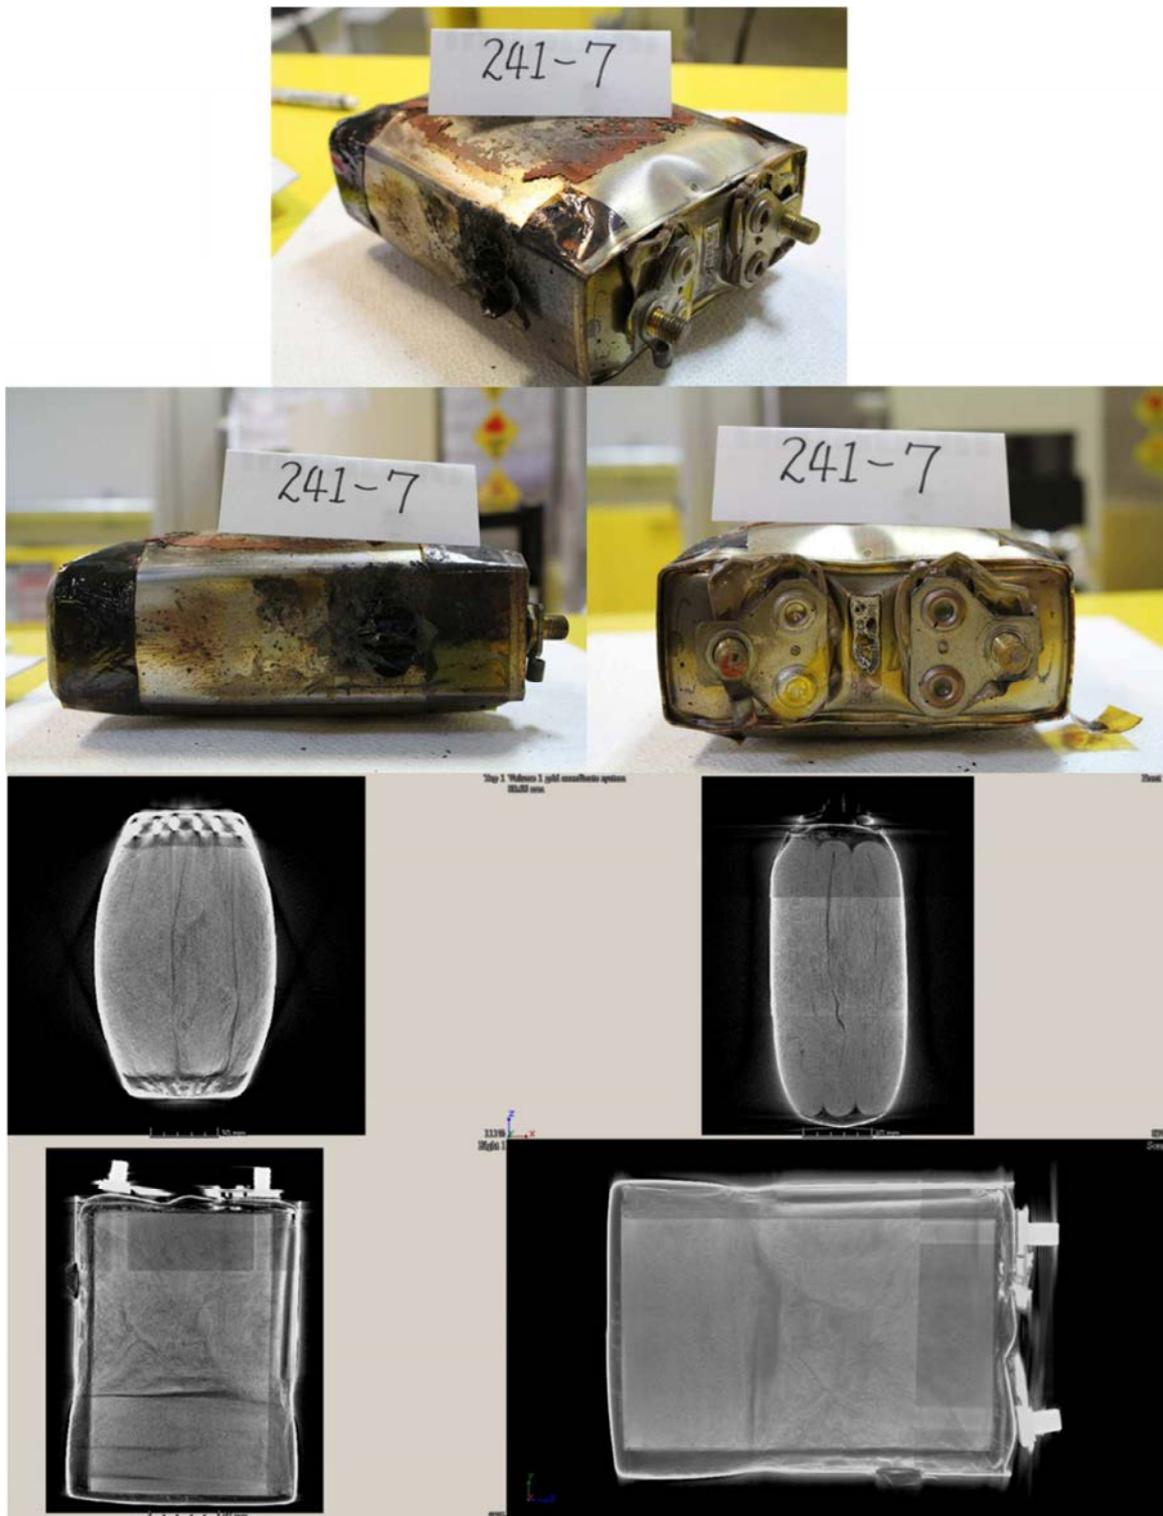
Figure 90. Appearance of Tested Sample and CT scan after HP test (Sample: 241-7)

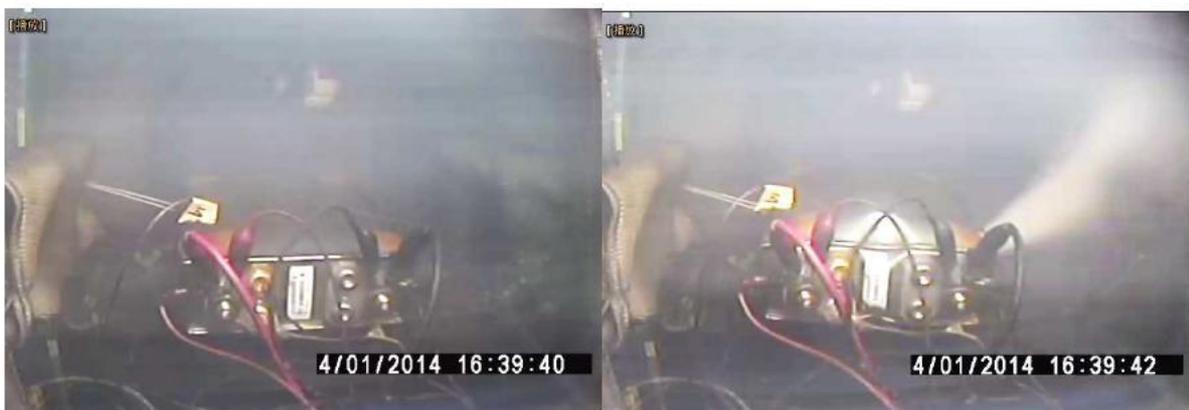
Figure 93. Failure mode observed in HP test with 8A load (Sample: 171-8)

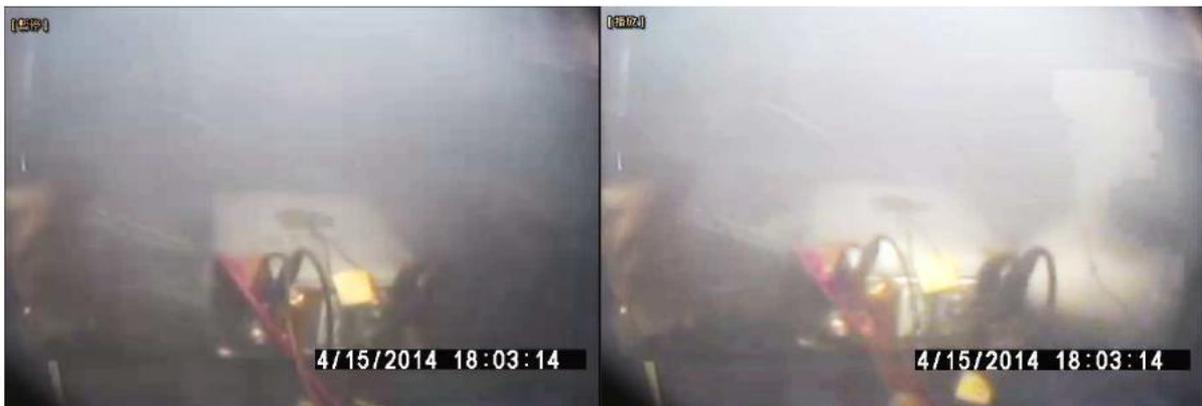
Figure 97 Failure Mode observed in HP test (Sample: 149-8)

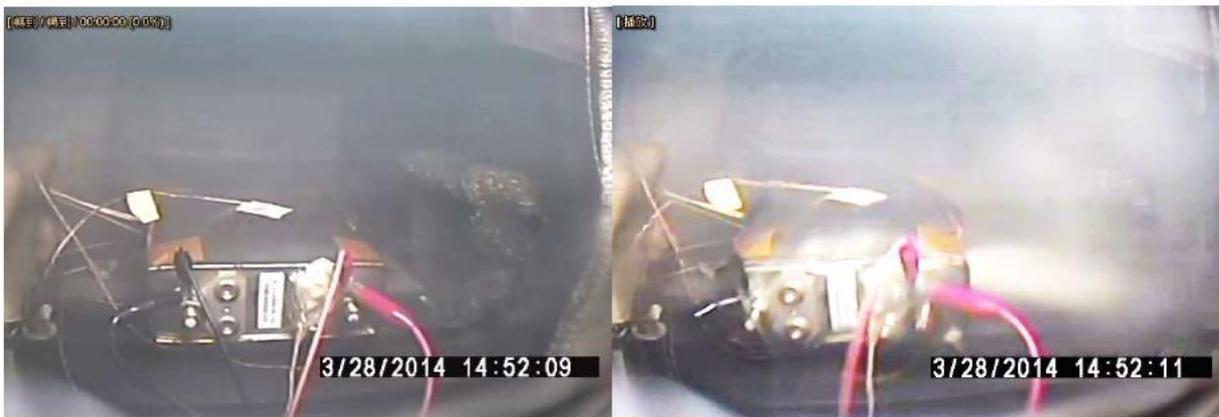
Figure 101 Failure Mode observed in HP test (Sample: 241-8)
