Airworthiness Investigation

Introduction

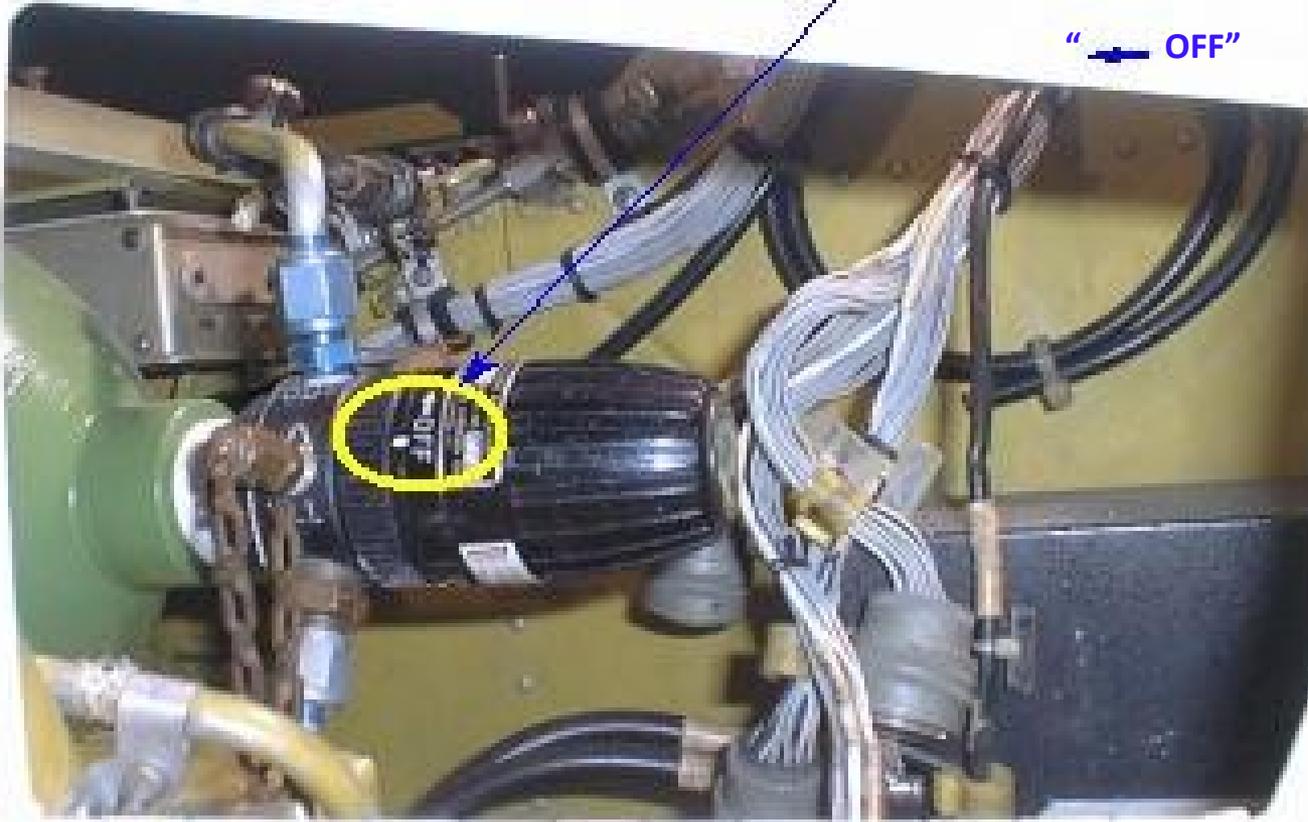
Regulator /Markings

- Pilot reports of confusion about valve status during preflight inspection
 - Labeling indicates “OFF” when the valve is open “ON”

“ ← OFF”

**Oxygen Bottle Regulator /Shutoff Valve
“Open (ON) Positon”**
