Conasauga, Tennessee Railroad/Highway Grade Crossing Accident

March 28, 2000

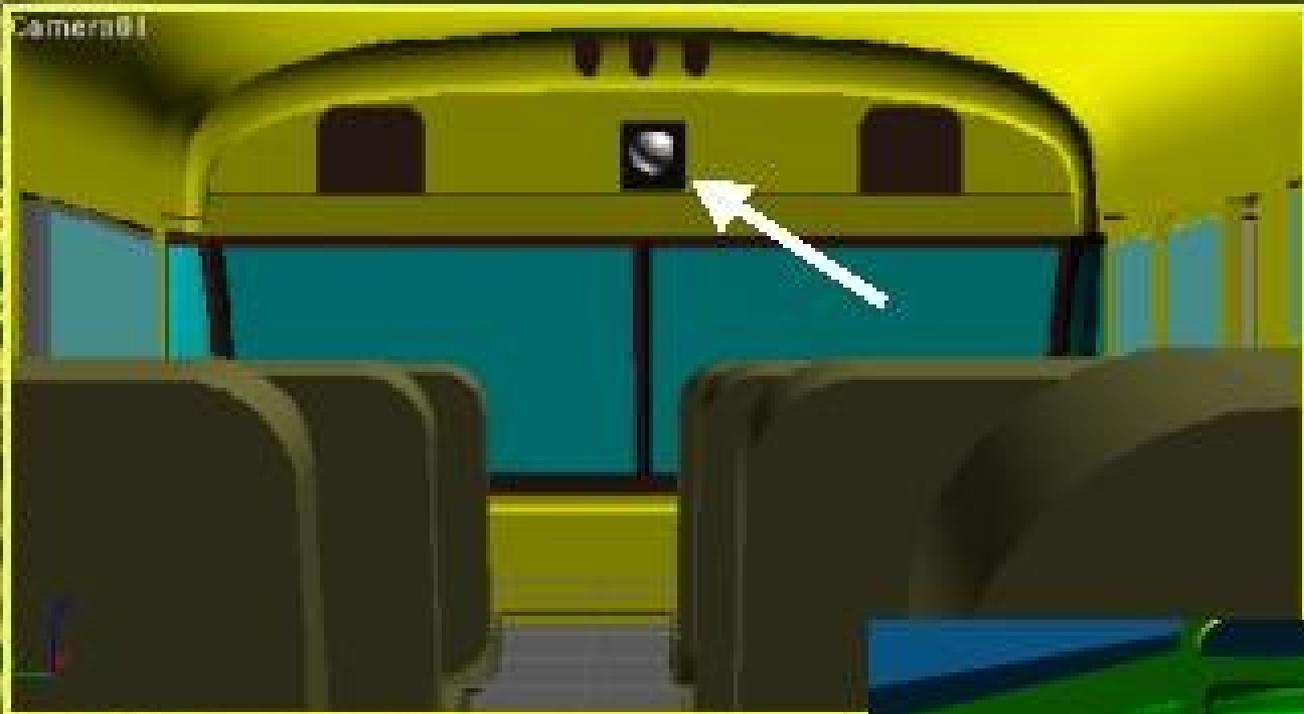
Video camera on bus

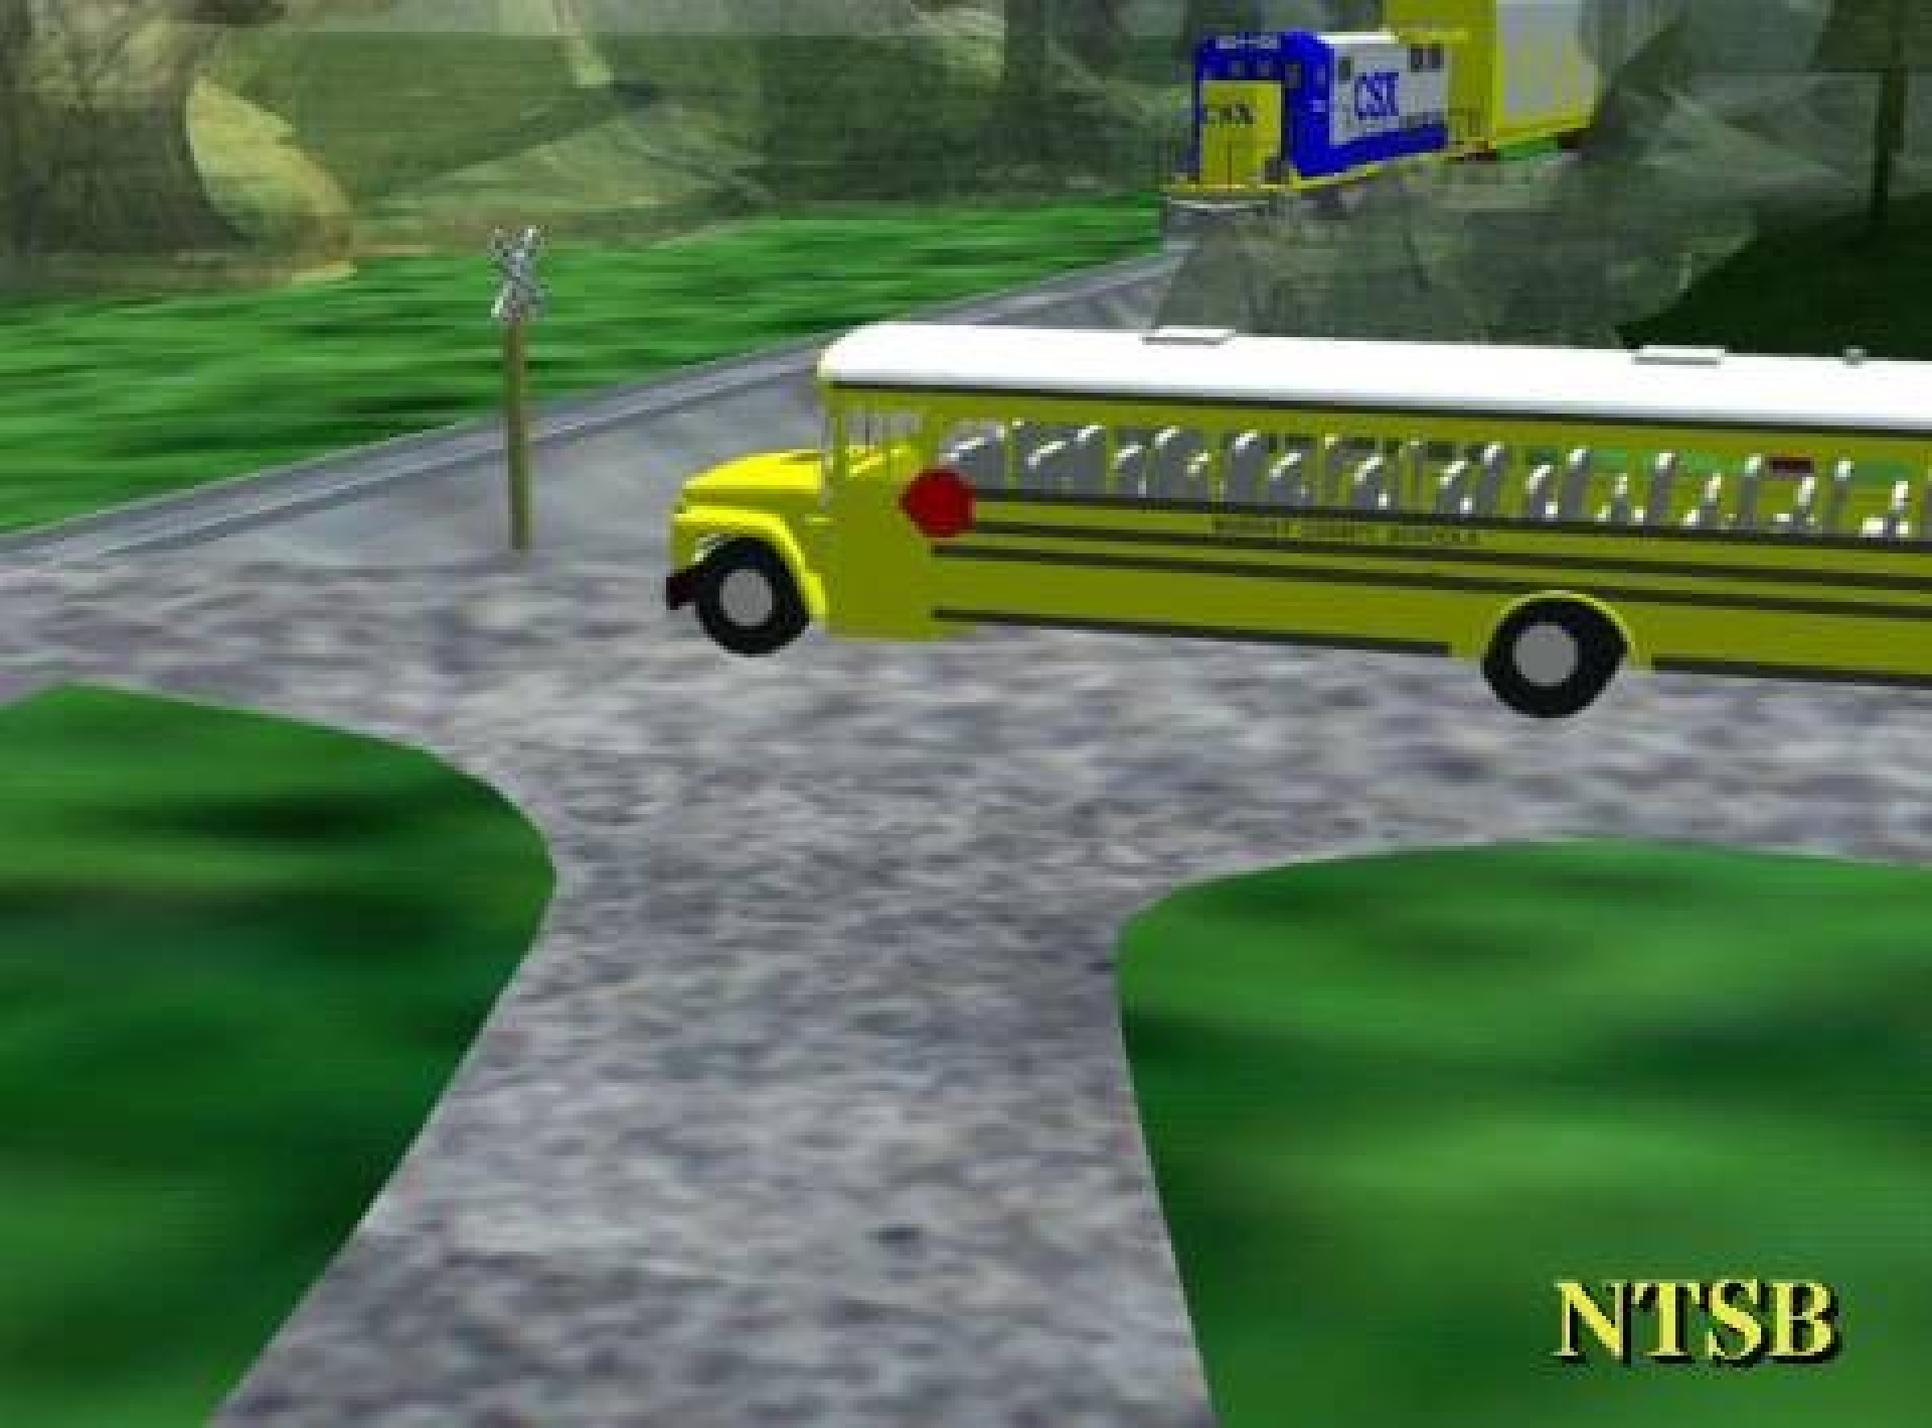
Vehicle Simulation

- Developed based on the physical evidence and onboard recording devices
 - Bus speed based on onboard video recorder
 - Train speed based on event data recorder
 - Vehicle damage patterns
 - Final rest locations
- Characterizes the best fit to physical evidence
- Representative of the accident sequence but does not show the actual accident

- School bus speed at impact was about 15 mph
- Train speed at impact was about 51 mph
- Peak school bus accelerations:
 - 30 Gs lateral acceleration
 - 2500 deg/second rotational acceleration
- Peak train deceleration: less than 2 Gs

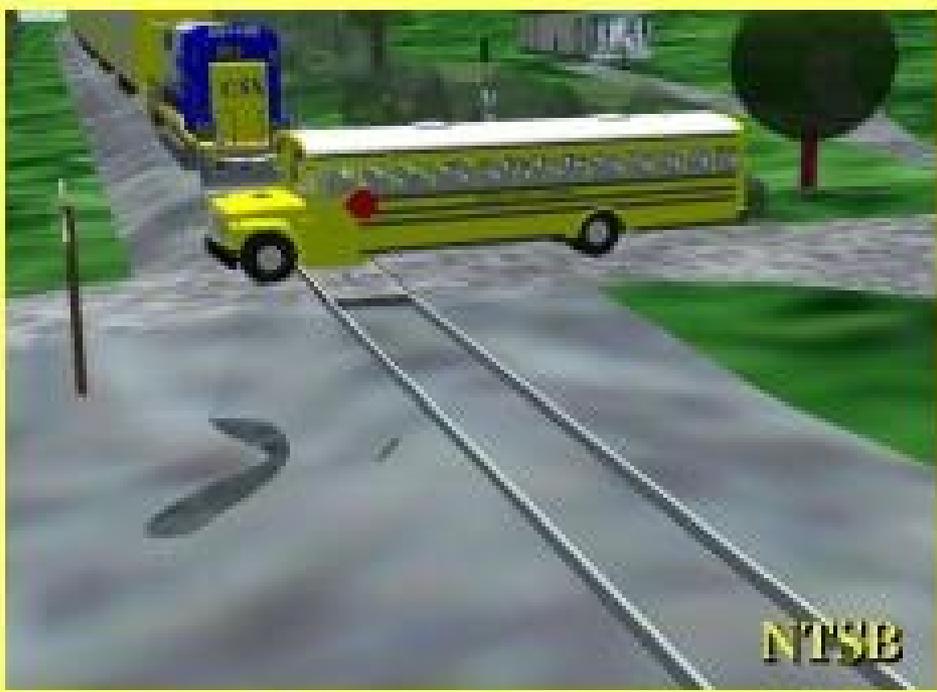
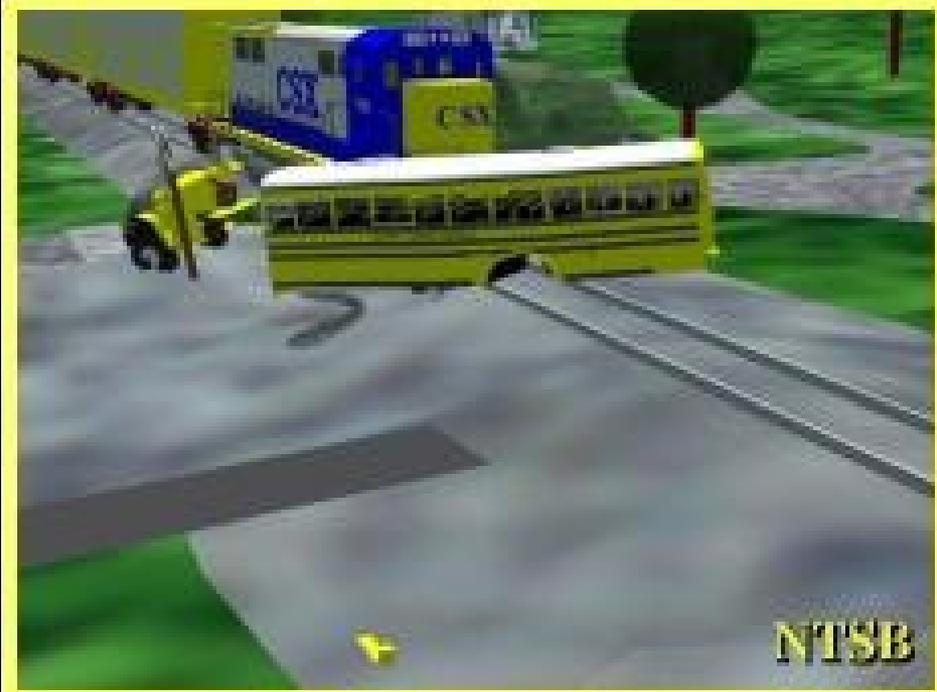
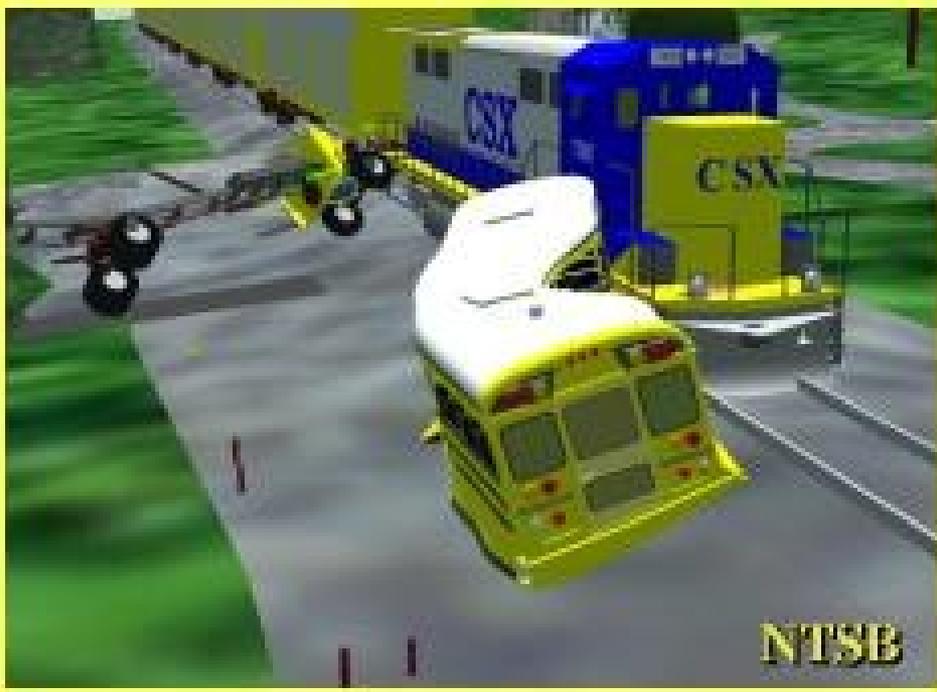
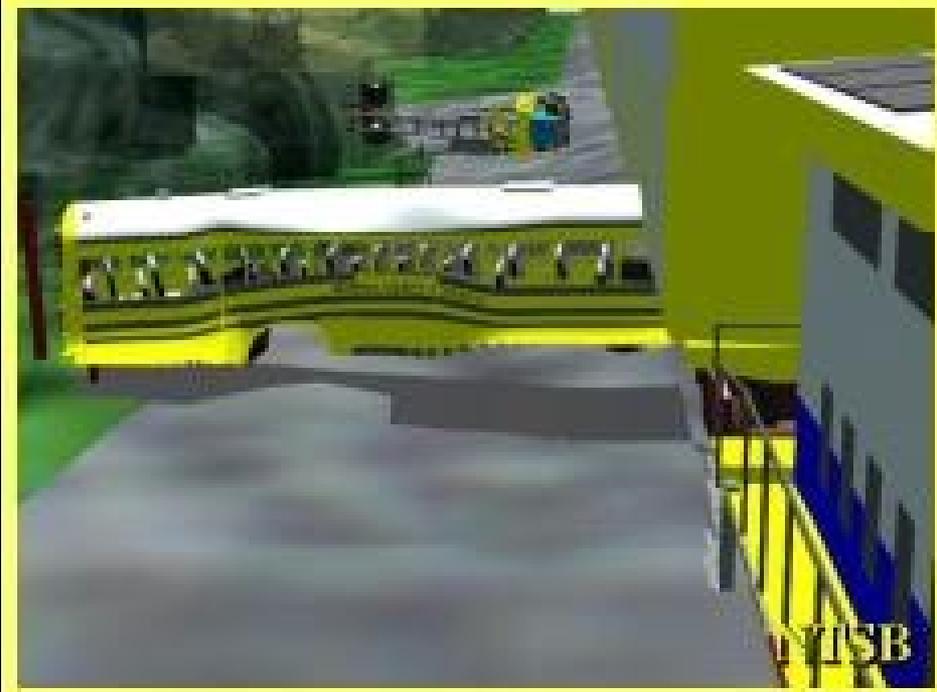
Simulation Videos

- Dynamic camera view trailing school bus
- Static camera view detailing collision and motion to final rest
- School bus driver's potential view
- Train engineer's potential view

- Train was potentially visible for about 2 seconds from the school bus driver's side window
- School bus was potentially visible for more than 4.6 seconds prior to impact

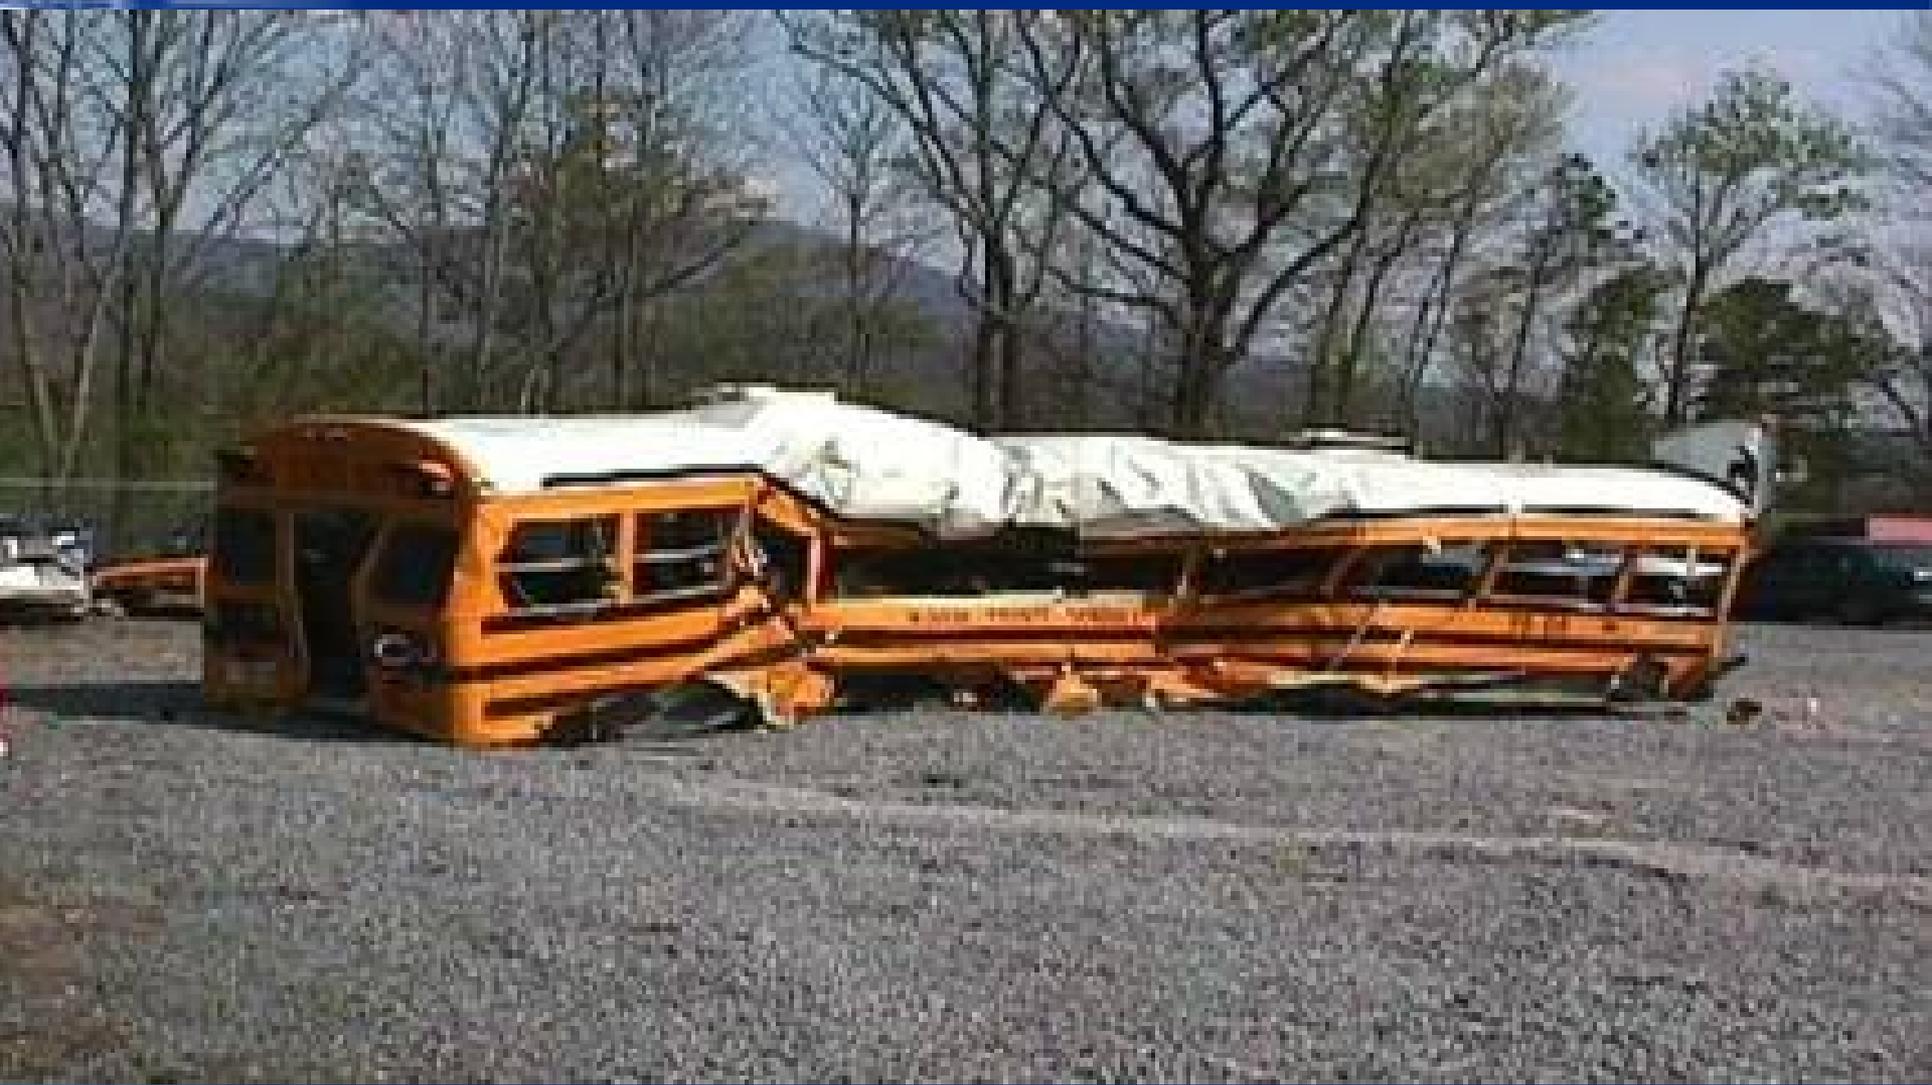
School Bus Driver Belt System

- Driver had been belted and was ejected
- Driver belt system anchor points spanned separated vehicle components
- Webbing failure occurred
- Potential for serious or fatal injury

- School bus driver seat belt system anchor point locations
- School bus sidewall and seat frame exemption from Federal Motor Vehicle Safety Standard (FMVSS) 222

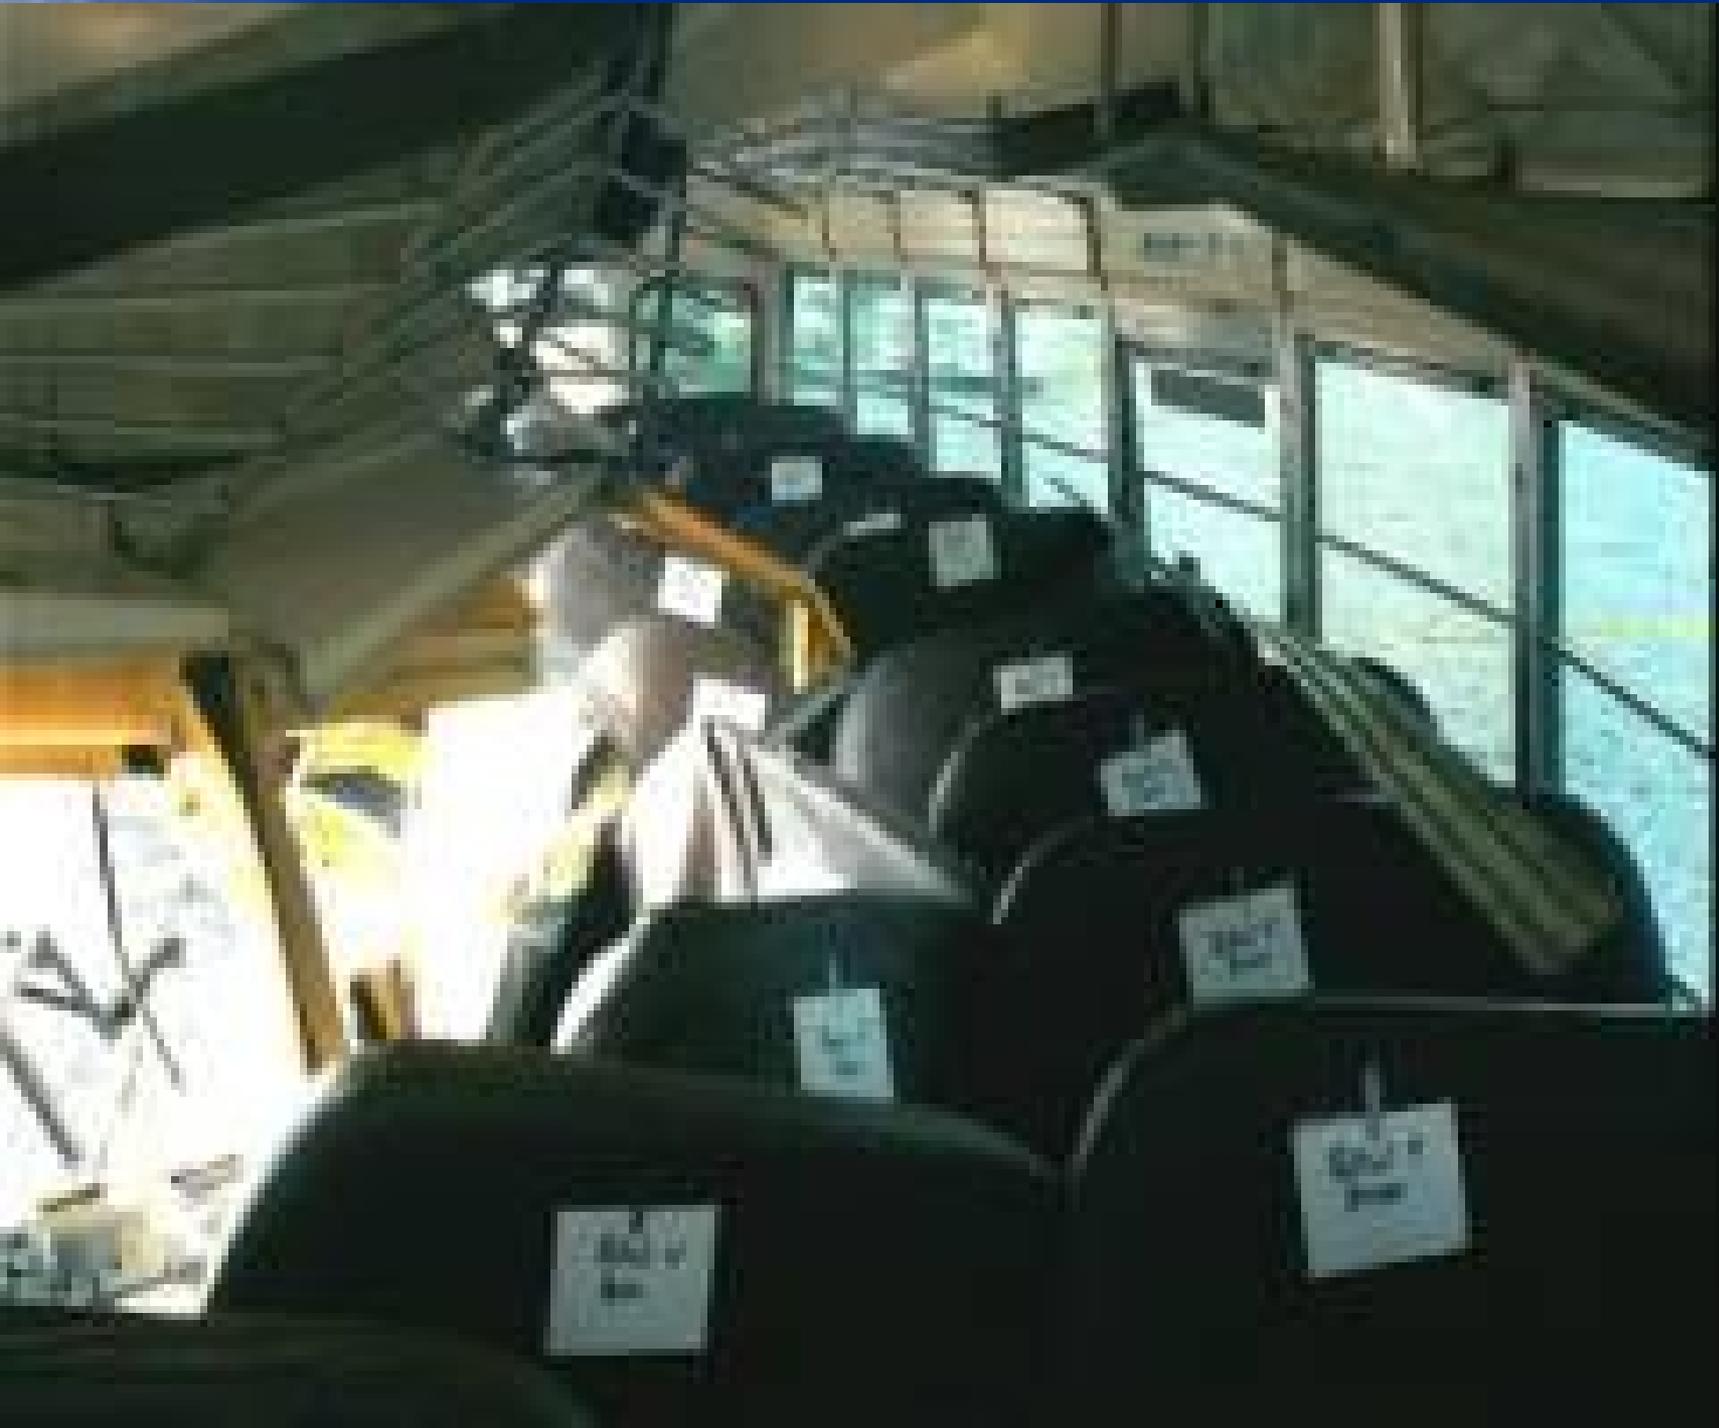
- Two front-row unbelted passengers were seriously injured and ejected; they impacted sidewalls and interior structures
- Second-row belted passenger not ejected; only passenger to sustain minor injury

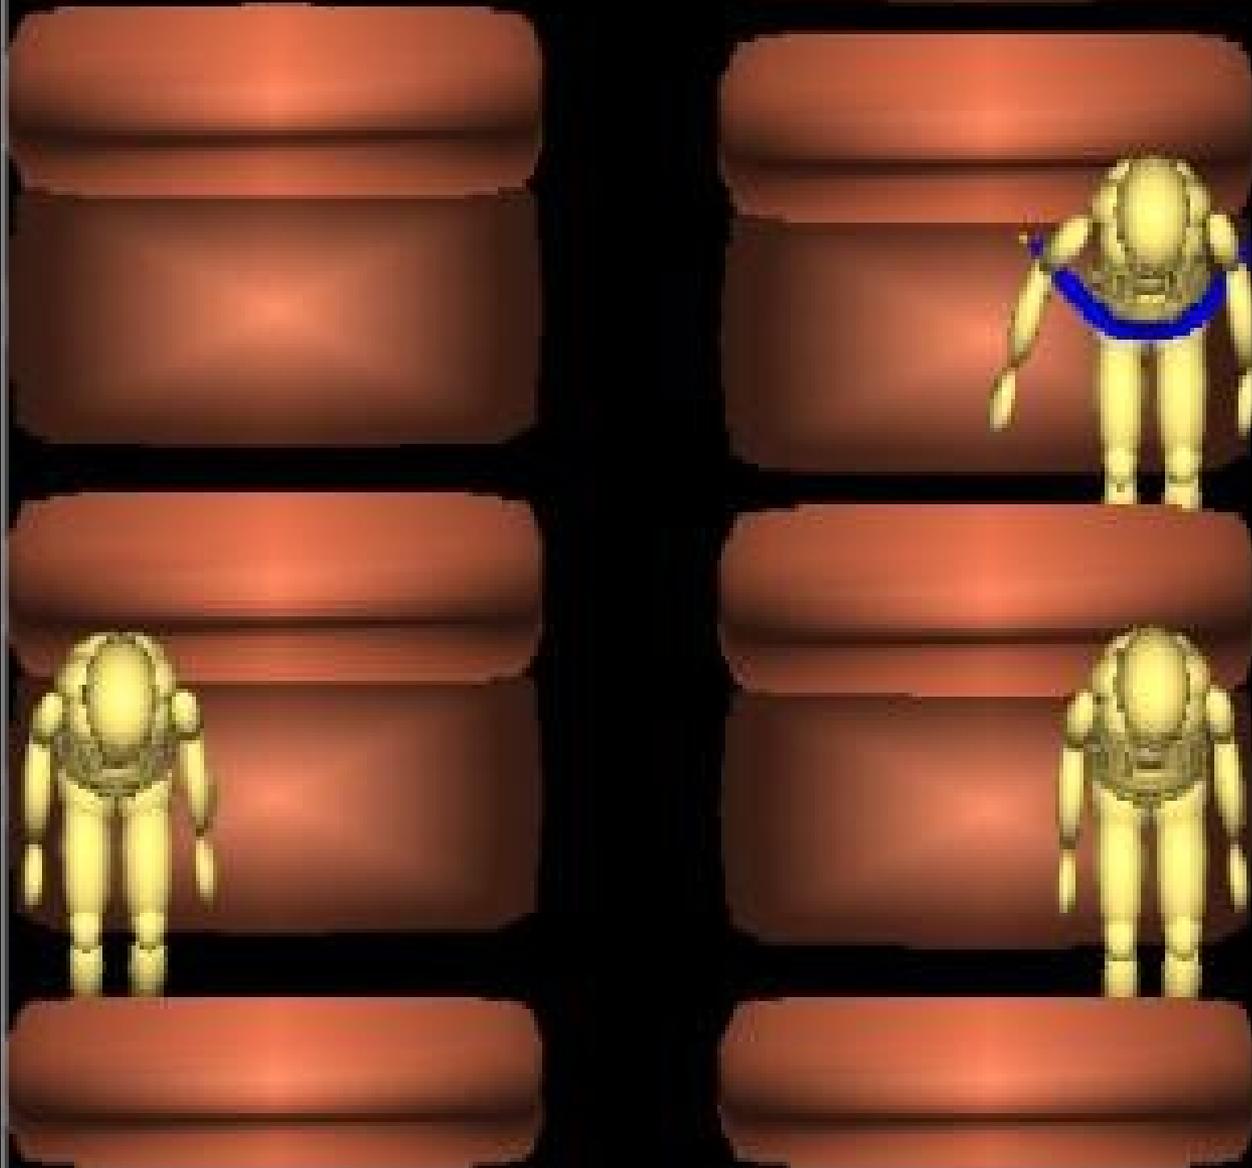
Time = 0.014000

Occupant Simulations

- Developed based on crash pulse from vehicle dynamics simulation
- Known initial seating positions based on onboard video recorder
- Linear contusion pattern on passenger seated in back of bus
- Representative of occupant motion but does not show actual motion; valid for comparisons

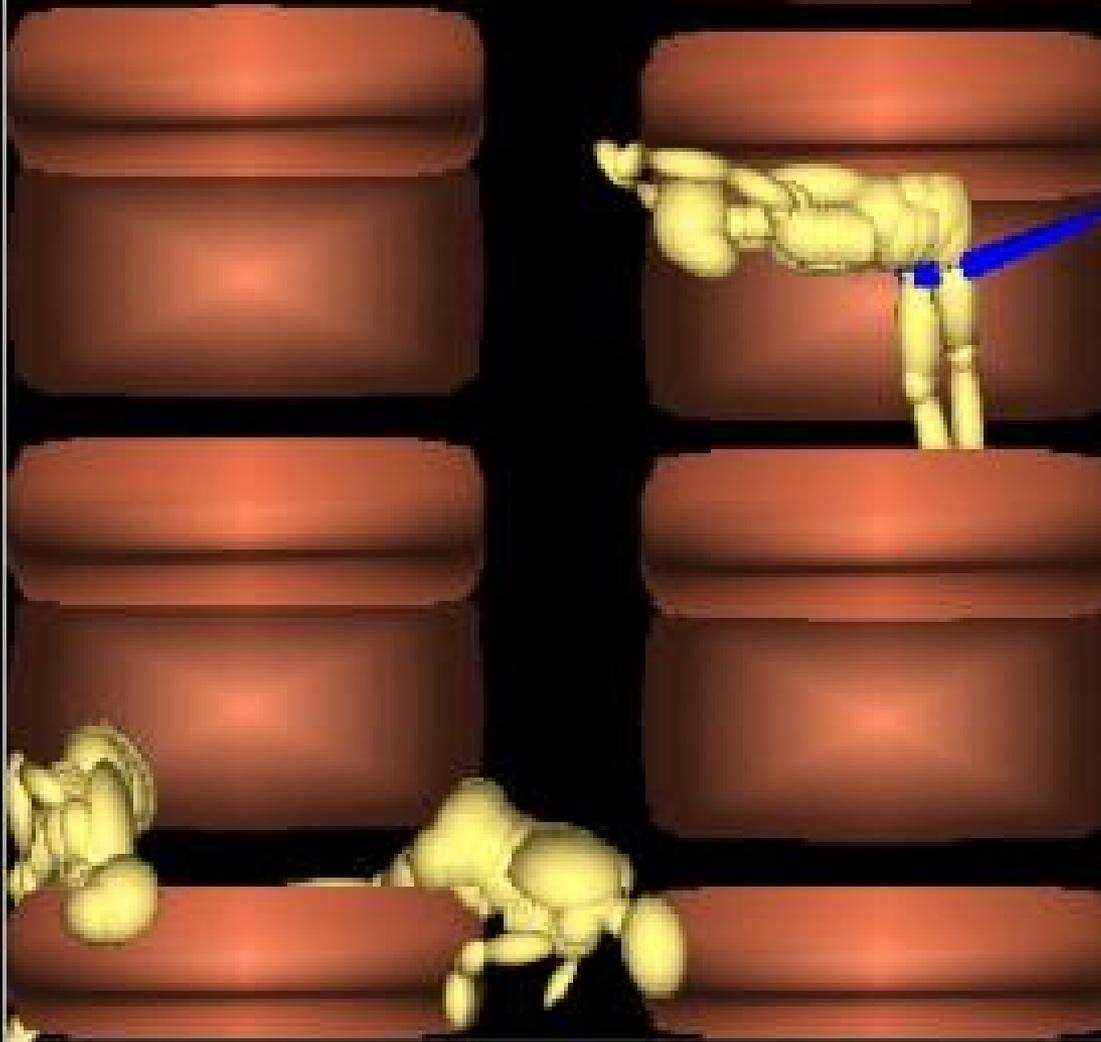
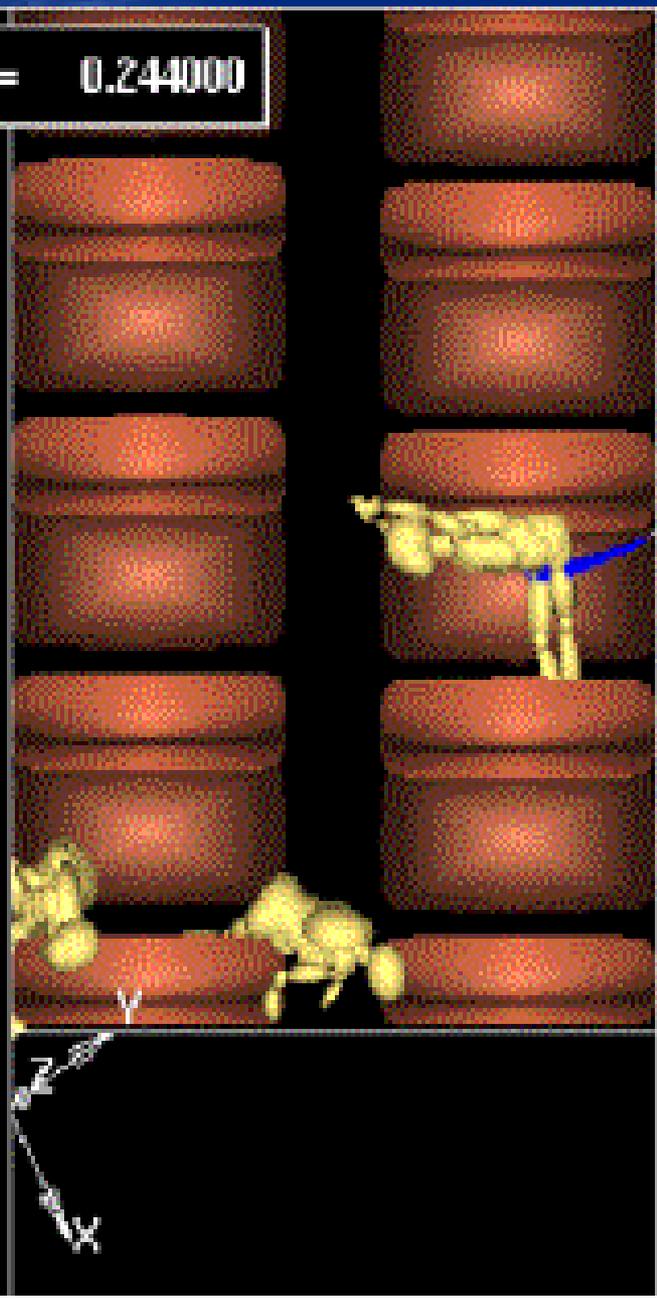
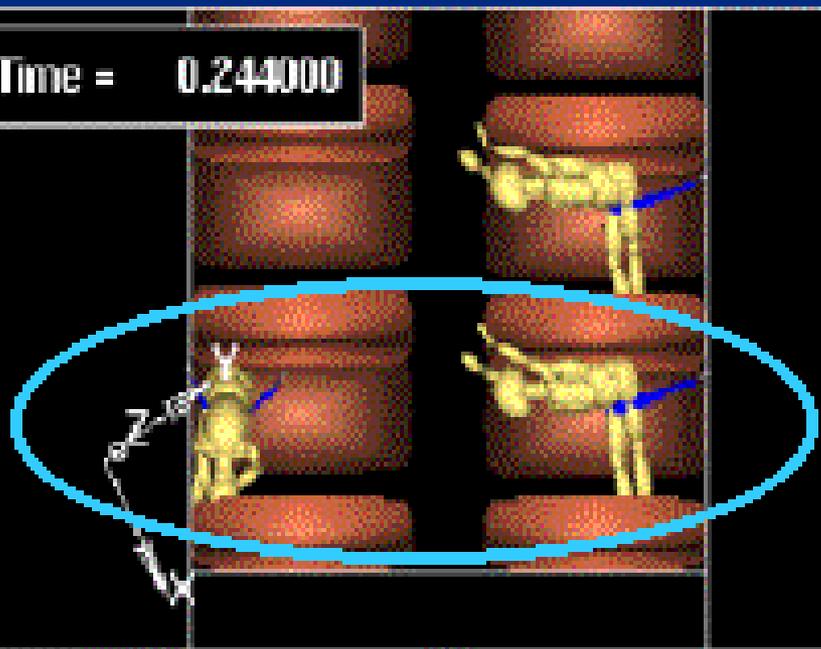
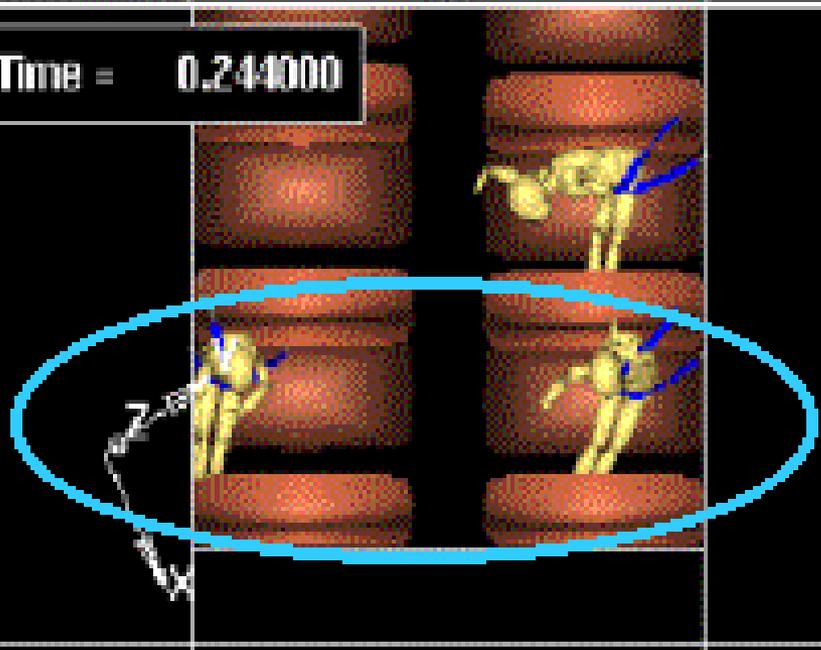
Simulation Results

- Rear of bus:
 - High lateral and angular accelerations
 - Restraints not beneficial
- Front of bus:
 - Properly fitted restraints beneficial
 - When unbelted, occupants struck interior surfaces and were ejected
