NTSB National Transportation Safety Board

Office of Highway Safety

Survival Factors and Occupant Safety

Survival Issues

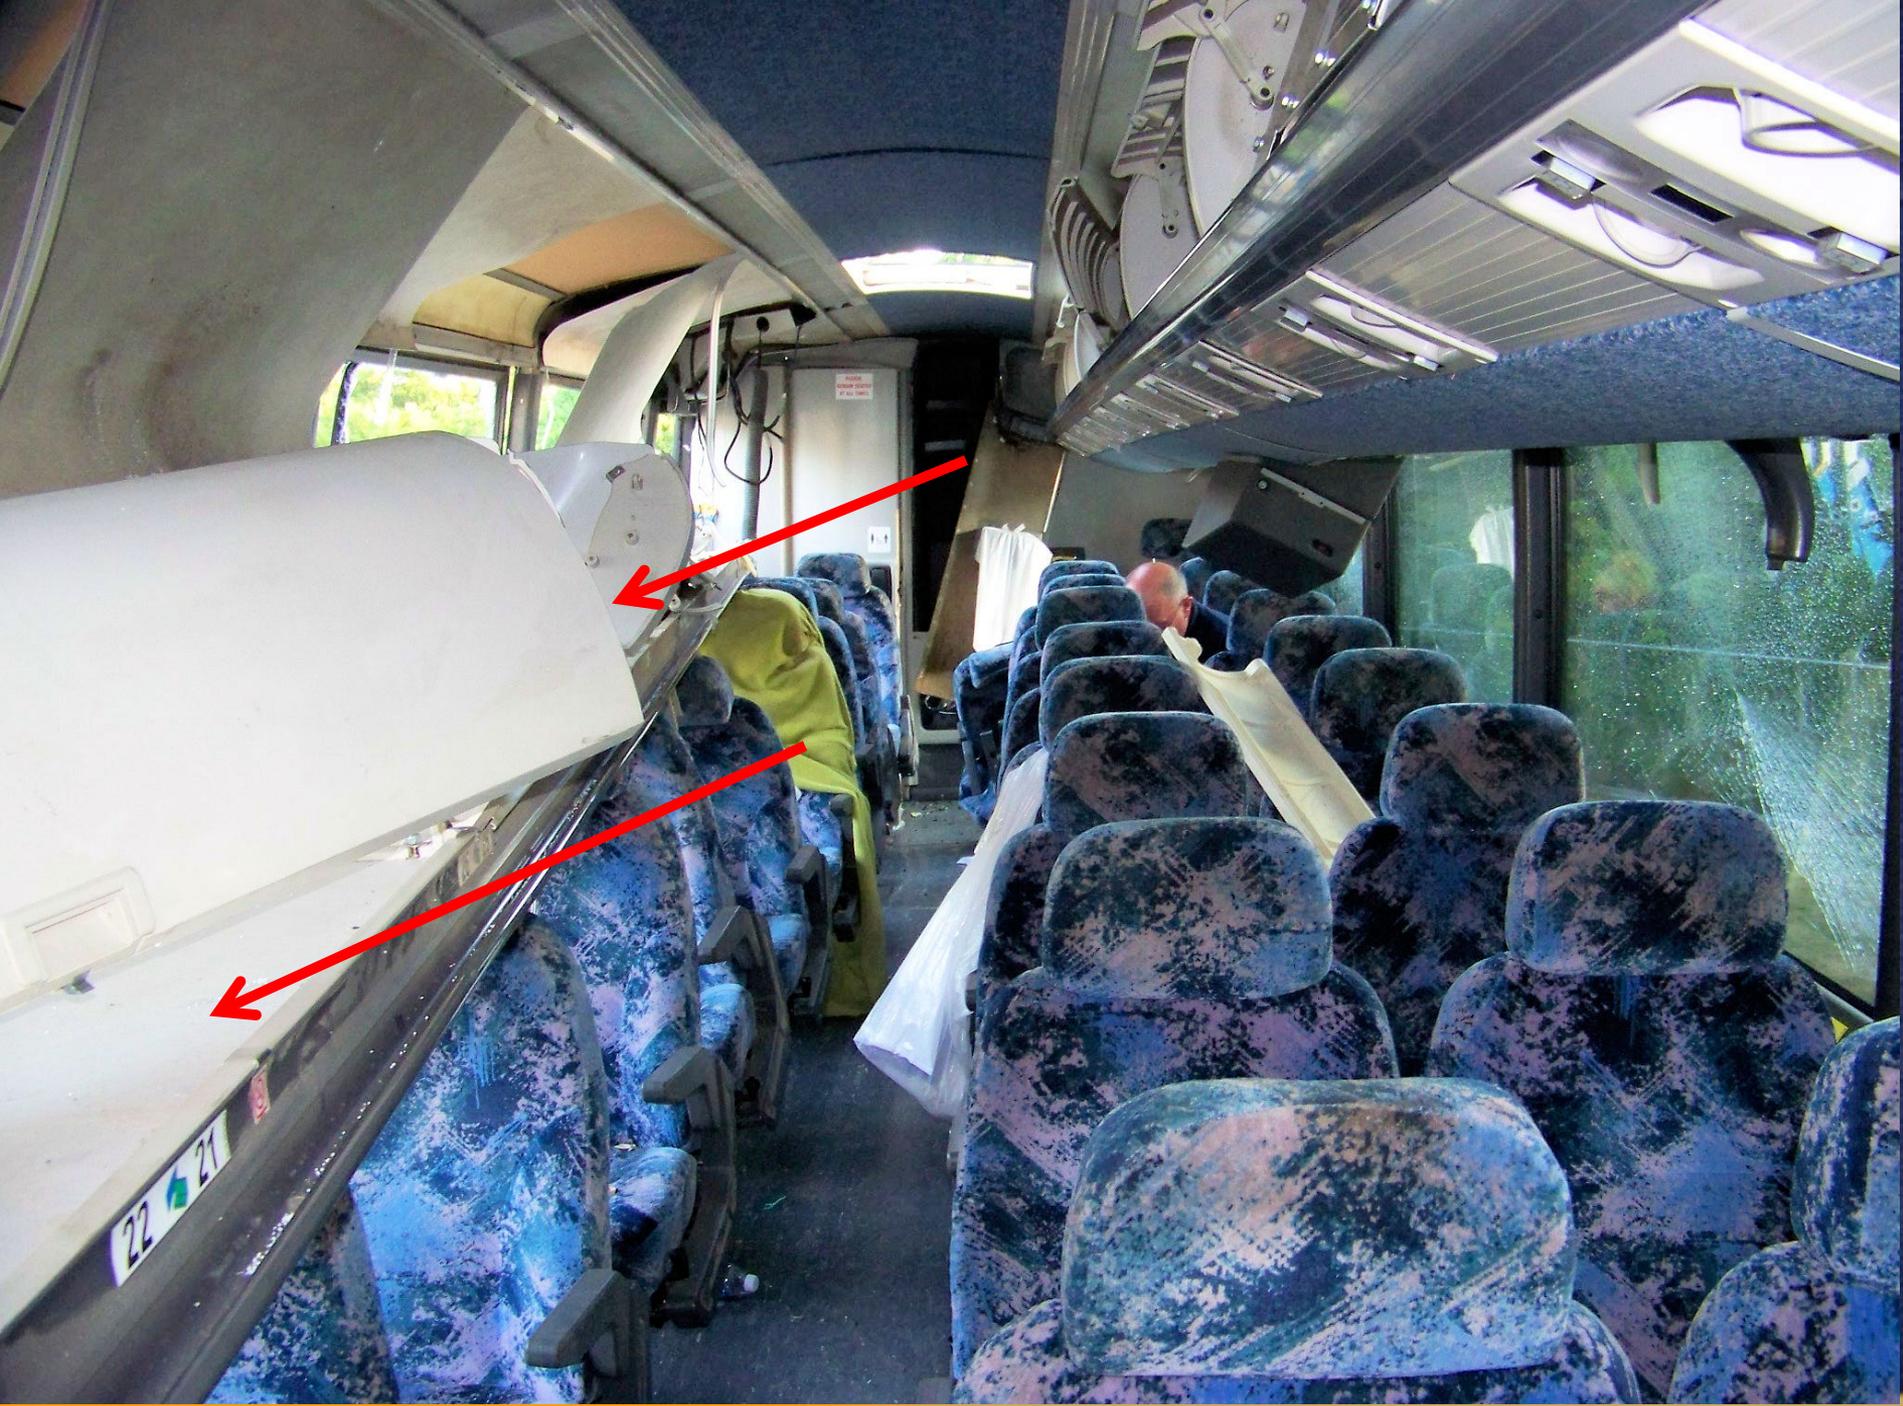
Luggage Rack Construction

- Luggage racks are secured by sidewall and ceiling brackets
- Aluminum anchorage points are ridged and secured by steel bolts
- All brackets failed on the right luggage rack

- Luggage rack anchorages failed
- Compromised lighting system
- Blocked egress and impeded rescue operations
- Recommending standards for luggage rack anchorages

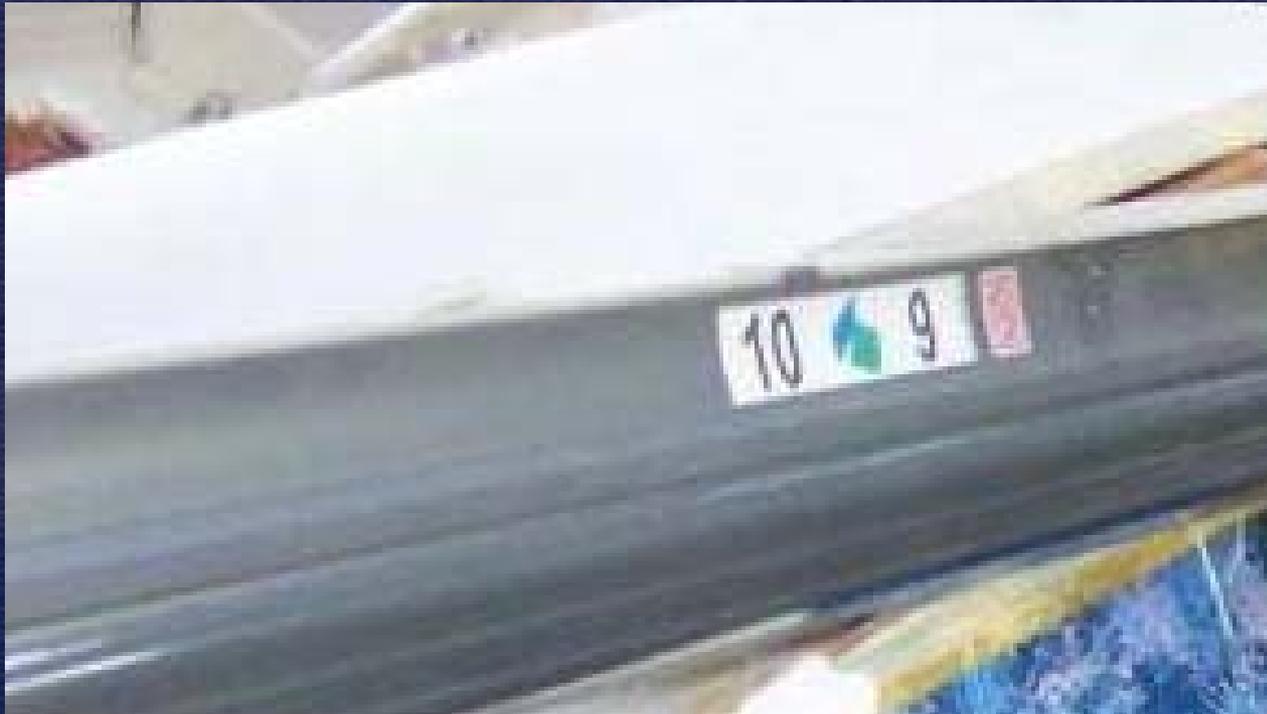
Luggage Rack Design

- Luggage rack was not designed to minimize injury
- Witness marks were discovered long the length of the rack
- Recommending design standards to reduce injury likelihood

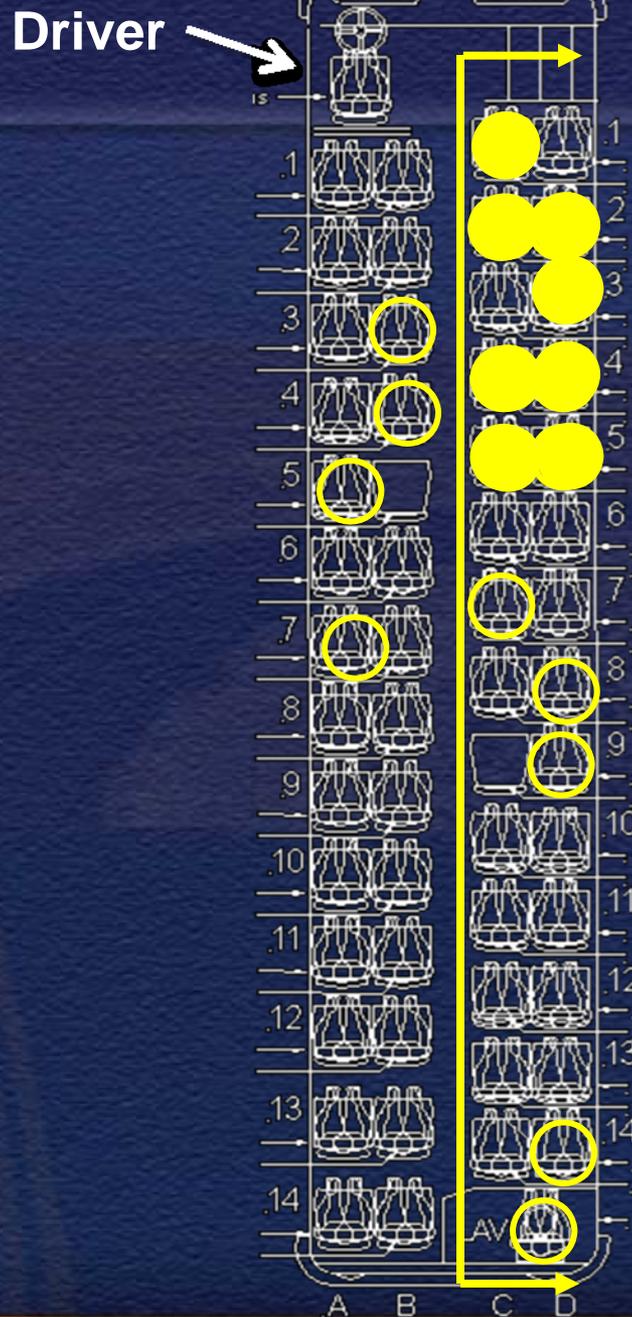
Injuries

- 56 Occupants
 - driver
 - 55 passengers
- 17 Fatalities
 - 13 on right
 - 8 of 13 in first five rows
