NTSB National Transportation Safety Board

Office of Marine Safety

Speed Determination

SPC-LE Visibility

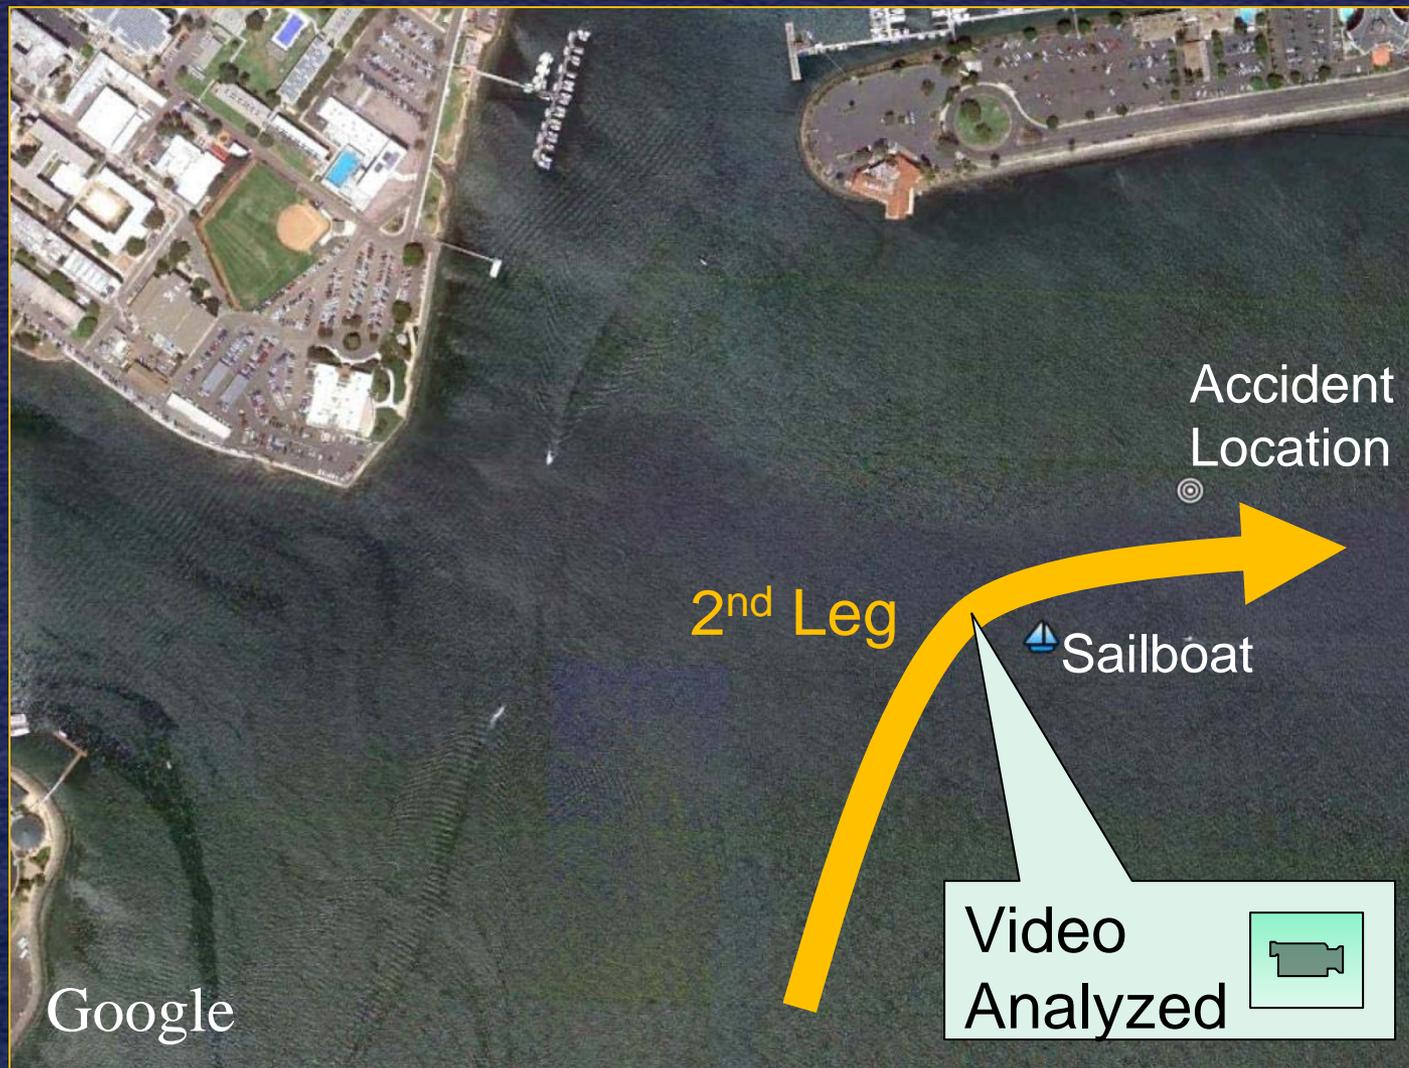
Video and Audio Study

- Attempt to determine speed and track
- Unable to determine
 - Sea Ray
 - CG 33118 on accident leg
- CG 33118 on leg (2nd) prior to collision
 - Calculated speed and portion of track

CG 33118 Speed

- Approximately 42 knots (about 5200 rpm)
 - During a portion of the eastbound or 2nd leg
 - A few minutes prior to the collision
 - Within 100 yards of the accident location
- At least planing speed (19 knots or more)
 - During the westbound accident leg

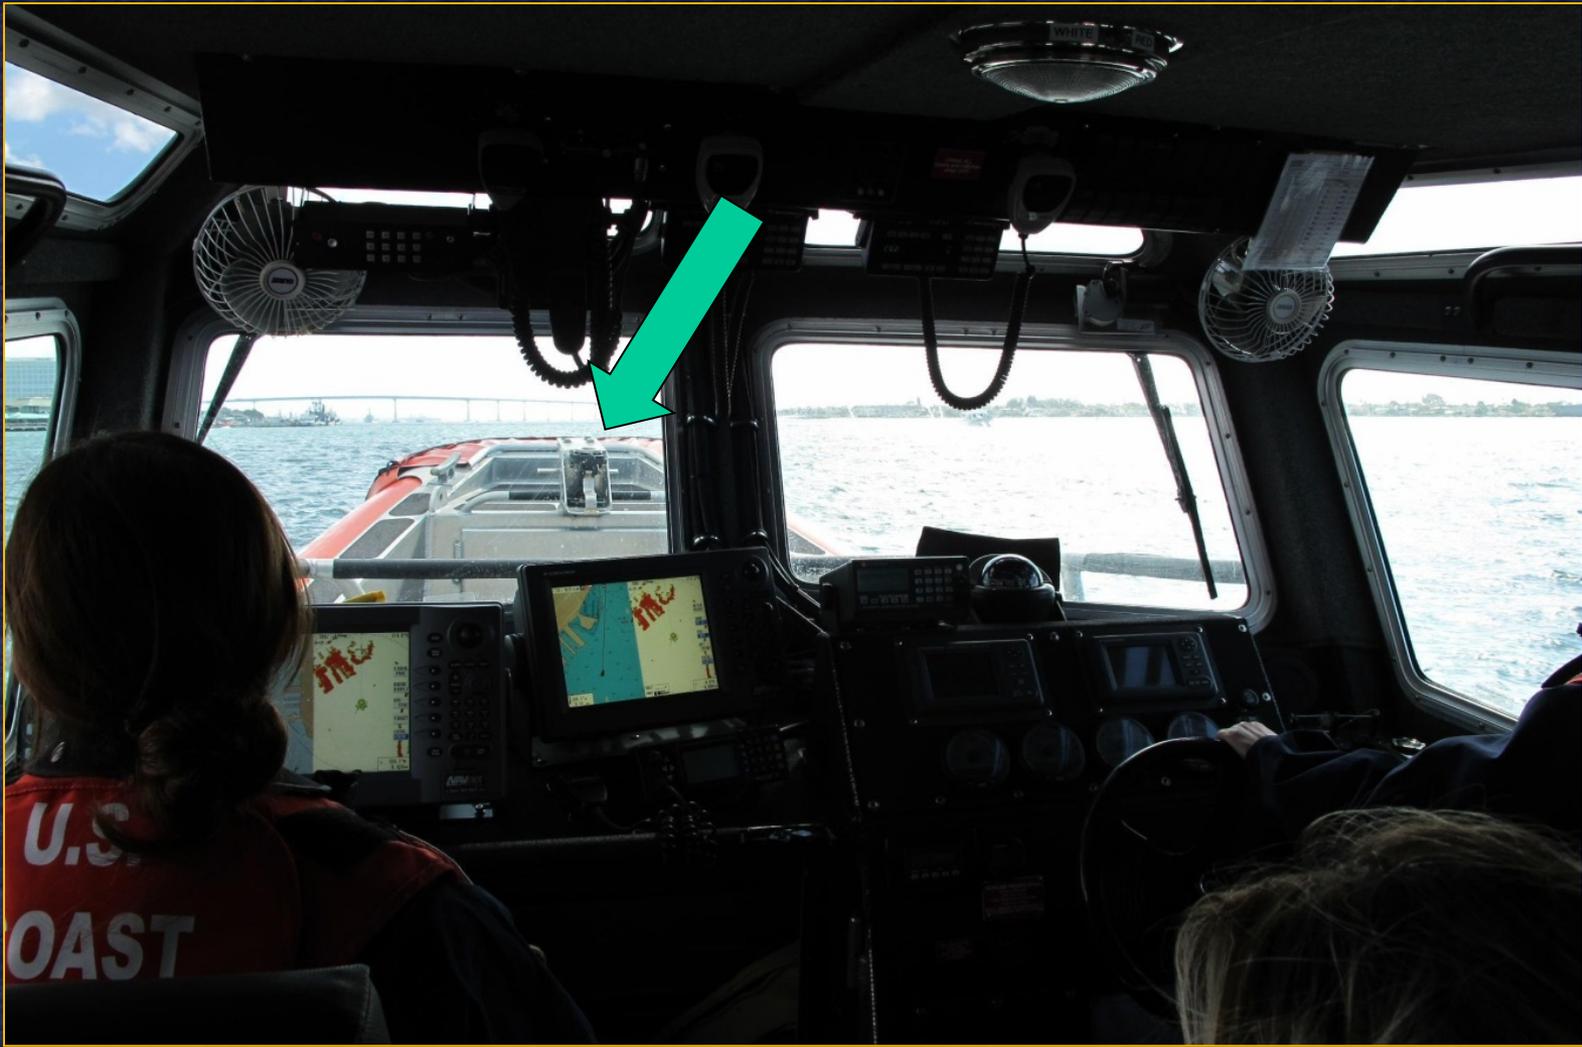
Vertical Visibility Comparison Study

- Indications visibility could be challenging
- Contract called for ABYC standards
 - H-1 visibility standard included
- SPC-LE did not meet H-1 standard
 - Vertical range of visibility
 - 3000 rpm highest trim angle
 - Corresponds with worst visibility

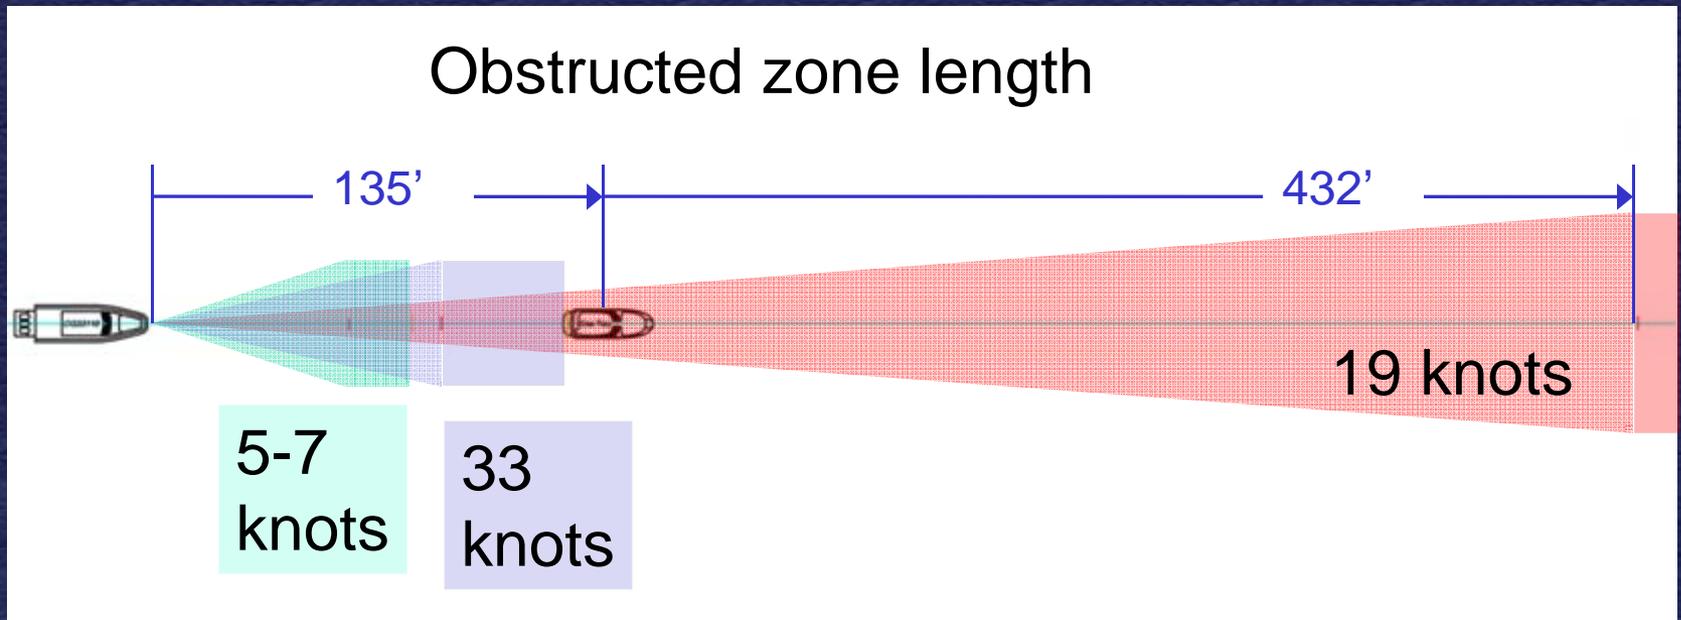
Comparison Study Results

- Can't precisely determine obstruction for crew before collision
- Shorter operators may have an obstructed view of the horizon
 - Specifically at lower planing speeds
