PB94-916301
NTSB/RAR-94/01

NATIONAL TRANSPORTATION SAFETY BOARD

RAILROAD-MARINE ACCIDENT REPORT

**DERAILMENT OF AMTRAK TRAIN NO. 2
ON THE CSXT BIG BAYOU CANOT BRIDGE
NEAR MOBILE, ALABAMA
SEPTEMBER 22, 1993**

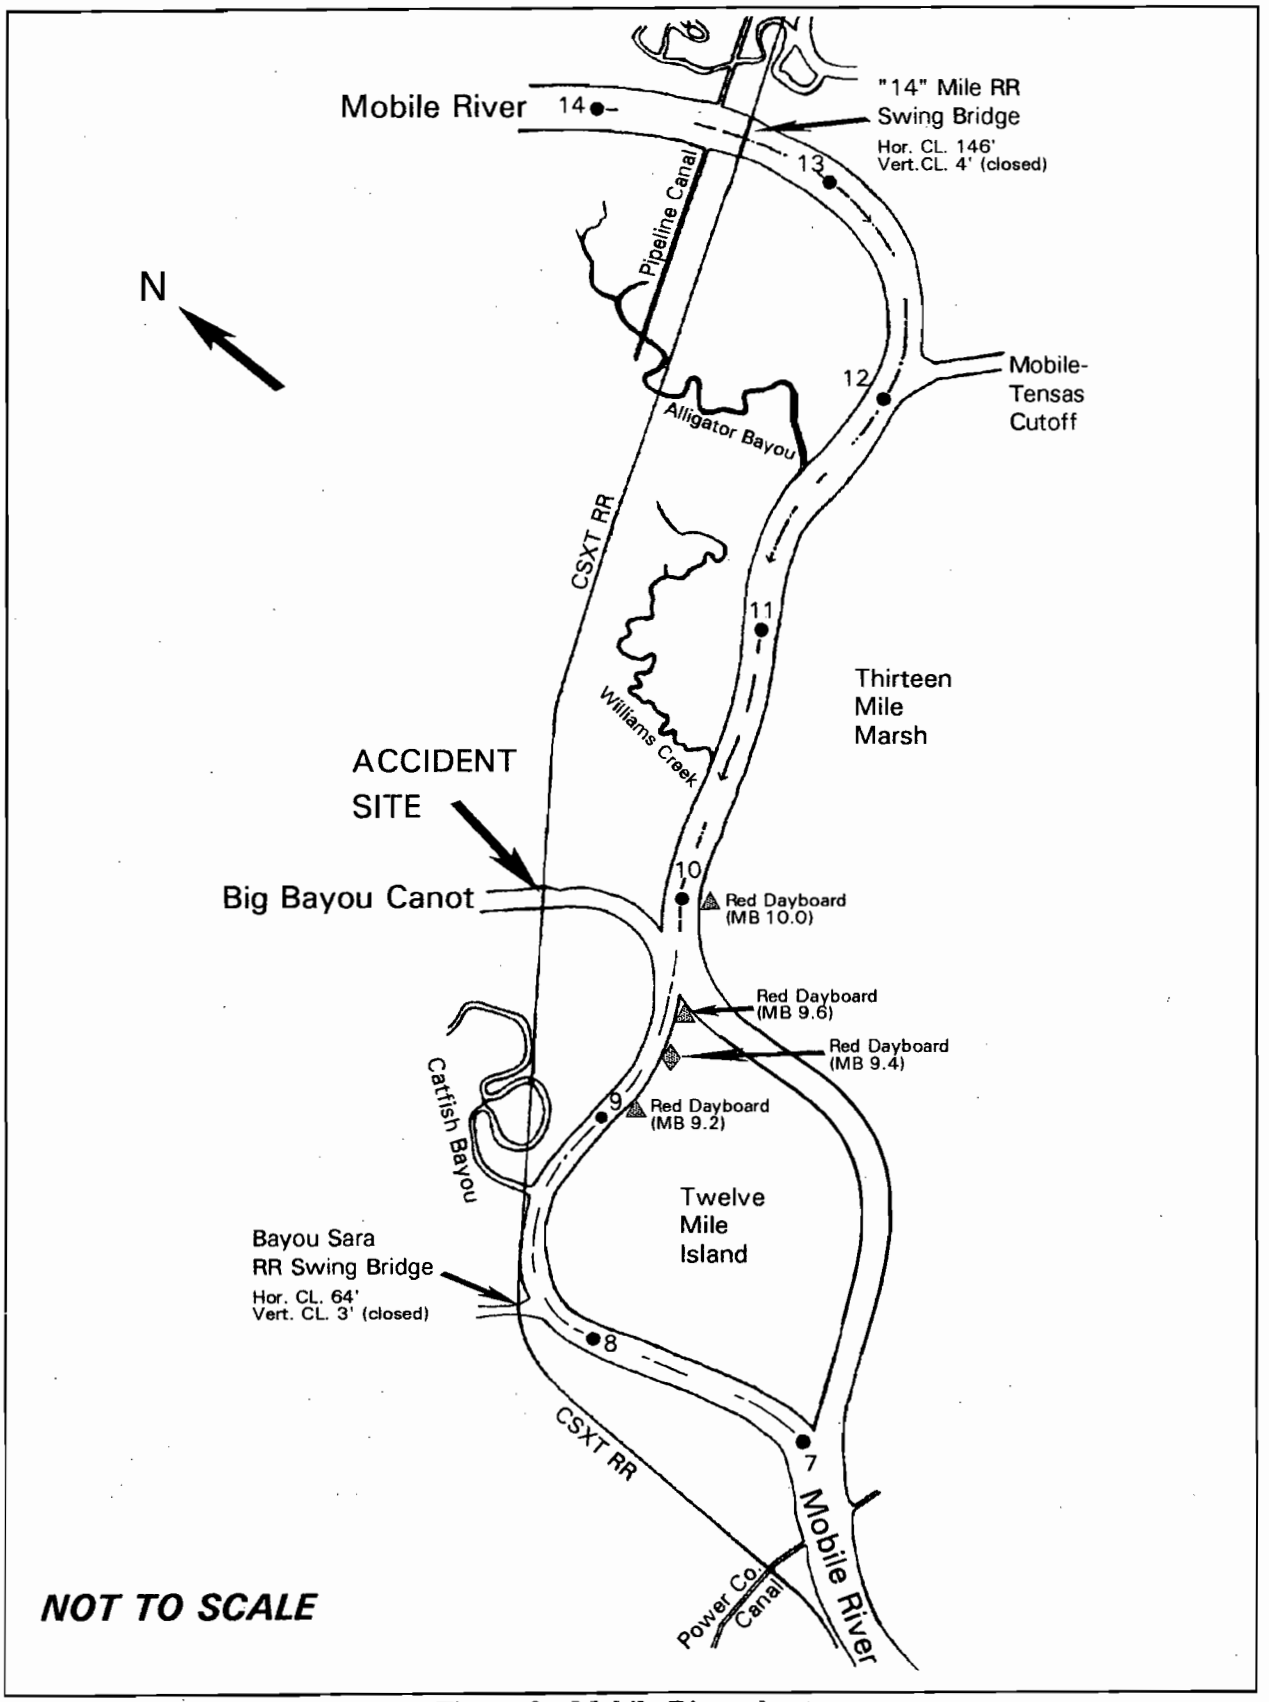
Figure 2.--Mobile River chart.

He stated that visibility was good[3] and recalled learning from marine radio conversations shortly before he departed that conditions were foggy north of his position. He could see the THOMAS B. McCABE's stern lights until that vessel rounded a bend in the Mobile River at Bayou Sara (about mile 8.2). The MAUVILLA's position at the time, according to the pilot, was near the south end of Twelve Mile Island (mile 7), and he recalled visibility beginning to become "hazy" there (see figure 2).

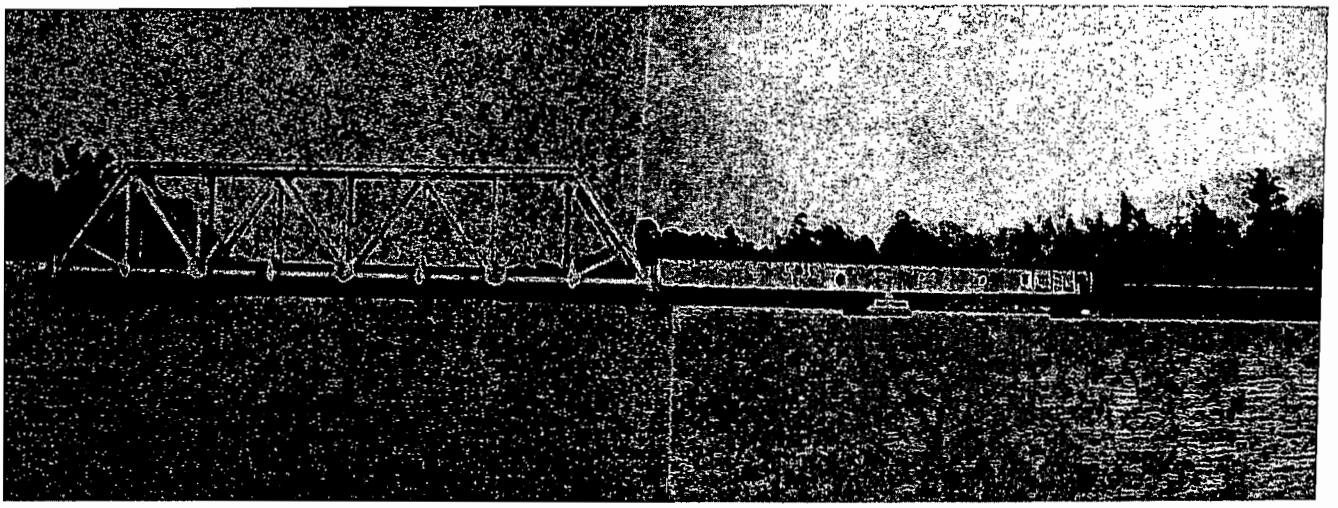
Figure 3.--Last inspection photograph of Big Bayou Canot railroad bridge before accident.

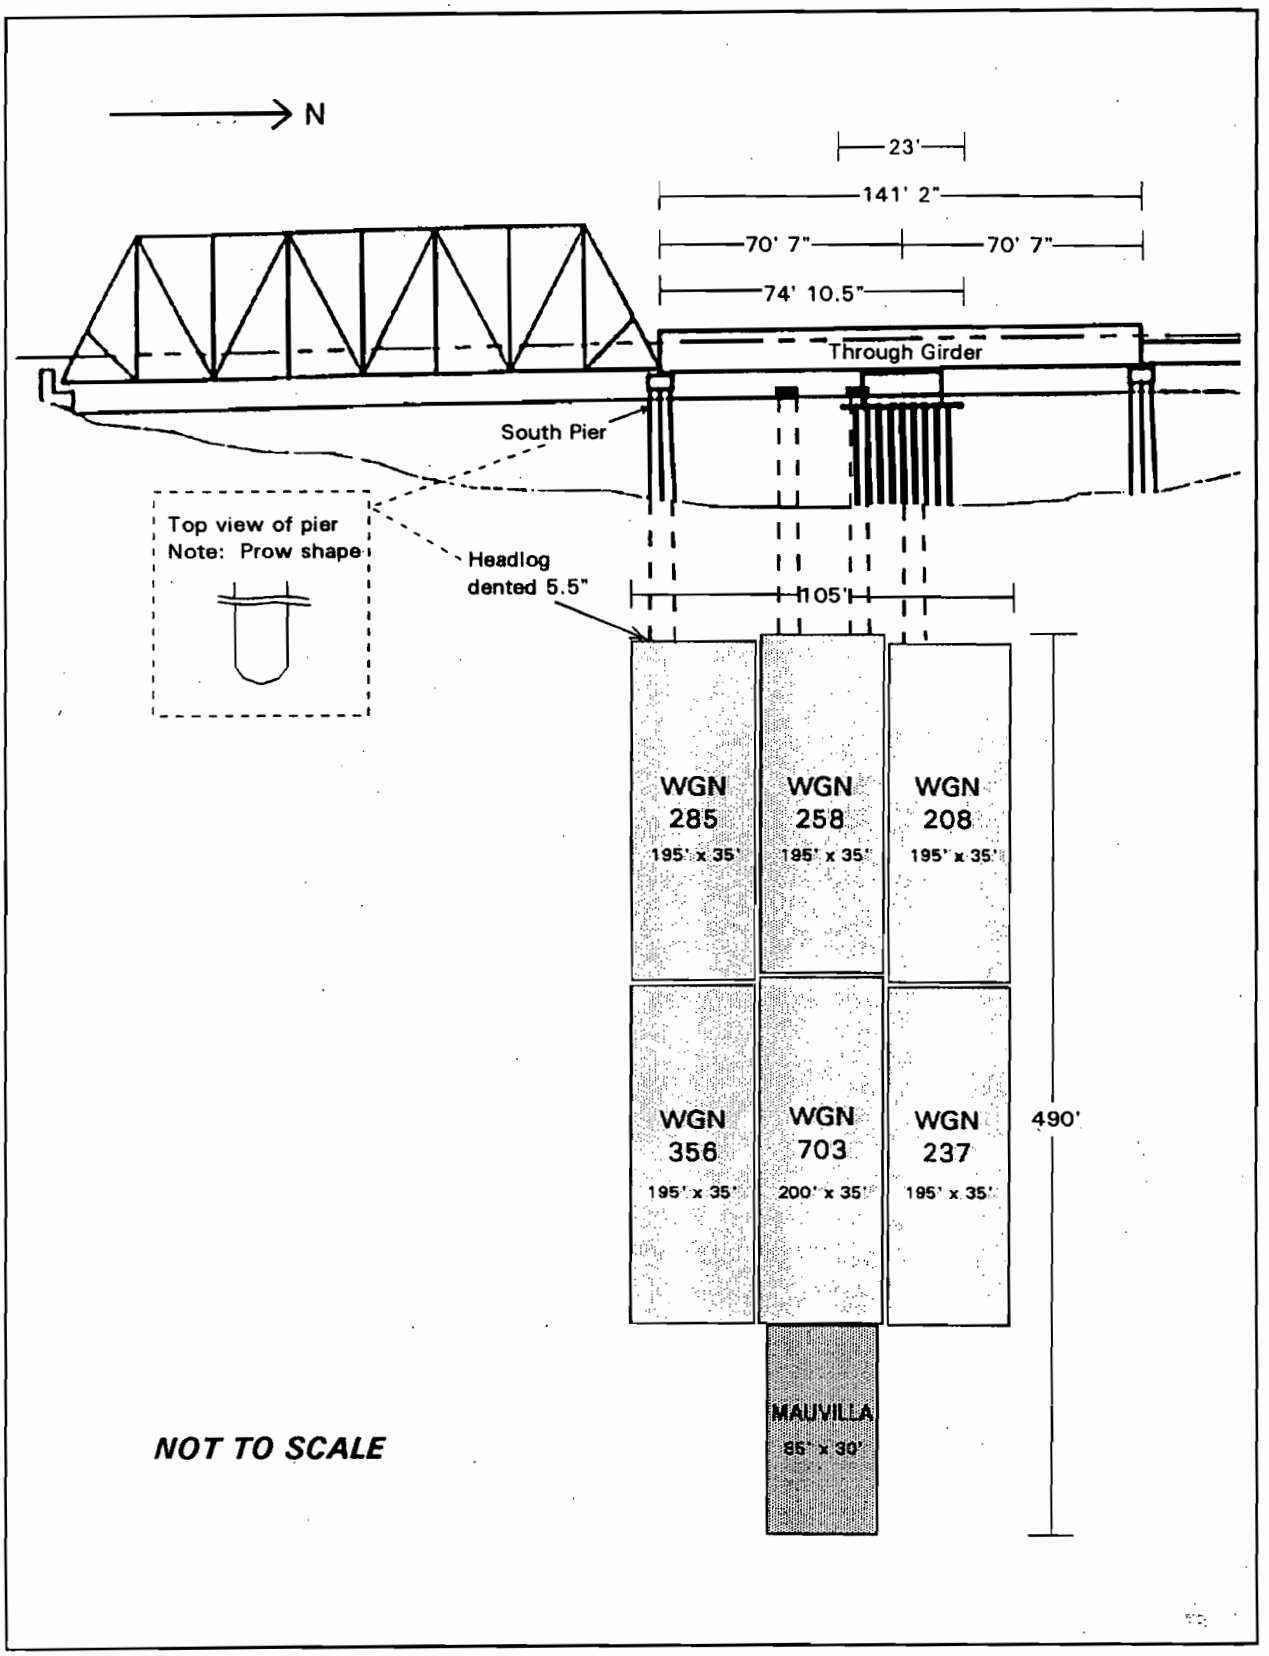
At some point as he continued toward the bridge, the pilot placed the throttles of the MAUVILLA in reverse. He testified that he was "still trying to figure out what was in front of me. And I never could." He said he felt a "bump" and thought he had run aground. The deckhand on duty testified that he also felt the "bump" while sitting in the galley and noted the time as 2:45 a.m. In fact, the lead port and starboard barges of the MAUVILLA had struck the south and center piers of the bridge's through-girder span (the other two sections of the bridge were a truss section and a timber trestle; see figures 3 and 4). The forward center barge, which protruded about 5 feet ahead of the port and starboard barges, struck the east girder between these two piers, displacing the south end of the girder span 38 inches to the west. Following the displacement, the east girder obtruded into the space traversed by trains. The port string of

Figure 4.--MAUVILLA tow configuration and Big Bayou Canot bridge.

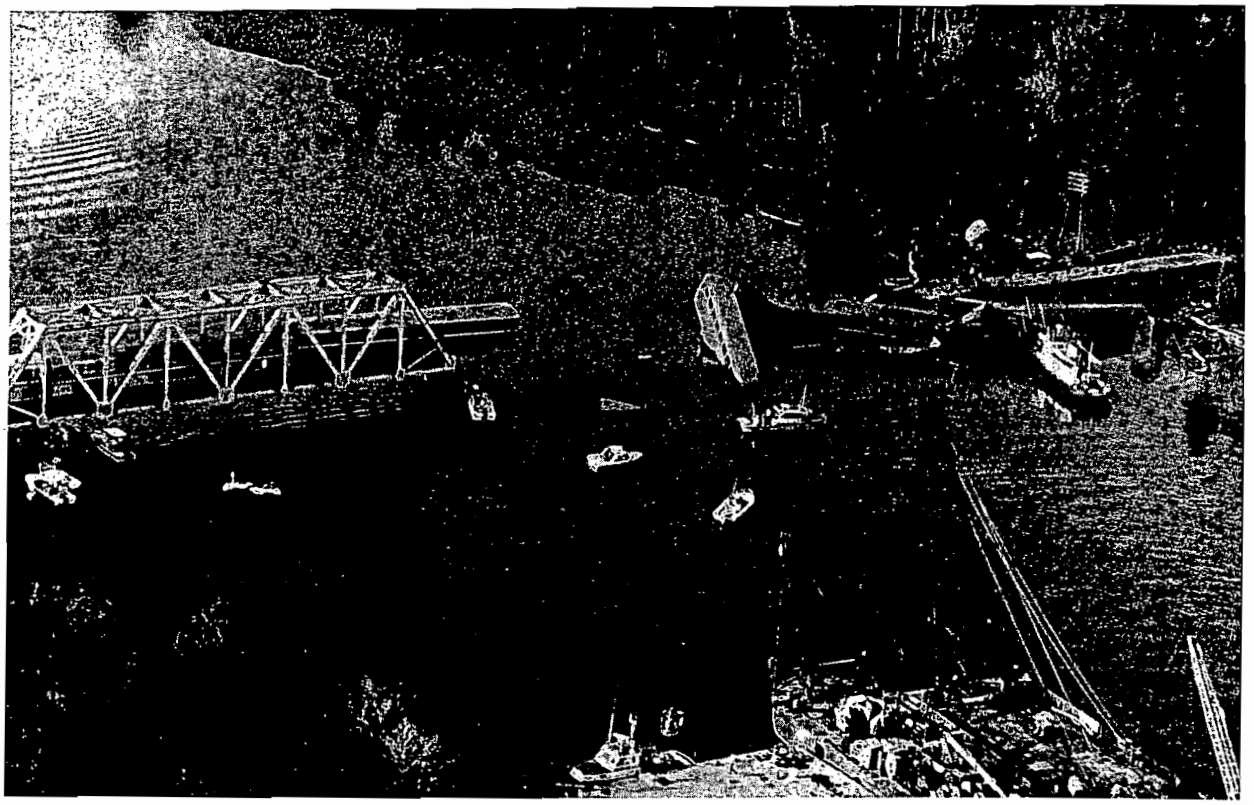
Figure 5.--Photograph of accident site.

Following the derailment, the three locomotive units came to rest on the east side of the bayou. Part of the lead unit, 819, was buried in about 46 feet of mud, and the part protruding above the embankment burned. The second unit, 262, also burned. The fuel tank of the third unit, 312, separated from it, and all equipment along the bottom of the unit below the frame was sheared off.

Baggage car 1139 and dorm-coach 39908, also on the east side of the bayou, were gutted by fire, and parts of both cars sustained major structural damage. About half of coach 34083, which rested against the bridge after the accident, was submerged, and coach 34068 was almost totally submerged. The next four cars, coach 34040, lounge 39973, diner 38030, and sleeper 32067, remained on the bridge. All passenger cars were double-decker cars. (See figure 6.)

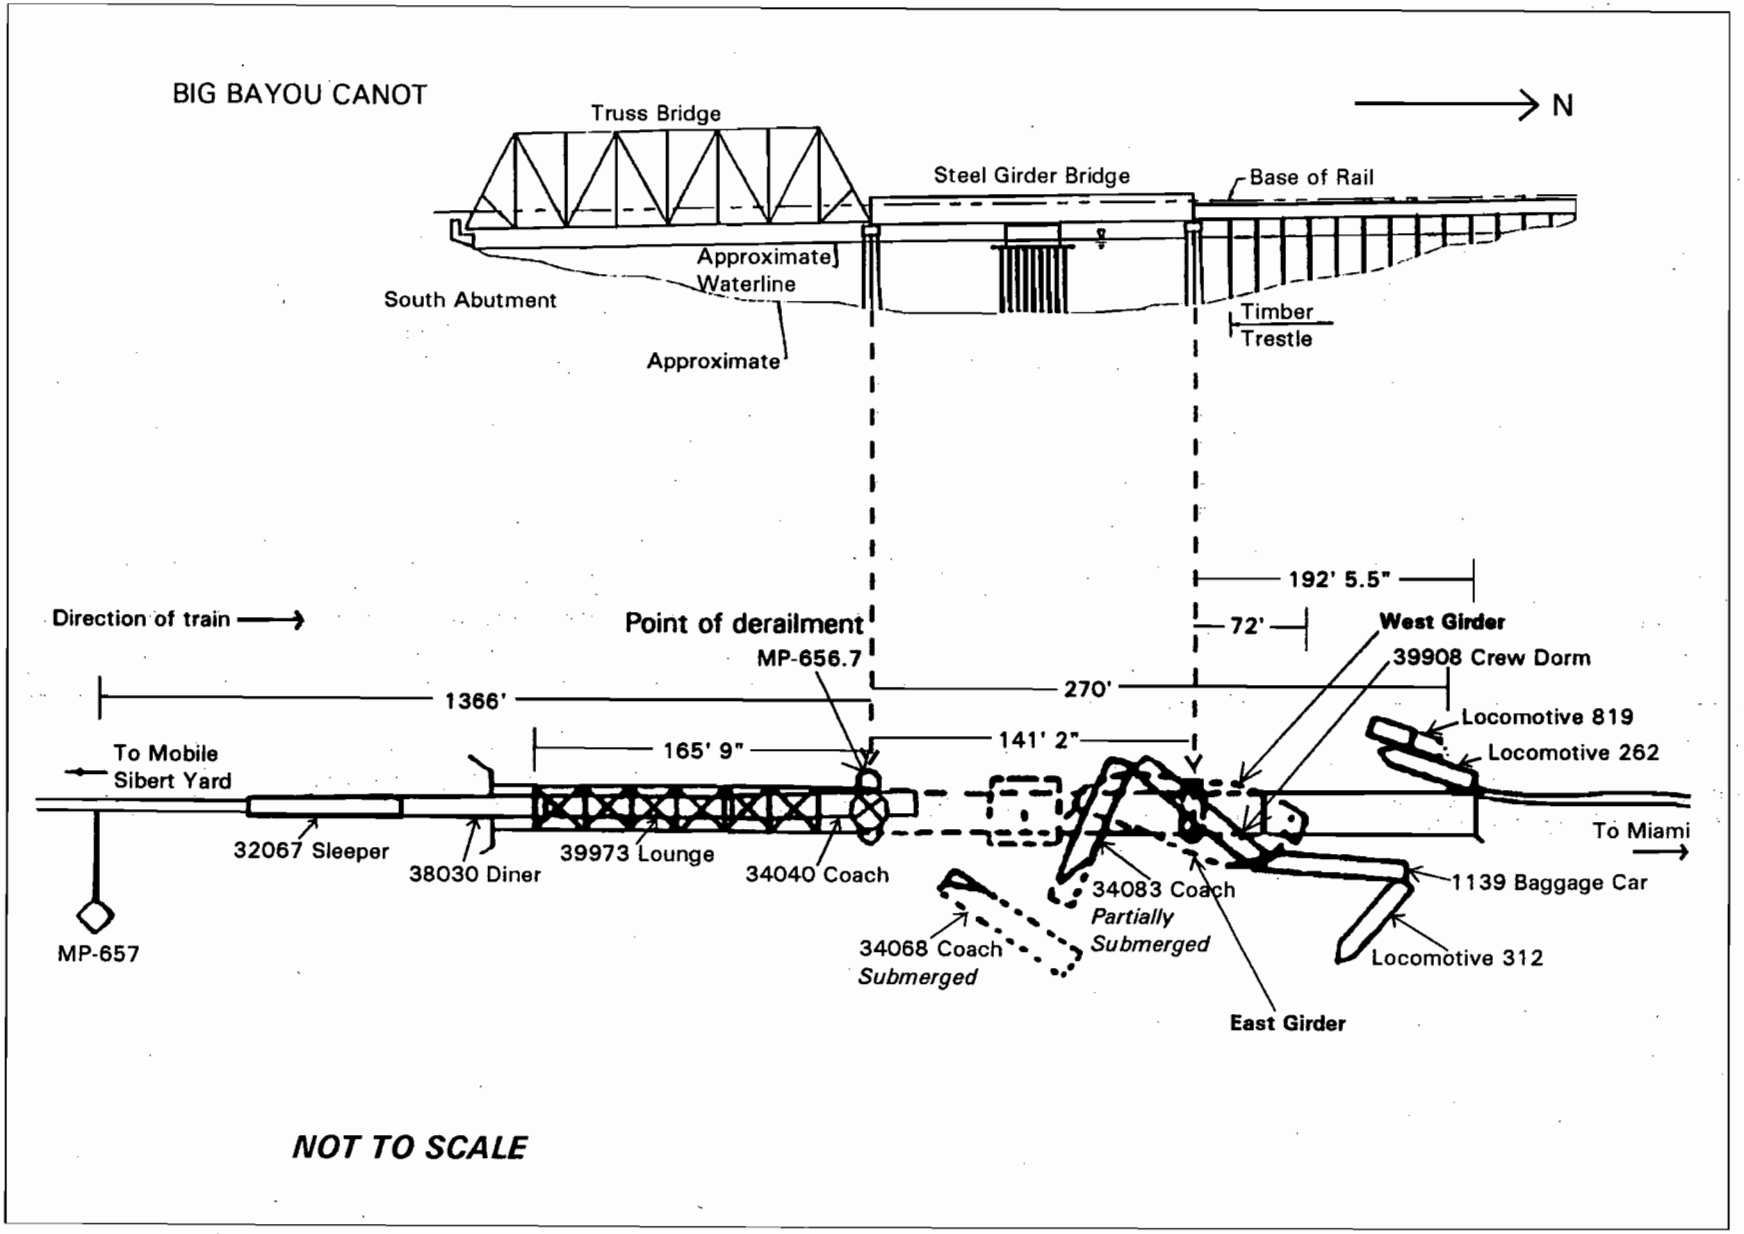
Figure 6.--Diagram of accident scene.

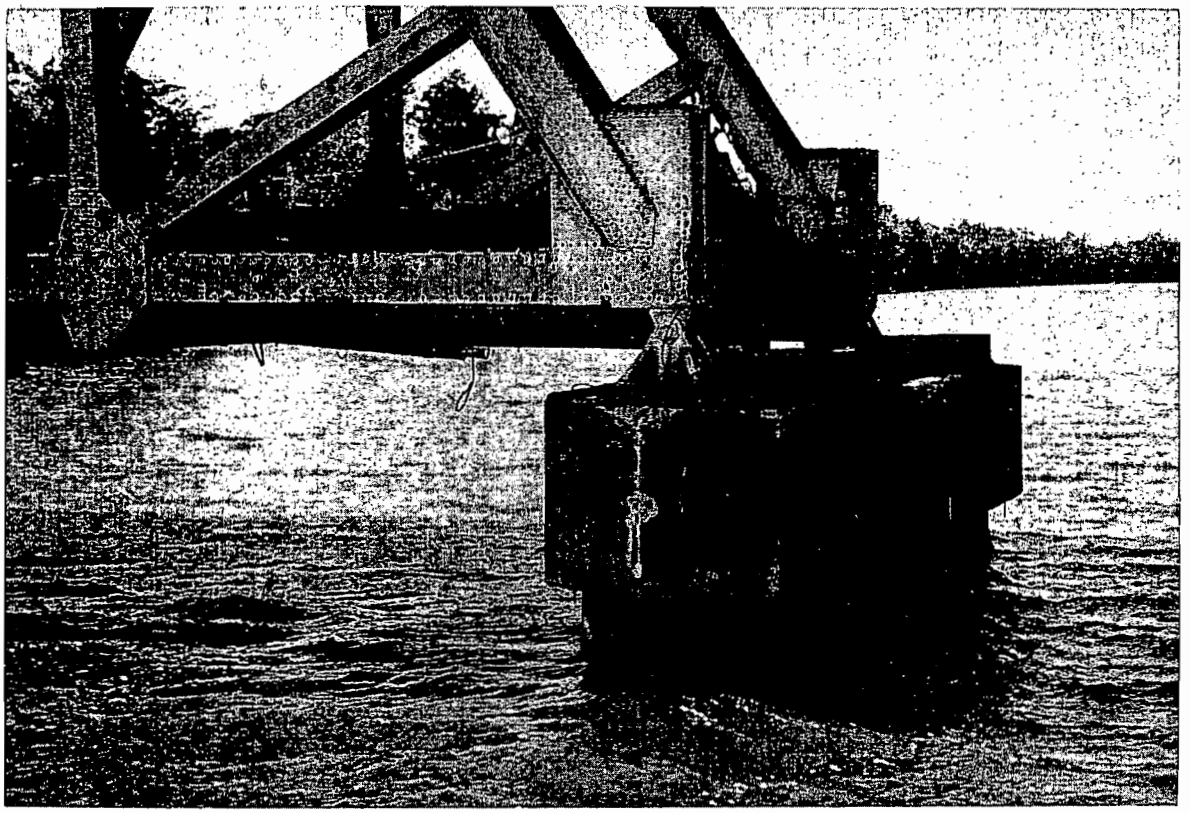
The nose of the south pier sustained some concrete spalling (chipping or scaling) from the MAUVILLA's lead port barge (see figure 7). The east edge of the sole and filler plates for the east girder's south bearing came to rest on the west edge of the east pedestal and the west edge of the pier cap plates. The west girder plates were found on the pier cap adjacent to the west edge of the west pedestal. The bottom of the east girder sole plate had large radius lateral striations (grooves or channels), and the west sole plate had straight lateral striations.

About 15 feet of the top flange of the east girder, beginning at the south girder face, was separated from the web. Part of the top of the plate over this 15-foot section was "accordianed"; the rest of the top flange was comparatively undamaged. The web sustained two tears, one extending from the top to the bottom flange and a large horizontal tear between the fourteenth and seventeenth stiffeners. The bottom flange had two indentations, 21 inches and 22 inches wide, respectively, on the bottom east side.

The girders, which were about 40 feet apart laterally at the widest point, were displaced some 70 feet to the north. The northernmost and two southernmost floorbeams remained connected to both girders. The other eight floorbeams were severed from the east girder but remained connected to the west girder. The stringers remained connected to the floorbeams. Concrete had broken off the east angular nose of the pier that supported the south end of the girders and off part of the north edge of the pier cap. Surface evidence indicated the fractures were recent.

Figure 7.--Collision marks on Big Bayou Canot bridge.

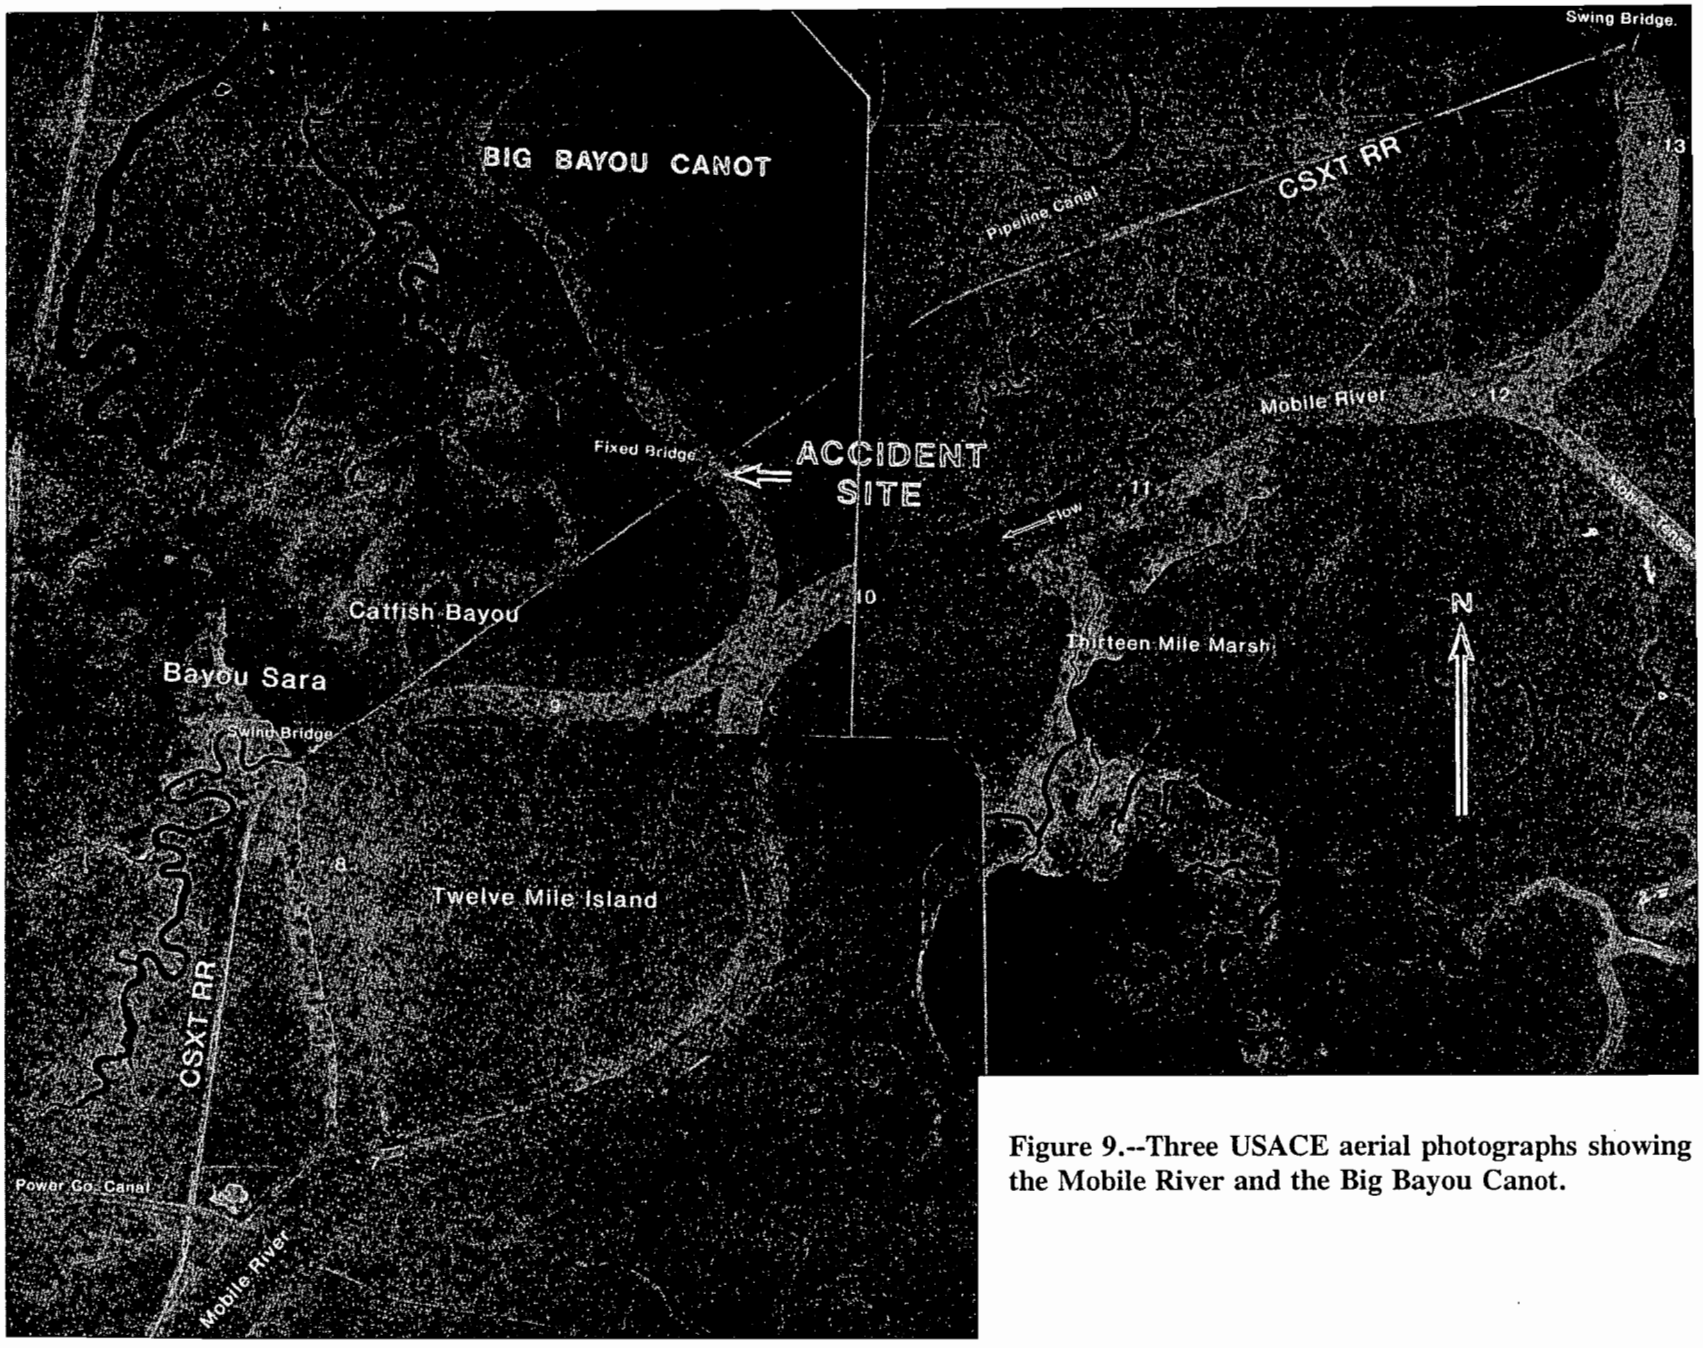
Figure 9.--Three USACE aerial photographs showing the Mobile River and the Big Bayou Canot.

To continue upriver and avoid entering the Big Bayou Canot, a tow following the river curvature must stop its leftward movement (see figure 9). When the shorelines are visible, cues are available to guide an operator through the intersection. When the shorelines are obscured, an operator needs radar information to stay on the intended courses. He or she has to correlate the radar information with chart information or memory of the waterway's geography to determine the tow's location and choose the proper waterway.

Heading upriver about mile 9.1, the Mobile River begins curving to the left and spans an arc of about 95 degrees to the entrance of Big Bayou Canot, a distance of about 0.8 mile. Although the pilot said he did not see the intersection of the two waterways on the radar, it should have appeared on the radarscope about the time the tow passed mile 9.1 and should have remained there even after the MAUVILLA entered Big Bayou Canot if the radar was set to the 1/2-mile scale. Even if the radar was set to the 1/4-mile scale, the triangular point of land marking the north end of the intersection should have appeared on the radar shortly after the tow entered the intersection.

The radar presentation varies as the tow proceeds, and the images must continually be interpreted because the outlines may differ from those shown on charts or sighted visually. The pilot either did not observe the radar sufficiently to obtain the information available, was inadequately trained to understand what the radar presented, or both. He testified that after receiving his license, W&GN "trained me as a copilot for almost a year, I believe. I went through to copilot training. That's learning how to operate the boat, running the rivers, and how to operate the radar." The pilot said he learned how to use radar through "on-the-job training," noting that he had not operated the type or model of radar on the MAUVILLA but had been exposed to and operated other models. He testified that he had received no formal training in the use and interpretation of radar: "Not going to school. Not for radar, no."
