PB95-910404
NTSB/AAR-95/04
DCA95MA007

AIRCRAFT ACCIDENT REPORT

CRASH DURING EMERGENCY LANDING
PHOENIX AIR
LEARJET 35A, N521PA
FRESNO, CALIFORNIA
DECEMBER 14, 1994

Abstract: This report explains the accident involving the Phoenix Air Learjet 35A that crashed while attempting an emergency landing at Fresno Air Terminal, Fresno, California, on December 14, 1994. Safety issues in the report focused on maintenance, inspection and quality assurance. Safety recommendations concerning these issues were made to the Federal Aviation Administration, Phoenix Air, and the Department of Defense.

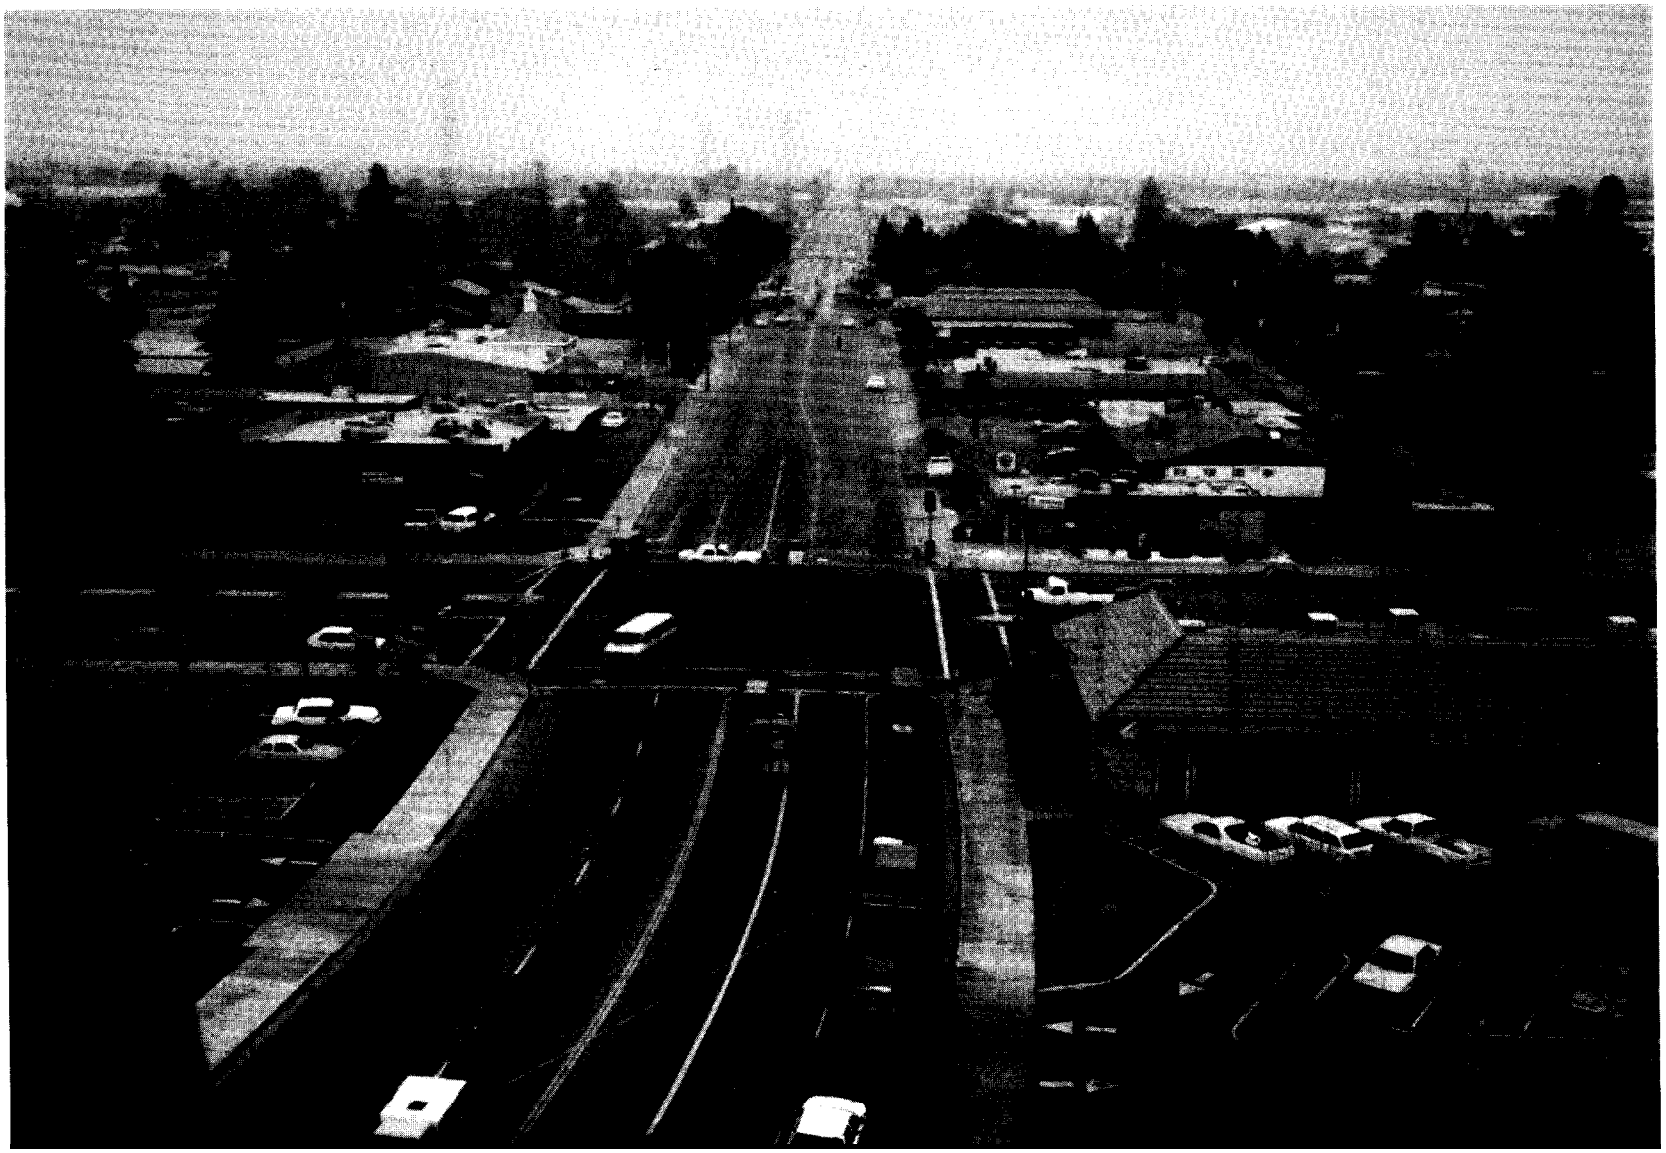
Figure 2a.--View to the west on E. Olive
looking approximately down the final flightpath.

Figures 2b.--View to the east on E. Olive from immediately east of N. Sierra Vista. Last major portions of wreckage in wreckage path are near the bottom of the photograph.

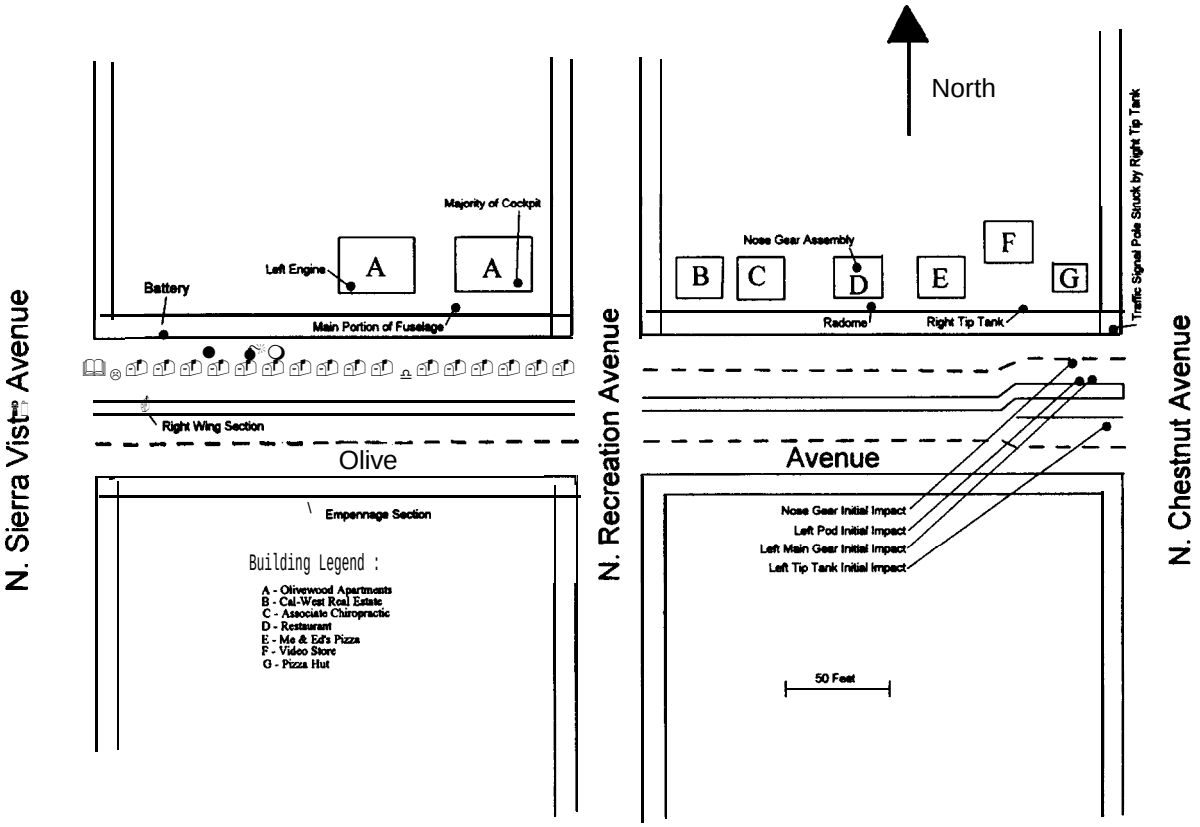
Figure 2c.--Wreckage path diagram.

Portions of the airplane, including the right wing, right engine, and empennage, came to rest on E. Olive. A substantial portion of the fuselage was consumed in fires located in and around the apartment buildings and associated foliage. The left engine came to rest in an unburned apartment unit.

Two buildings in the Olivewood apartment complex facing E. Olive sustained the most severe damage. Of the two apartment buildings, the one to the east or the first building in the impact path sustained primarily impact damage. The westerly building sustained both impact and fire damage, and some of the apartment units in that building were destroyed by fire. Lesser damage, primarily flash-fire and minor impact damage occurred to businesses on the north side of E. Olive.

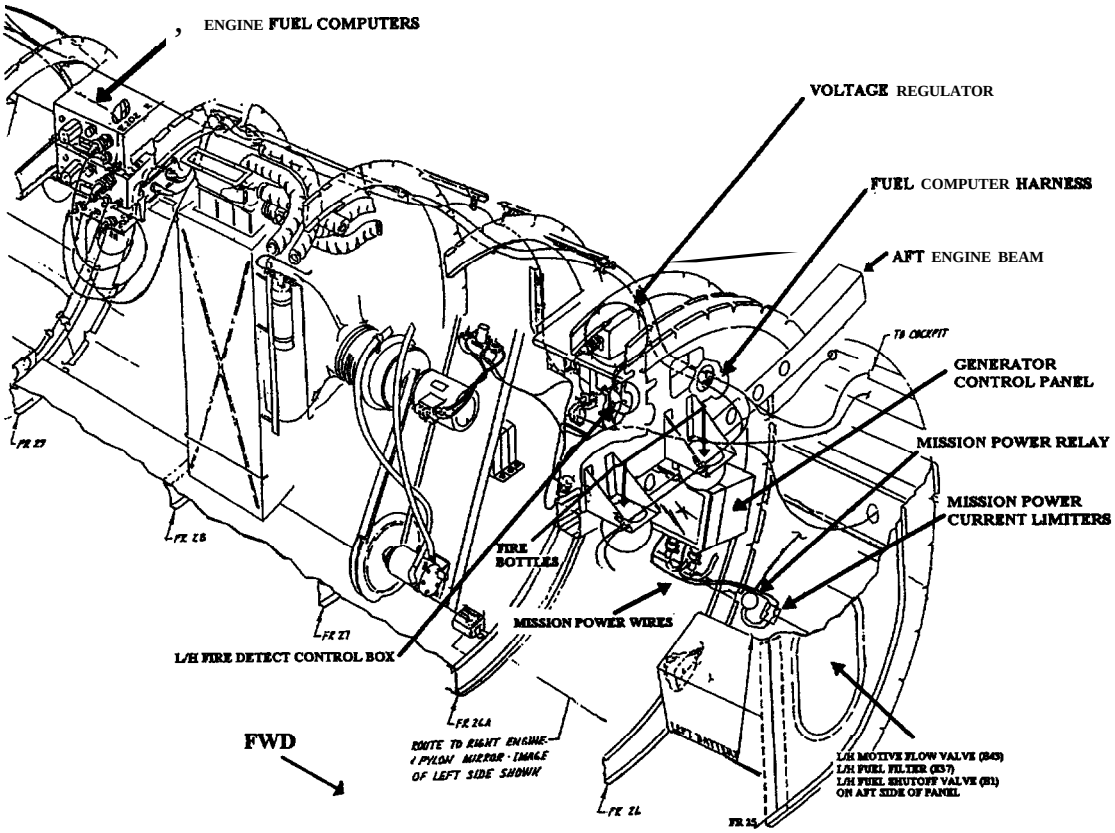
Figure 3a.--Components in tailcone.

The investigation found that in the actual mission equipment wiring of N521PA, the power wires were routed directly to the battery charging bus. (Figure 3a is a drawing of major components in the tailcone. Figure 3b shows the intended versus actual routing of the power wires in N521PA.)

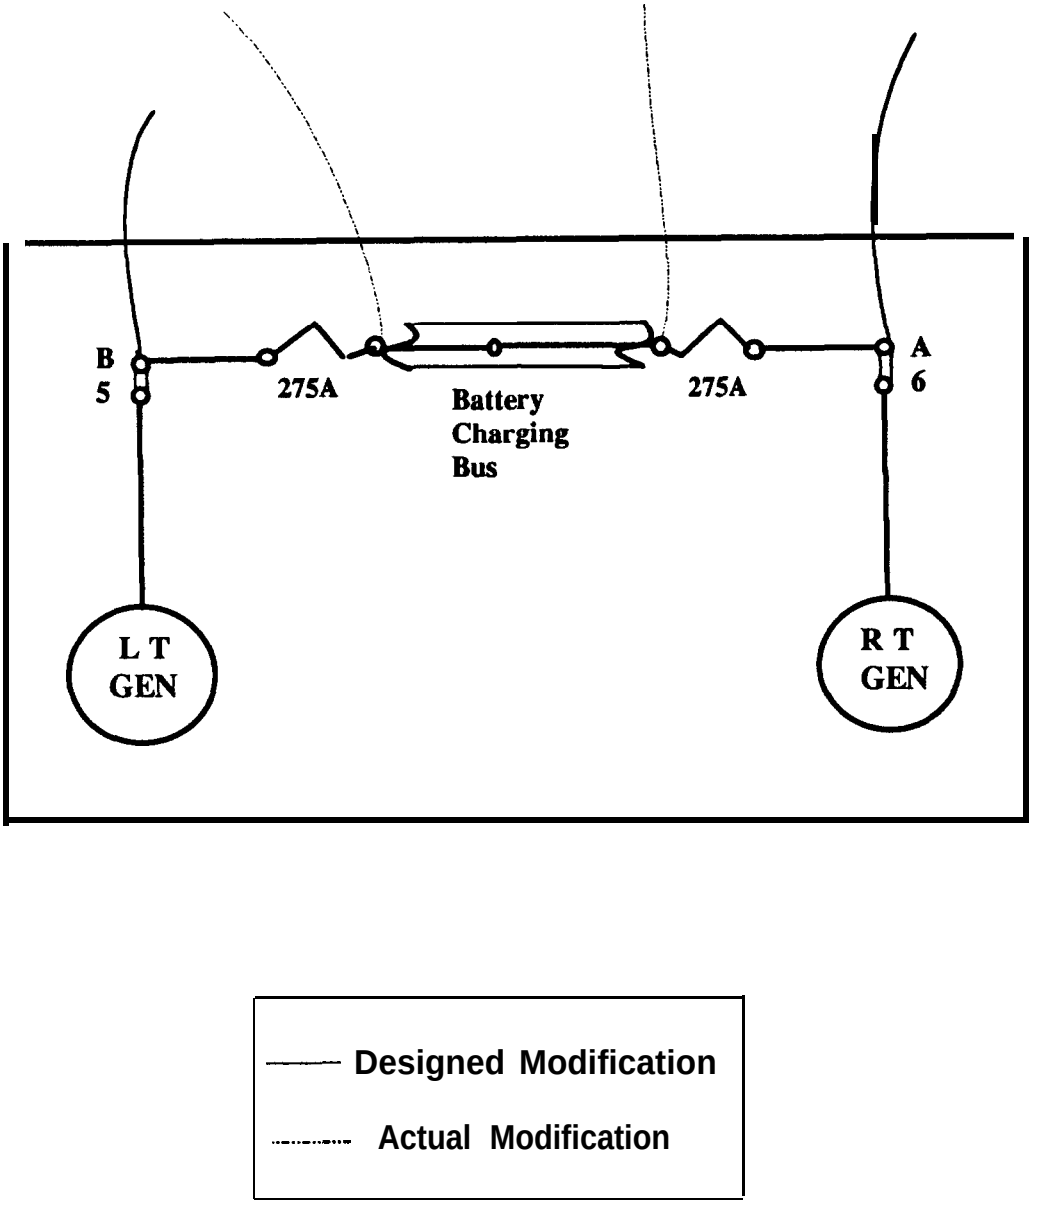
Figure 3b.--Mission power wiring.

asked where to install the wires was misdirected in the confines of the "hell hole." Another mechanic said, "put it there," and the mechanic working on that airplane thought that he was being pointed towards the battery bus, rather than properly towards the terminals for the generator bus. (The investigation found that the subject wires had been attached to terminals on the battery charging bus.) The Director of Maintenance stated that after the first airplane was miswired, the incorrect wiring alteration was copied on 14 subsequent Learjets and that a drawing was not referenced.

On December 20, 1994, 6 days after the accident, the Phoenix Air Director of Maintenance issued an "Immediate Airworthiness Action" to Phoenix Air's seven maintenance sites to immediately stop flying the remaining 17 mission-equipped Learjets until the wiring was inspected for chafing, then "disconnect the special mission power wire from the generator control panel to the current limiter and remove this entire section of wire." On December 23, 1994, Learjet sent a letter to its operators, worldwide, stating that, "It is strongly recommended that [an inspection] take place prior to the next flight."

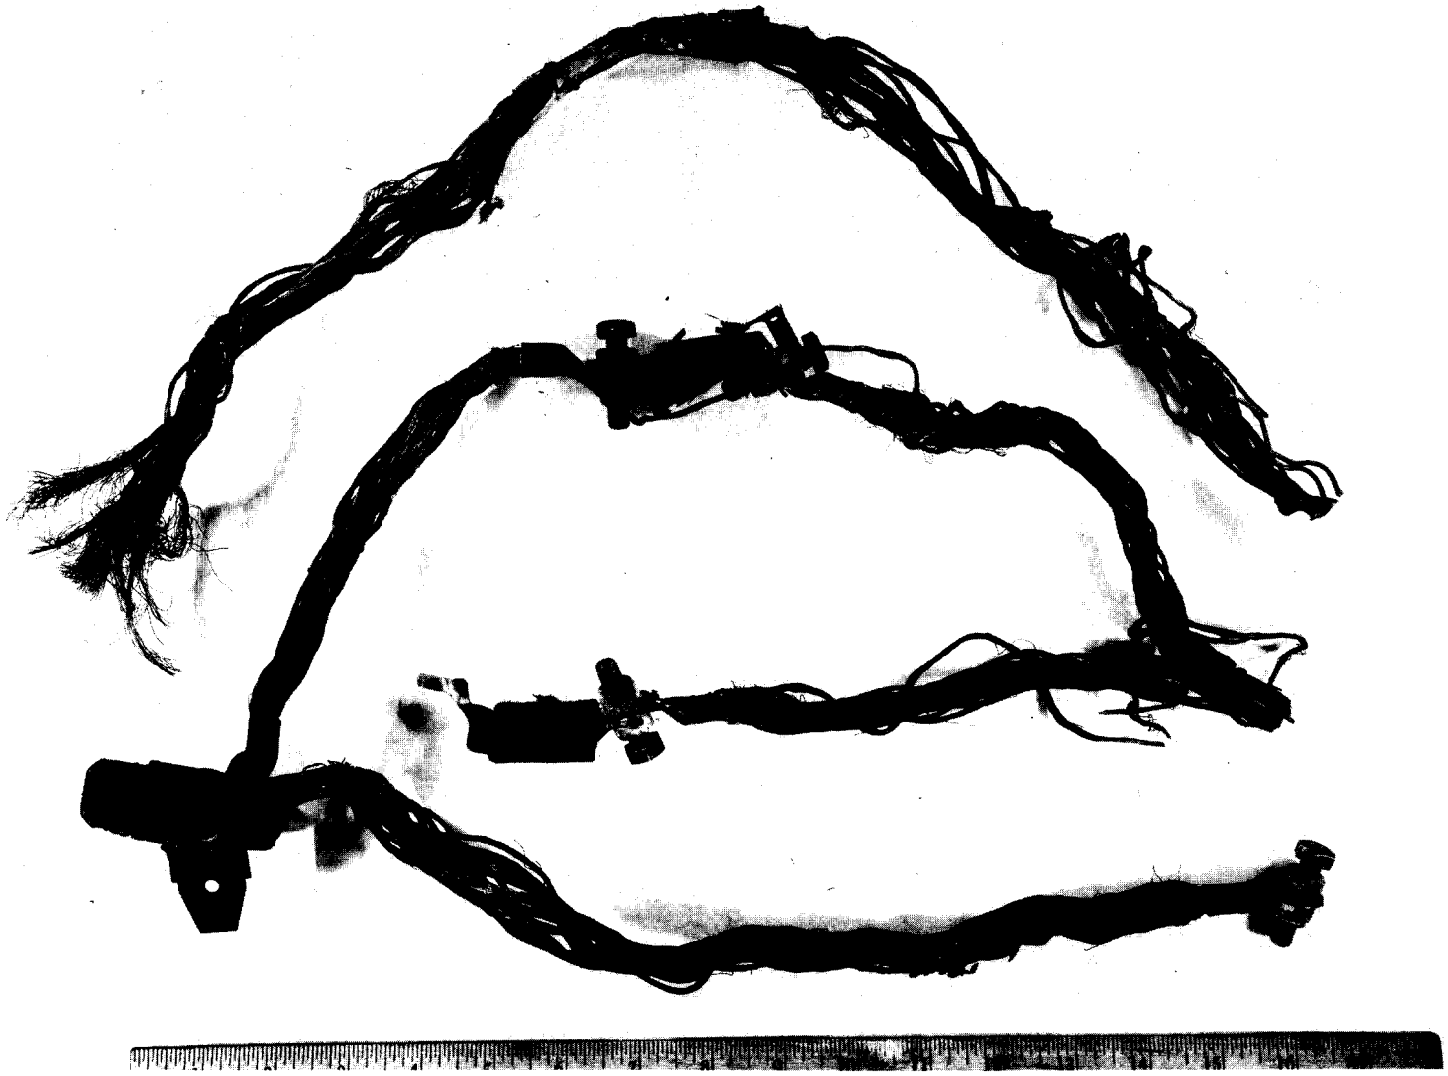
Figure 4.--View of cables as received for examination.

Portions of the wires, identified as part of the electrical power source for the special mission package, were size No. 0 awg and were found on E. Olive, near the wheel of an unburned vehicle. The wires had evidence of high heating prior to impact, including areas fused together for about 2 inches in length, and individual strands of the wires had a beaded appearance. (See figure 4.) Current limiters (fuses) were found attached to the nonwelded ends of one of the two sets of wires. In subsequent testing, the current limiters were found to provide electrical continuity (in the closed position).
