Crash Following Loss of Engine Power Due to Fuel Exhaustion
Air Methods Corporation
Eurocopter AS350 B2, N352LN
Near Mosby, Missouri
August 26, 2011

Accident Report

NTSB/AAR-13/02
PB2013-104866

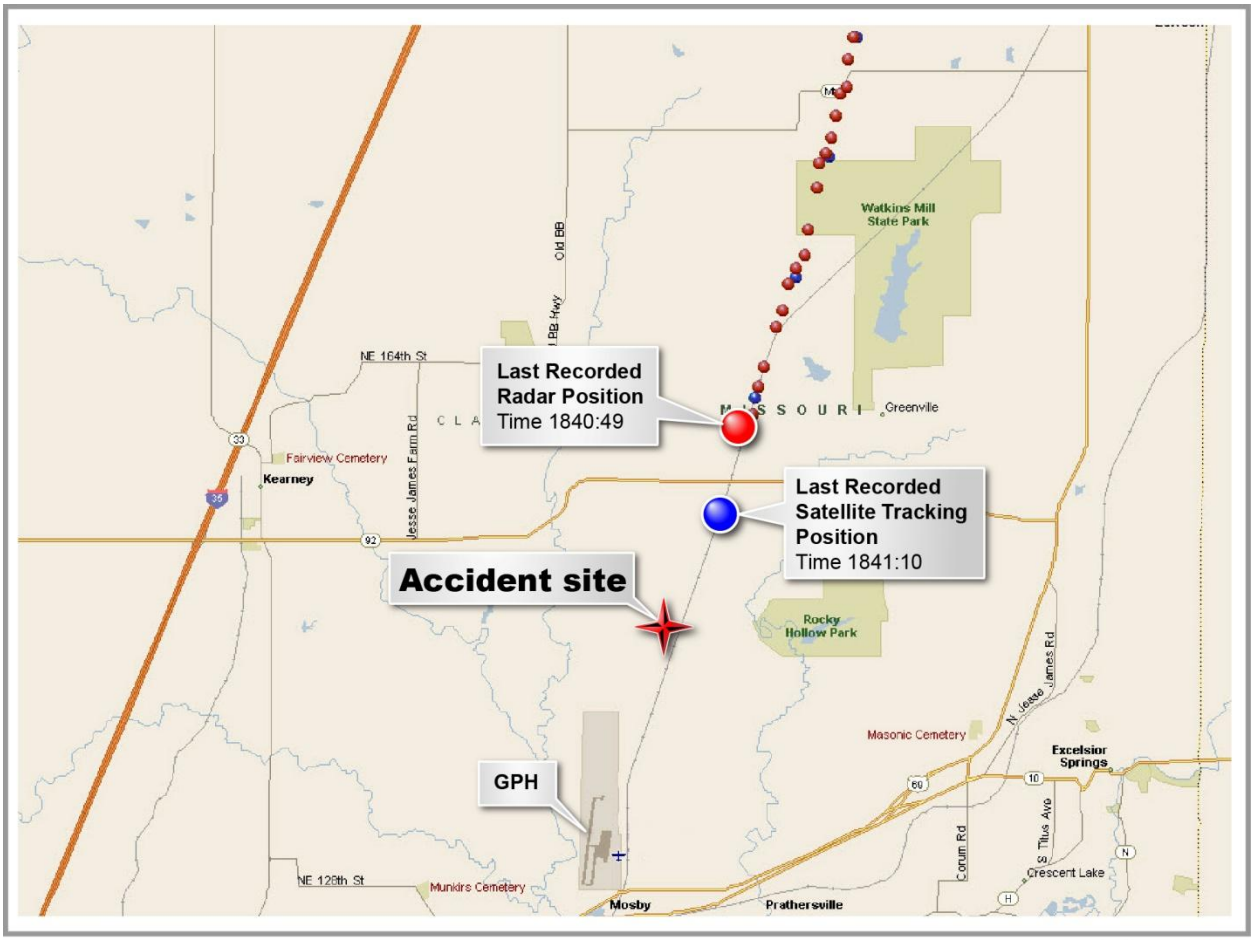
an average ground speed of 111 to 116 knots. The last few minutes of data showed the helicopter in a shallow descent. About 1841, the last satellite tracking system position recorded was about 0.9 nm from the accident site and showed the helicopter was about 373 feet agl with a 116-knot ground speed. Figure 3 shows the last few miles of flight track data.

Figure 3. Flight track of the last few miles of the accident flight showing radar data (red dots) and Air Methods satellite tracking system data (blue dots).

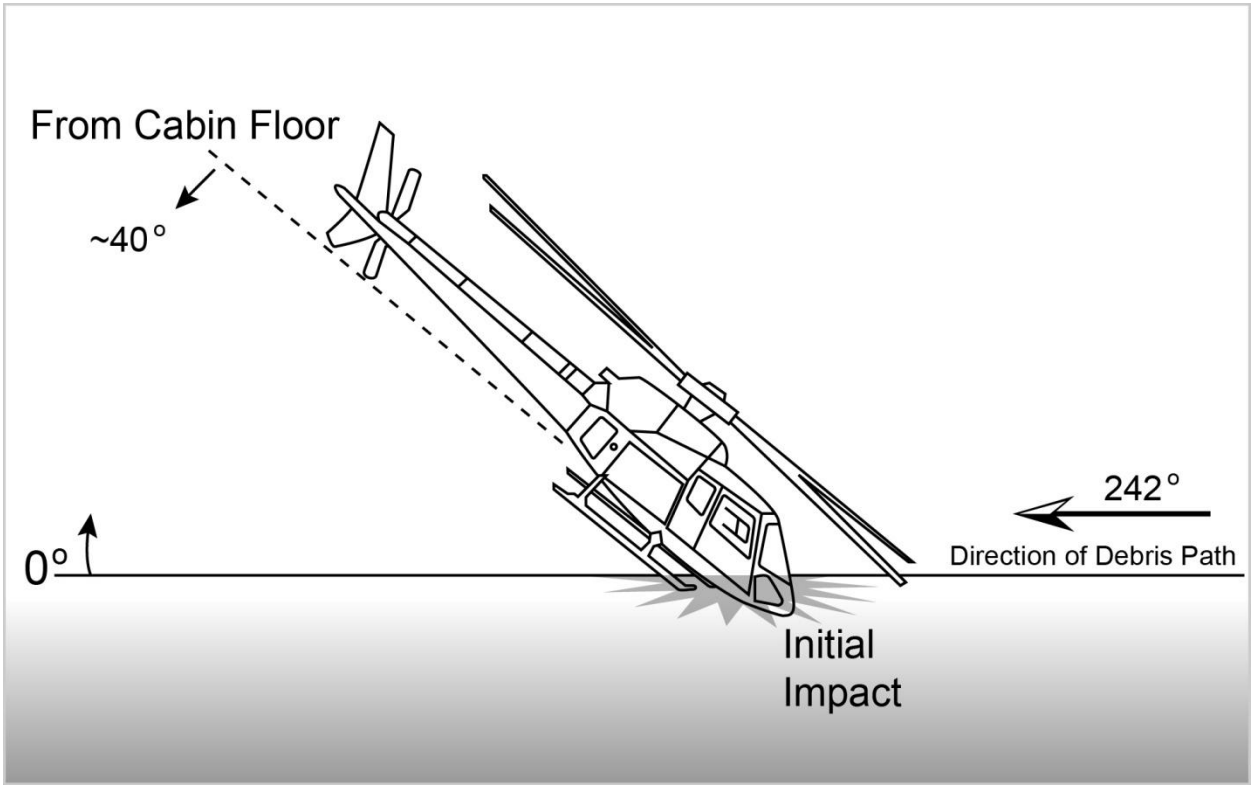
The wreckage displayed vertical crush damage consistent with impact at a high rate of descent. The main rotor blades remained attached to the rotor hub, were bent but not twisted, and had minimal leading-edge damage. Similarly, the tail rotor blades exhibited little impact damage and were relatively straight, although one blade was partially separated at the blade root. The damage to the main and tail rotor blades was consistent with a low rotor rpm at impact. The impact signatures to the components of the airframe structure were consistent with the initial impact occurring in a 40° nose-low and slight left-bank attitude, on a heading of about 030° (nearly opposite to the direction of travel). Figure 5 is a diagram illustrating the estimated impact attitude of the helicopter.

Figure 5. Diagram showing the estimated impact attitude of the helicopter.

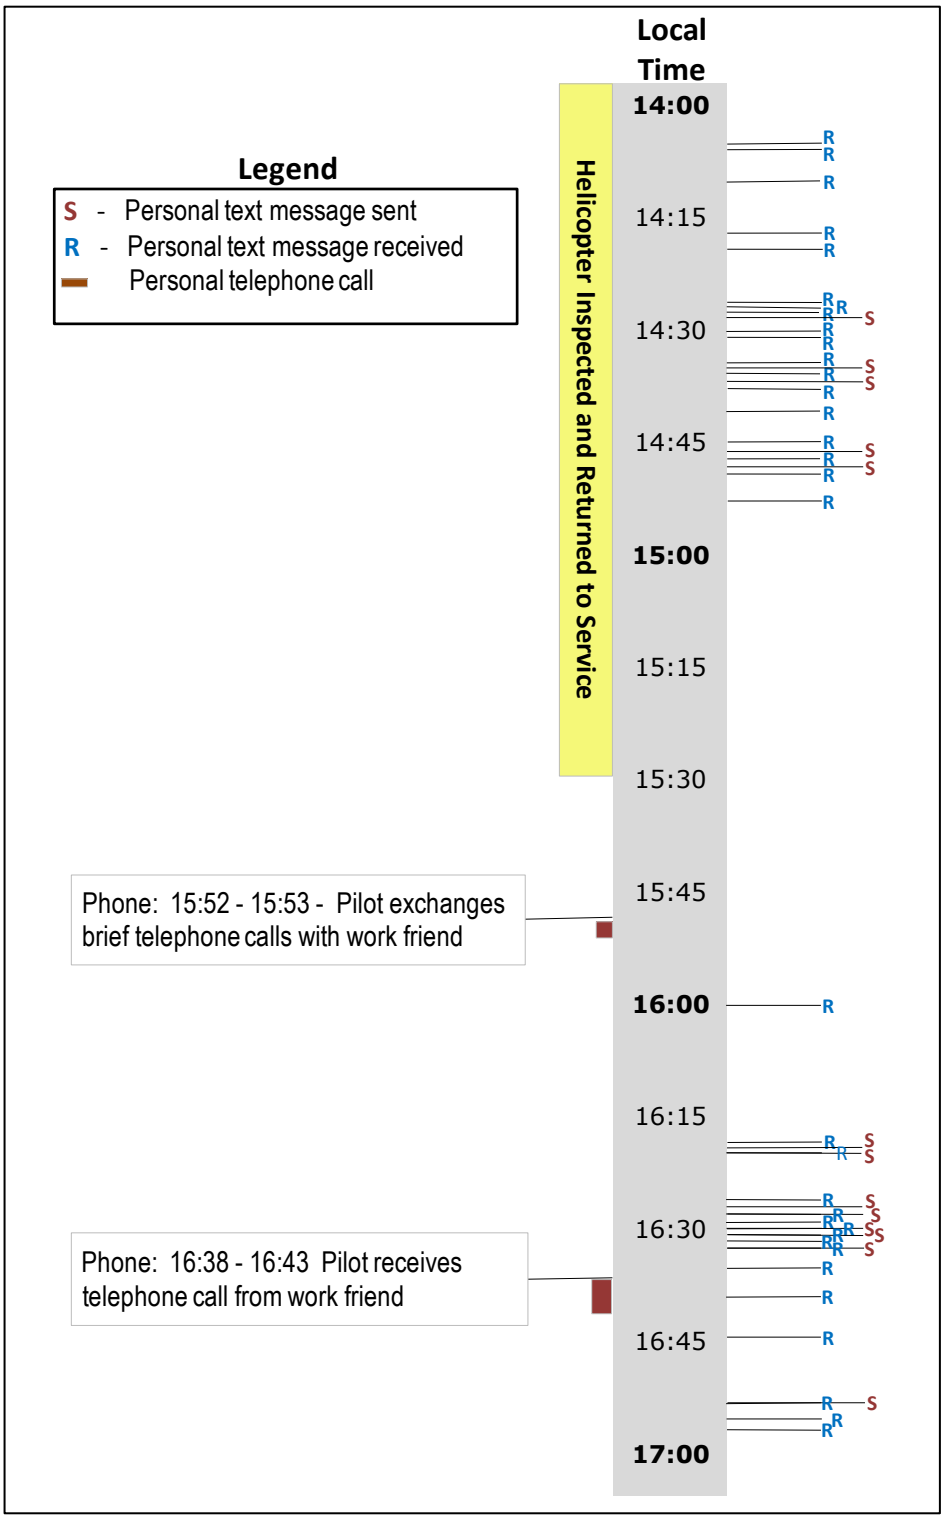
Figure 6a. Timeline of the pilot's communications from 1400 to 1700.

According to cell phone records, the pilot made and received multiple personal calls and text messages throughout the day. Figures 6a and 6b show the timing of the cell phone calls and text messages with the timing of radio communications and flight activities from 1400 (the time identified by the mechanic as when he and the pilot began the walk-around inspection) until the accident about 1841. Figure 6a, which covers the time period from 1400 to 1700, shows that

during about 20 minutes (1430 to 1450) of the 90-minute time period (1400 to 1530) identified by the mechanic as when the helicopter was being prepared by the pilot and medical crew for its return to service, the pilot sent multiple text messages.

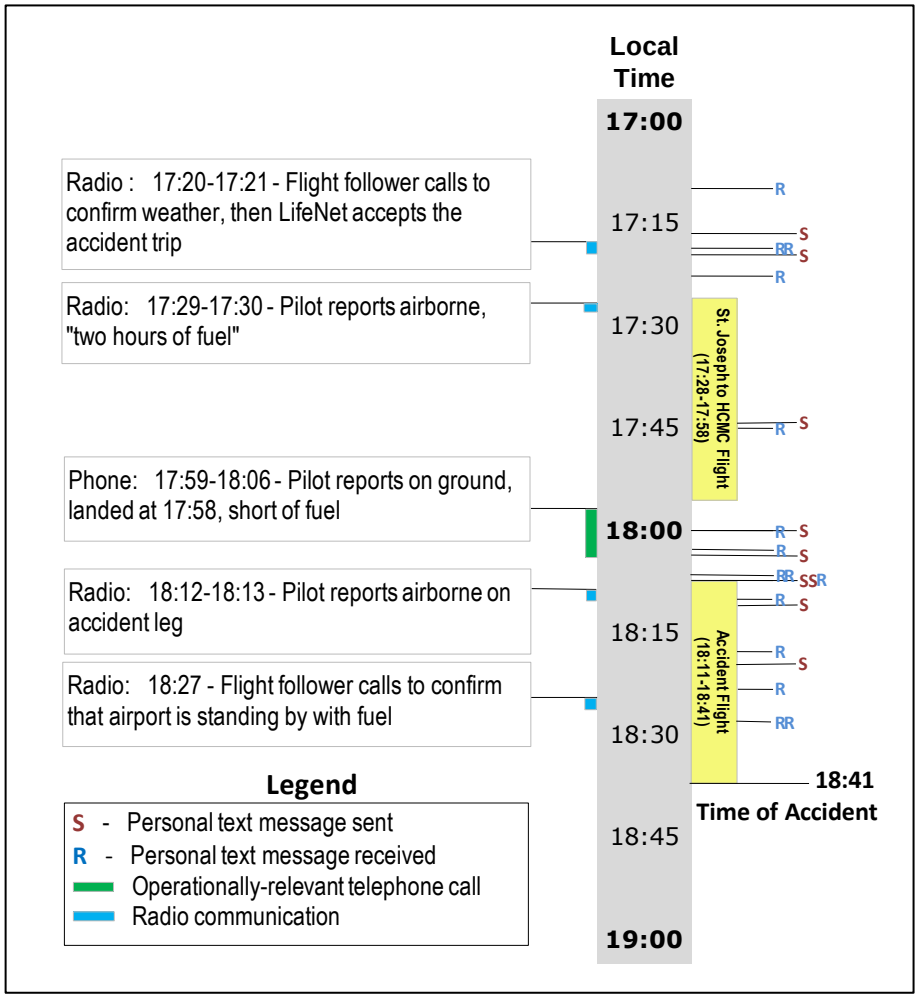
Figure 6b. Timeline of the pilot's communications from 1700 to the accident about 1841.

Figure 6b, which covers the time period from 1700 to the accident, shows that text messages were sent from the pilot's cell phone during time periods when the helicopter was in flight on the accident leg and the preceding leg and while the helicopter was on the Harrison County Community Hospital helipad.

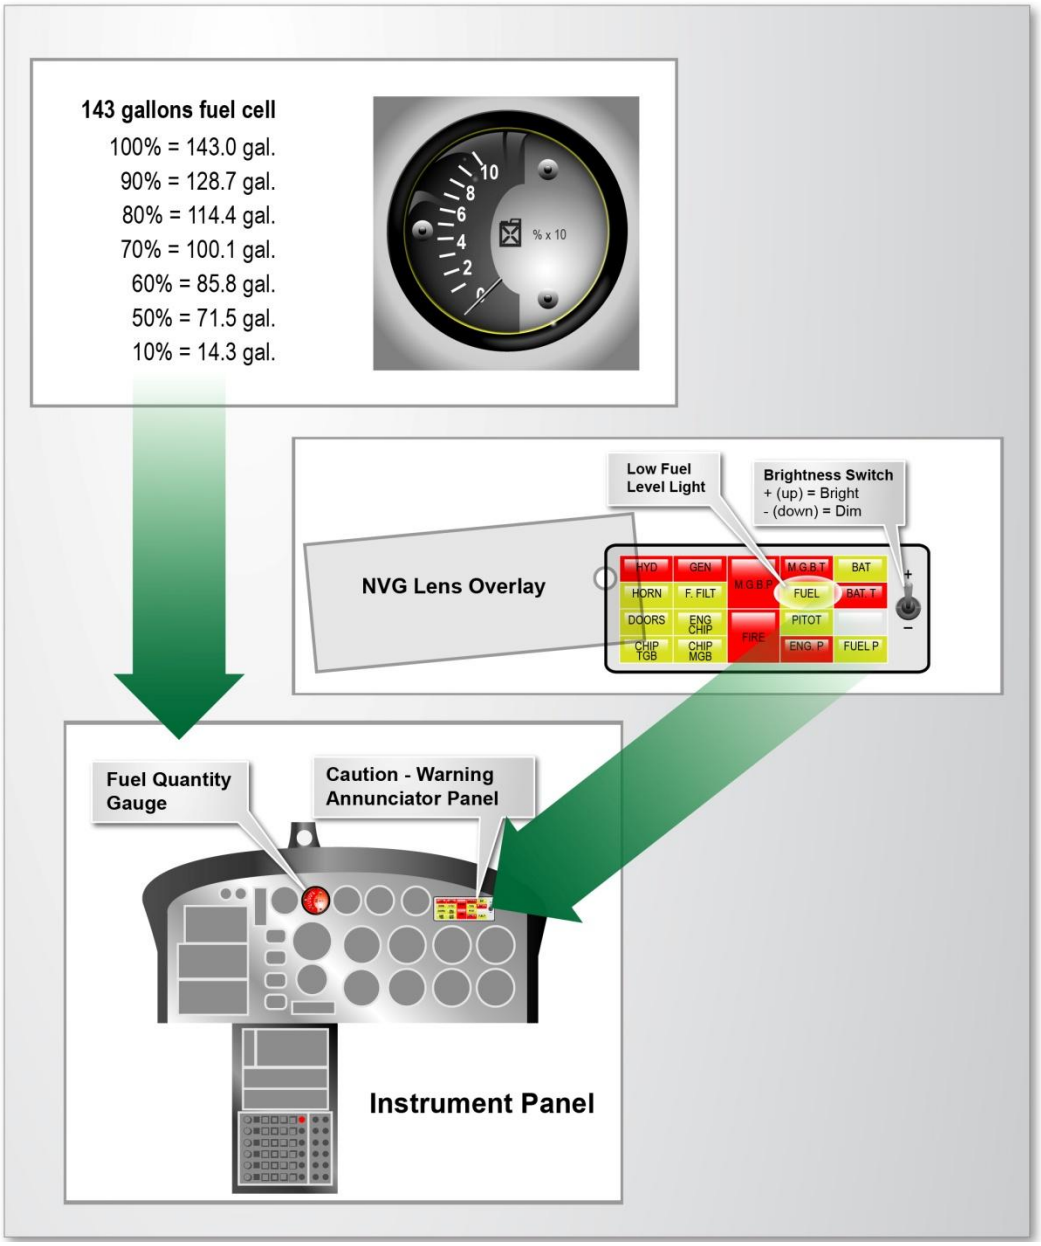
Figure 7. Diagram of the instrument panel, the fuel quantity gauge, and the caution/warning annunciator panel.

The low fuel level light is an amber-colored light labeled "FUEL" in the caution/warning annunciator panel located on the upper right portion of the pilot's instrument panel. The light illuminates when the fuel quantity is below 11 percent (15.8 gallons). According to the Eurocopter AS350 B2 Rotorcraft Flight Manual (RFM), when the light illuminates, the pilot is to "Avoid large attitude changes." The RFM also states, "Note: Remaining usable fuel allows approximately 18 minutes level flight at maximum continuous power." According to flight test data provided by Eurocopter, the airspeed in level flight at maximum continuous power would be about 119 knots.

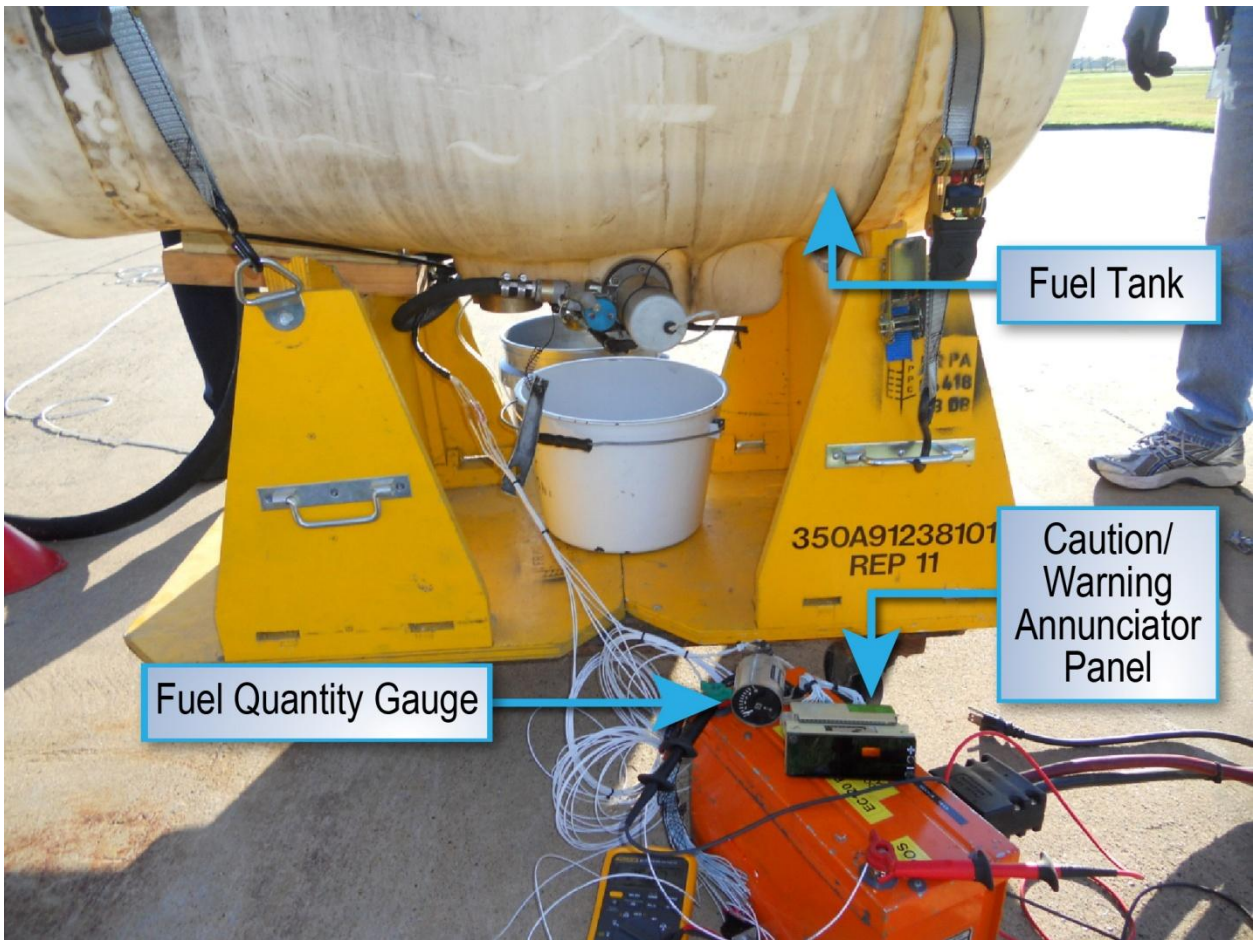
Figure 8. Photograph of the fuel system component examination setup.

An operational check of the caution/warning annunciator panel was performed and revealed that all lights were working properly. Examination of the individual light bulb filaments revealed that the filaments for both bulbs from the low fuel level light exhibited slightly stretched coils consistent with the light being illuminated at the time of impact.

The brightness switch on the caution/warning annunciator panel was found on the dim setting at the accident site. During the examination, the panel was illuminated in daylight conditions and observed in both bright and dim settings. With the panel in the dim position, only the low fuel pressure light (the only light that does not convert to the dim setting by design) was conspicuously illuminated. It was not possible to determine whether the panel was switched to the dim setting during the previous NVG training flight and never returned to bright for the accident flight, whether the panel was switched to the dim setting during the accident flight, or whether this setting occurred during impact.

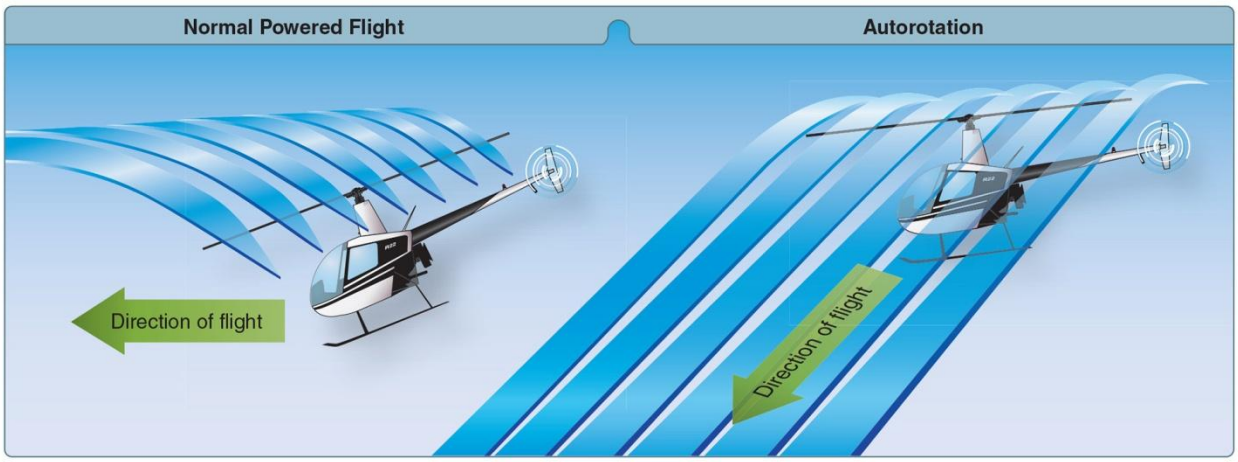
Figure 10. Airflow through the main rotor system during normal, powered flight and during autorotation.

As illustrated in figure 10, a helicopter is not in an autorotation until the airflow is passing upward through the rotor blades. Pilots are taught to lower the collective following an engine failure because it results in a descent that produces an upward flow of air. However, when a helicopter is in cruise flight at the time the engine fails, using aft cyclic to increase the pitch attitude (a cyclic flare) will more rapidly produce an upward flow of air because it tilts the main rotor system aft so that the oncoming air is flowing upward through the rotor blades. As noted in *Rotary Wing Flight* (Ean 1987), this cyclic flare will help prevent excessive rotor rpm decay, which is critical in helicopters with low inertia rotor systems because they lose rotor rpm very quickly.
