Collision of Union Pacific Railroad Freight Train with BNSF Railway Freight Train Near Chaffee, Missouri May 25, 2013

Accident Report

NTSB/RAR-14/02
PB2015-102084

NTSB/RAR-14/02
PB2015-102084
Notation 8507A
Adopted November 17, 2014

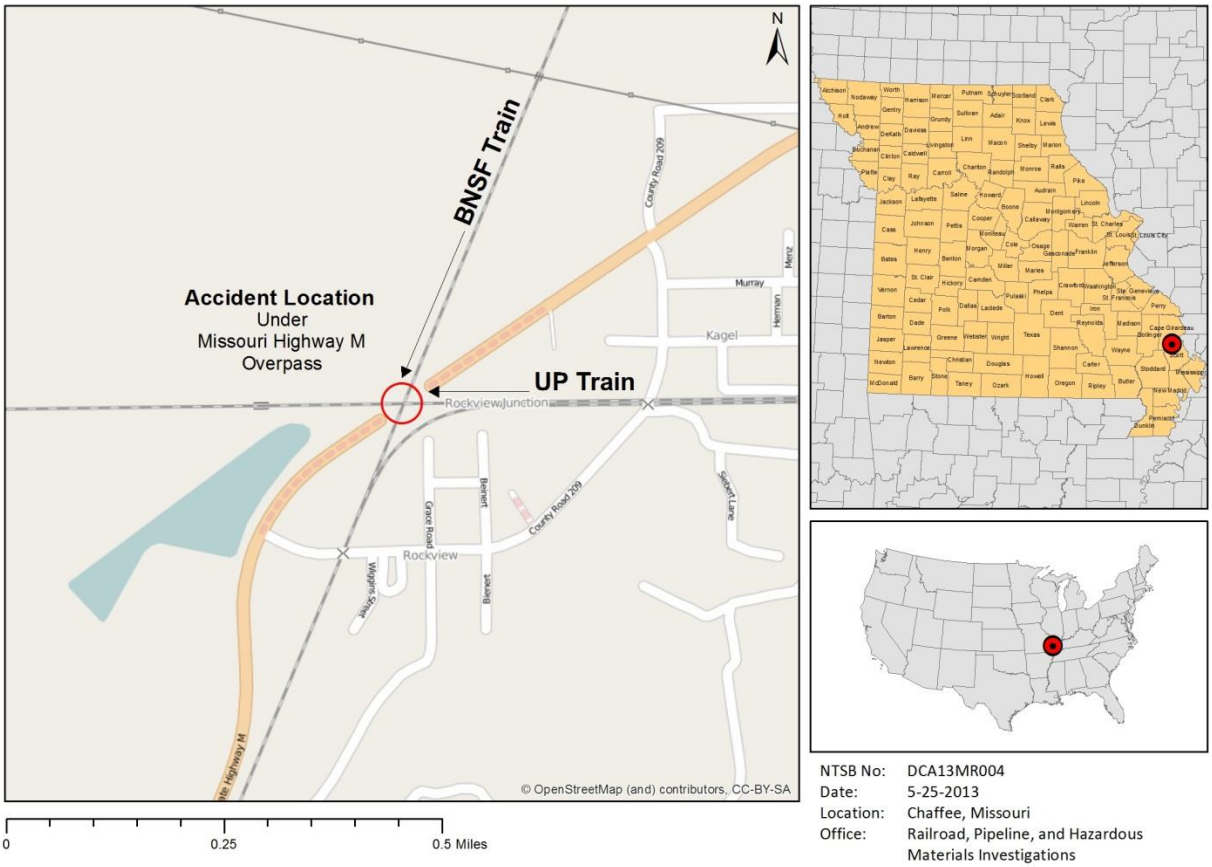
Figure 2. Accident location.

The conductor also told investigators that he did not notice anything out of the ordinary until the train got closer to the interlocking. He said that he was familiar with the Rockview Interlocking area, which has "a sweeping curve to the right, when you're heading south, and … the signal is at the south end." He said that after the train went around the corner he saw the Restricting signal (flashing red aspect). At that point, he did not think the train was slowing down like it should have been, so he used the emergency brake valve to place the train into emergency braking. The UP train struck the passing BNSF train shortly thereafter. Event recorder data indicated that the speed at impact was 43 mph. (See figure 2 for accident location.)

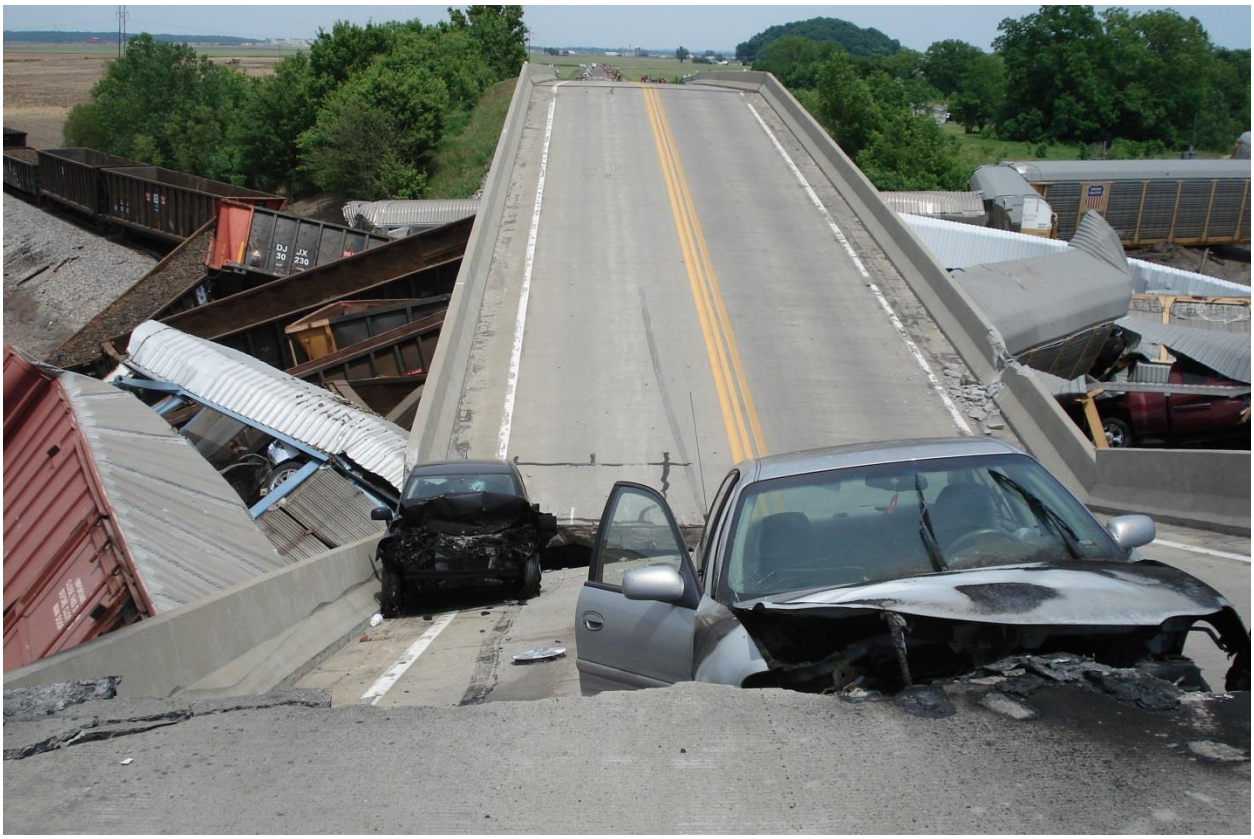
As a result of the train impact after the derailment, bent 3 was sheared off at the base of the footing. This loss of structure allowed spans 2 and 3 to collapse. (See figures 3 and 4.) The downward vertical movement of these spans was stopped by the wreckage of the derailed train cars underneath the structure. Several UP auto-rack cars came to rest against the fractured columns of bent 3. Also, oval-shaped impact damage 42 inches wide and 39 inches deep, consistent with an impact with one of the bent columns, was found on one BNSF car. This car was the 22nd car in the BNSF train, 10 cars behind the point where the UP train struck the BNSF train. The vertical clearance between the track elevation and the bottom of the girders was about 24.5 feet. The horizontal clearance from the center of the rails to bent 3 was 21 feet 9.75 inches. There was no crash-protection wall shielding the bents from impact with railroad equipment.

Figure 3. Derailed train cars and damaged bridge supports.
