DIVER/ROV TARGET LOGS

TWA 800
Oceaneering Data Center

DAILY DIVE SITREP

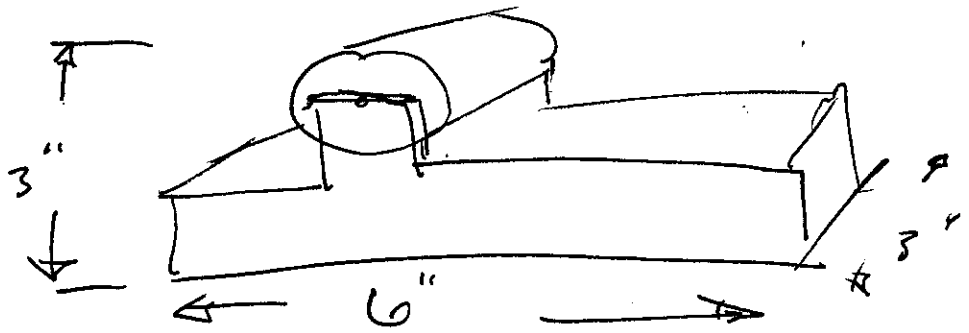
Describe Target: WHEELED COMPONENT

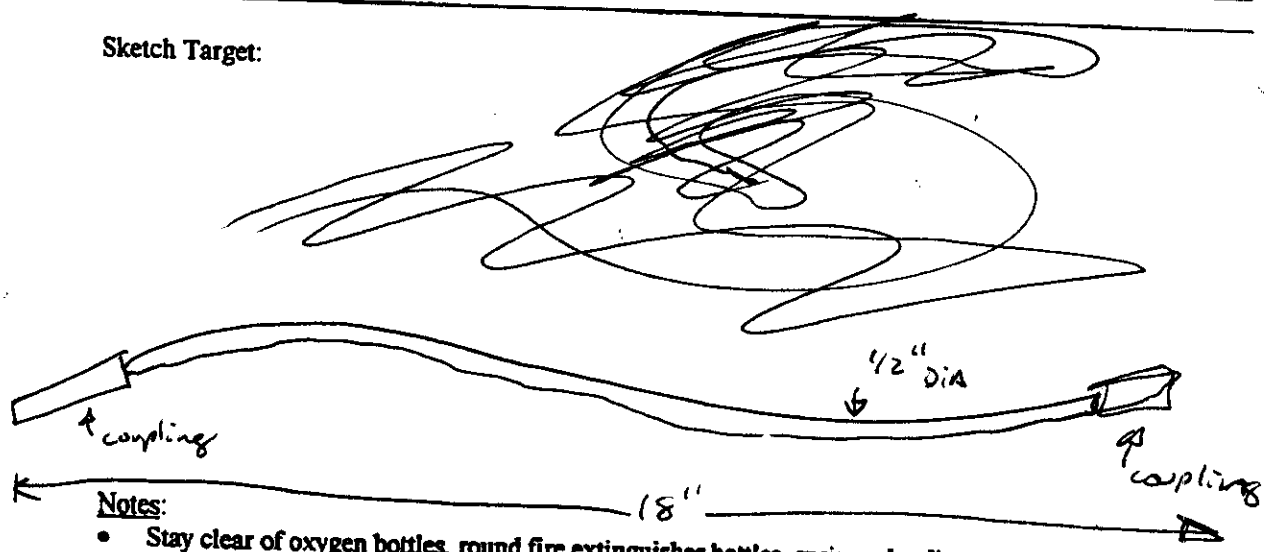
Target Type: 18" x 1/2" STAINLESS ~~STEEL~~ PIPING
(Metal Structure/Wiring/Piping/Mechanical Components)

Condition: TWISTED
(Fire Damage/Darkened Areas/Soot/Insulation Missing/Bent)

Describe Target: 18" x 1/2" DIA STAINLESS ~~STEEL~~ PIPE W/ ~~COUPLING~~ COUPLINGS

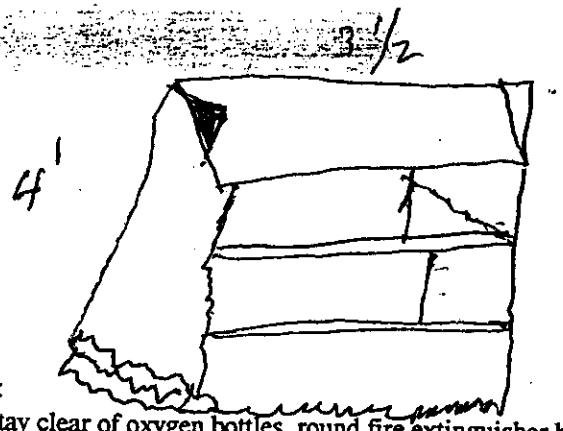
Condition: Bent Crushed
(Fire Damage/Darkened Areas/Soot/Insulation Missing/Bent)

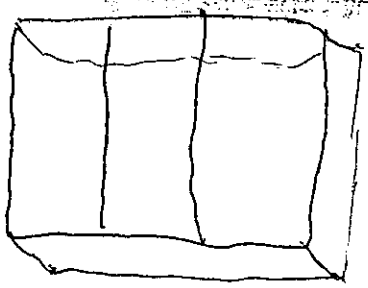
Describe Target: One left Sandal # E461 07/95
One Oxygen Mask
One GAP Blue Jean Jacket Size Large
One GFR, Book (Banks and Banking)

Metal Debris with following
ID #
(a) 65B02790 3D
(b) - 65B03143-4
(c) - 69B 70310-2SK
(d) - 65B5053-31
(e) - 65BU3625

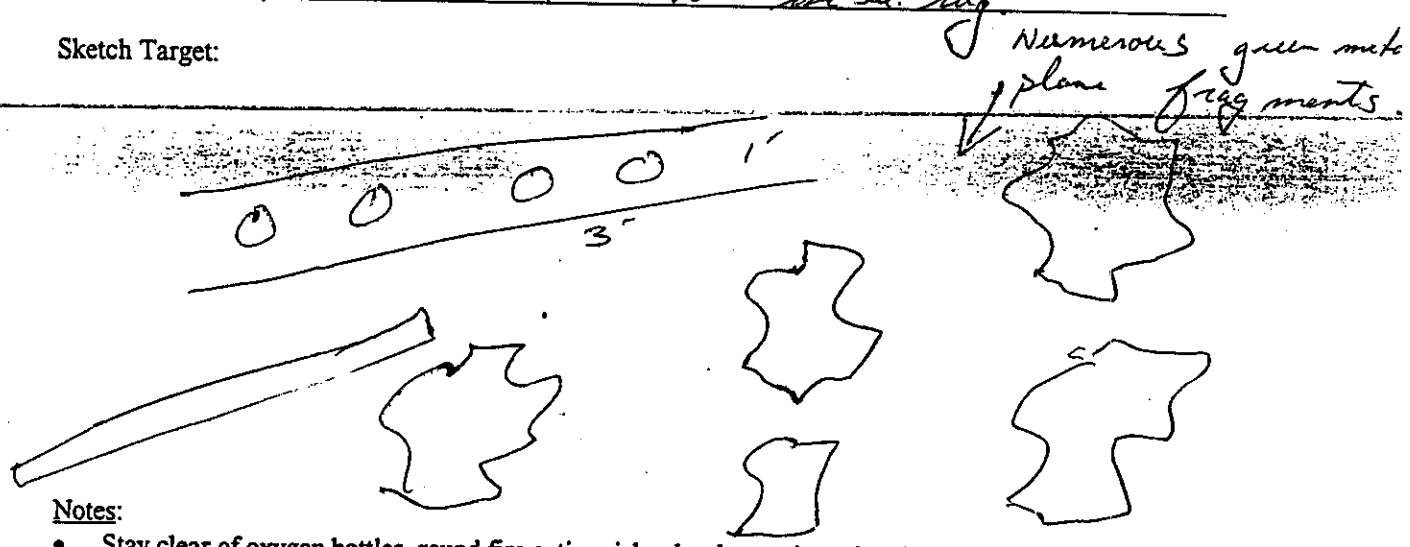
Target Type: Misc. Metal Structure / Burned suitcase
(Metal Structure/Wiring/Piping/Mechanical Components)

Condition: Bent metal
(Fire Damage/Darkened Areas/Soot/Insulation Missing/Bent)

Describe Target: Numerous targets of various sizes recovered and marked. Targets were light green, slightly bent and tinted with above identifying numbers. Suitcase was burnt through to the zippers. All recovered evidence turned over to the Sal. Tug.

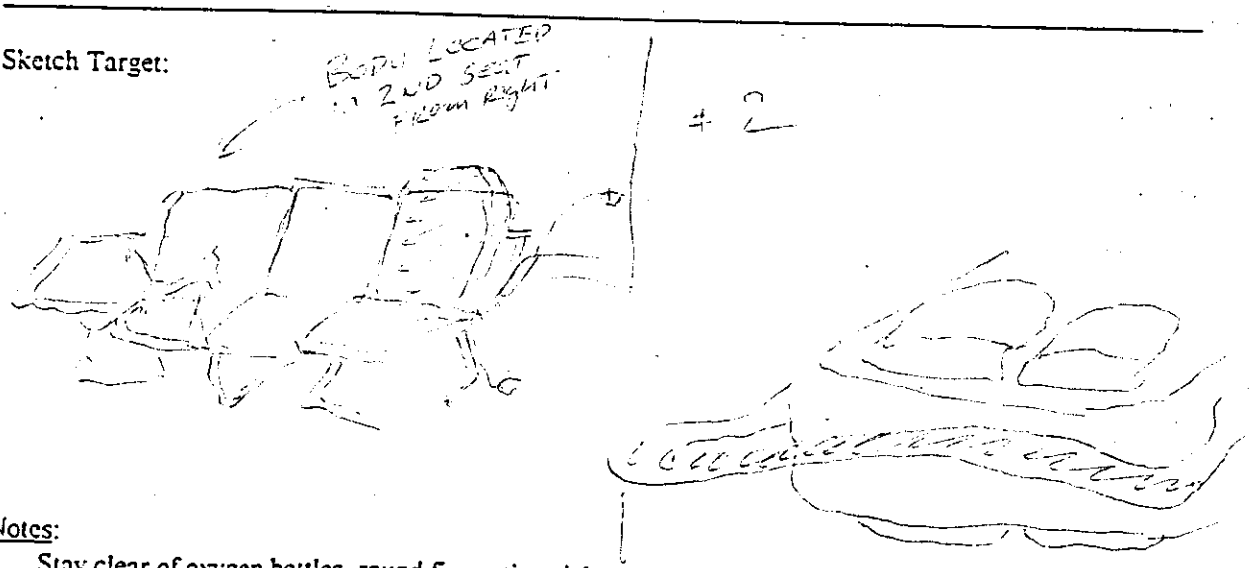
Condition: #1 BENT / ~~[illegible]~~ #2 INTACT
(Fire Damage/Darkened Areas/Soot/Insulation Missing/Bent)

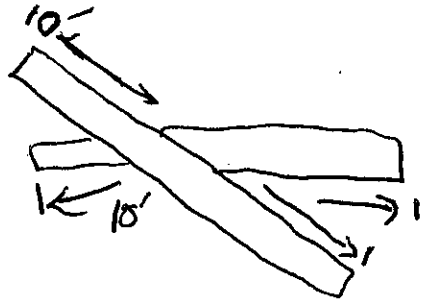
Condition: ROTTEN
(Fire Damage/Darkened Areas/Soot/Insulation Missing/Bent)

Describe Target: APPEARED TO BE OLD BOAT WRECKAGE, ROTTEN WOOD SPARS

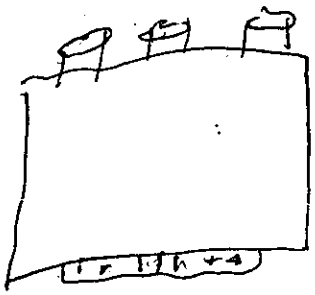
Condition: BENT BROKE
(Fire Damage/Darkened Areas/Soot/Insulation Missing/Bent)

Describe Target: VIDEO PROJECTOR

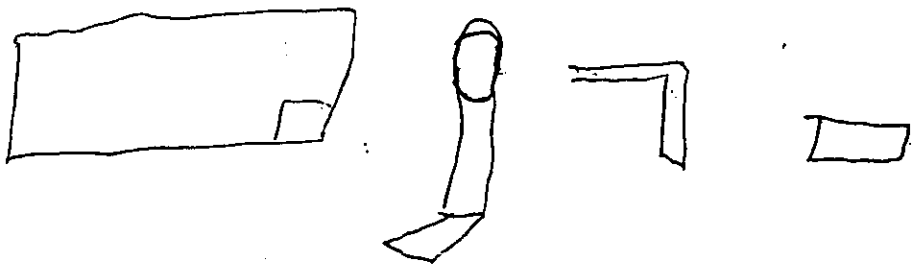
Condition: BENT
(Fire Damage/Darkened Areas/Soot/Insulation Missing/Bent)

Describe Target: MEDIUM METAL RECTANGLE PIECE WITH STYROFOAM PIECE ON ONE SIDE 3 SMALLER PIECES 2 METAL 1 PLASTIC ALL RECOVERED

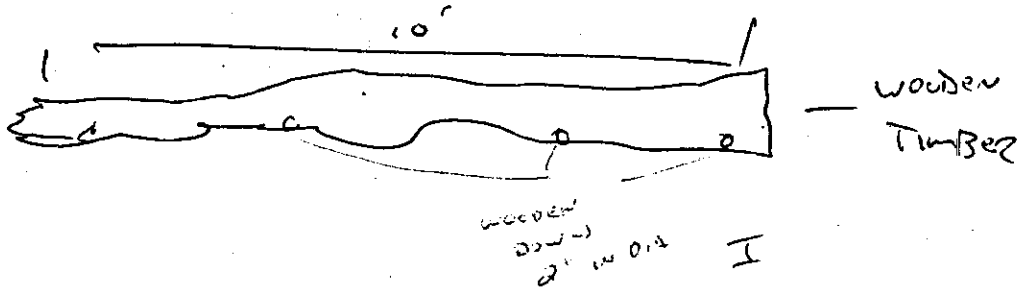
Condition: Rotted
(Fire Damage/Darkened Areas/Soot/Insulation Missing/Bent)

Describe Target: WOODEN TIMBER ON BOTTOM
LOOKS LIKE IT CAME OFF AN OLD SHIP!
IT WAS BROUGHT TO WARFING TUG!

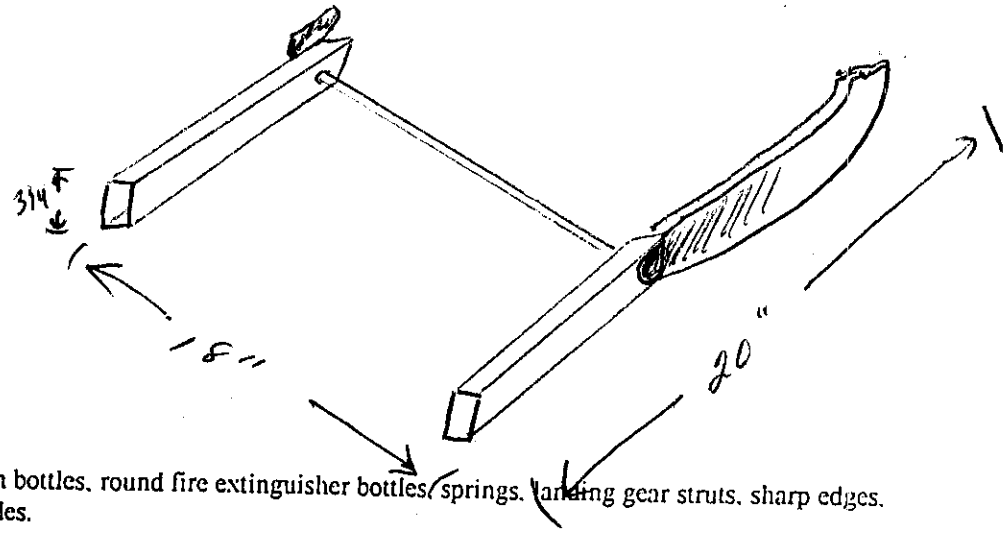
Condition: BROKEN
(Fire Damage/Darkened Areas/Soot/Insulation Missing/Bent)

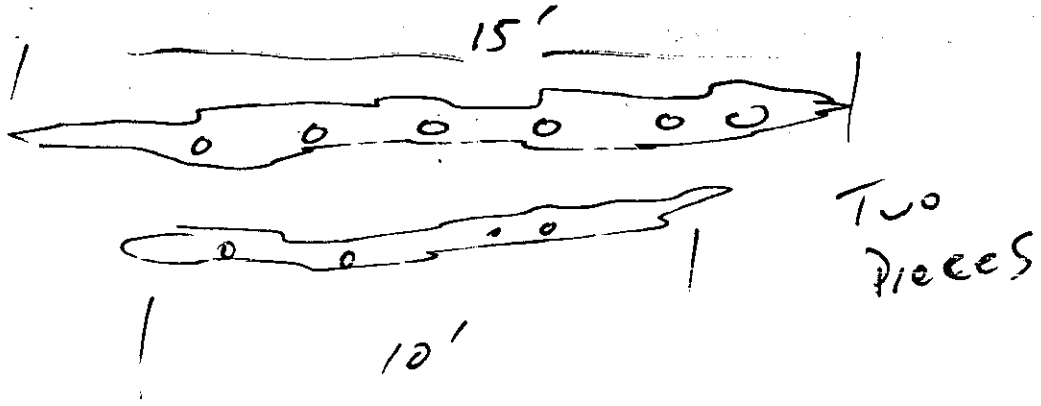
Condition: Rotted
(Fire Damage/Darkened Areas/Soot/Insulation Missing/Bent)

Describe Target: Wooden wreckage wood. Had Dowels in it, possibly more under SAND

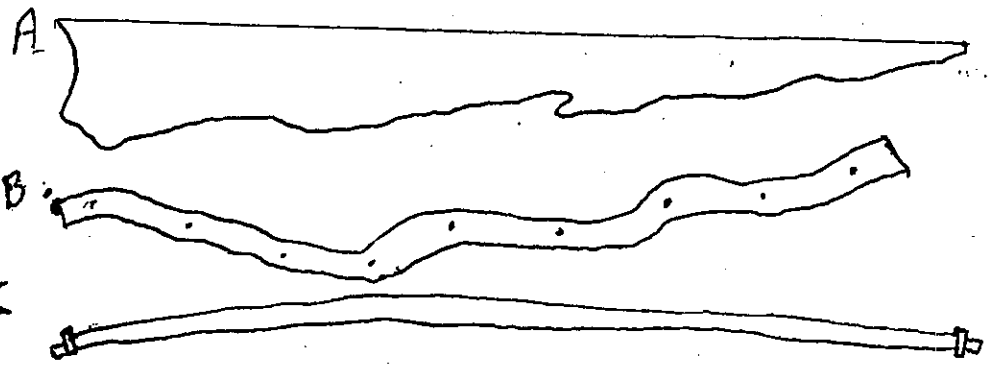
Condition: A (Burn Aluminum-Soot) B (Bent Metal) C (Bent) D (Broken tangled wire)
(Fire Damage/Darkened Areas/Soot/Insulation Missing/Bent)

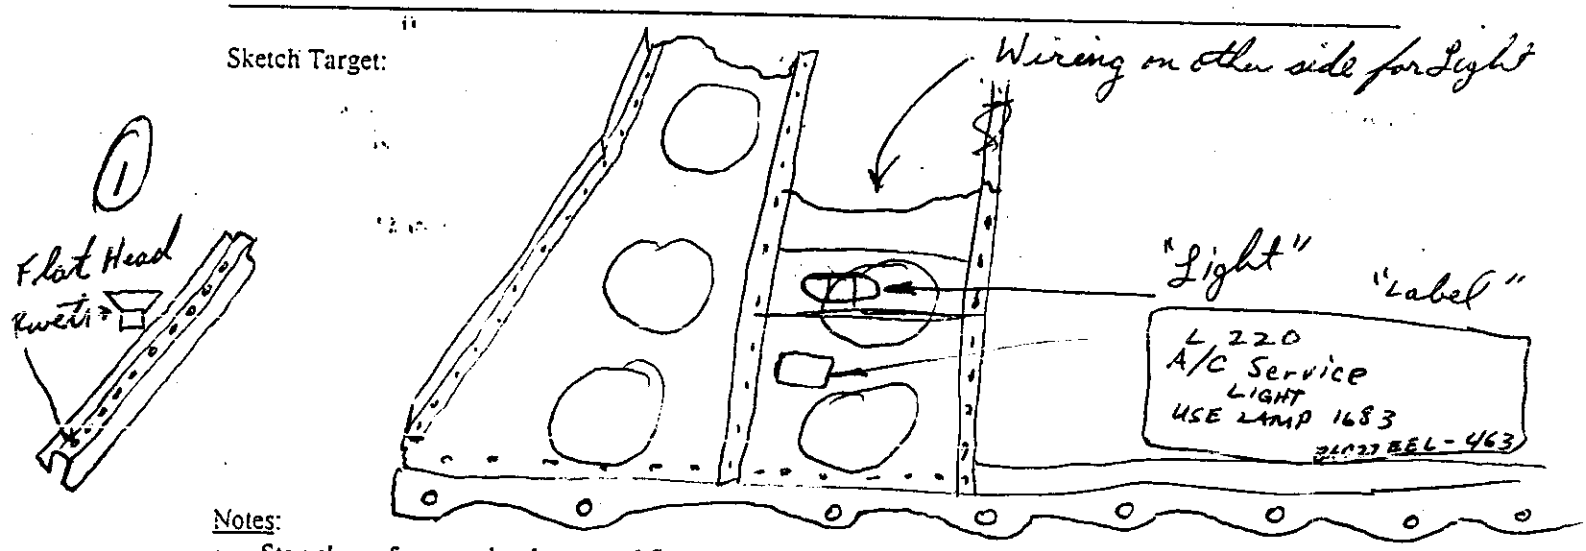
Condition: Bent & Torn
(Fire Damage/Darkened Areas/Soot/Insulation Missing/Bent)

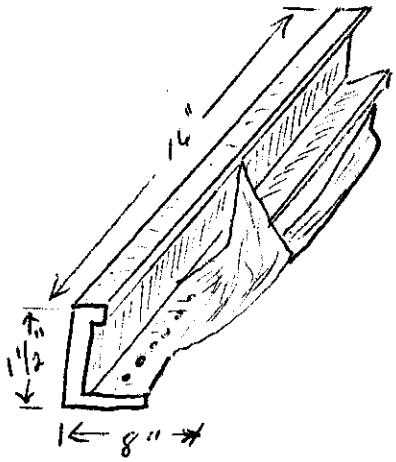
Condition: BENT / TORN
(Fire Damage/Darkened Areas/Soot/Insulation Missing/Bent)

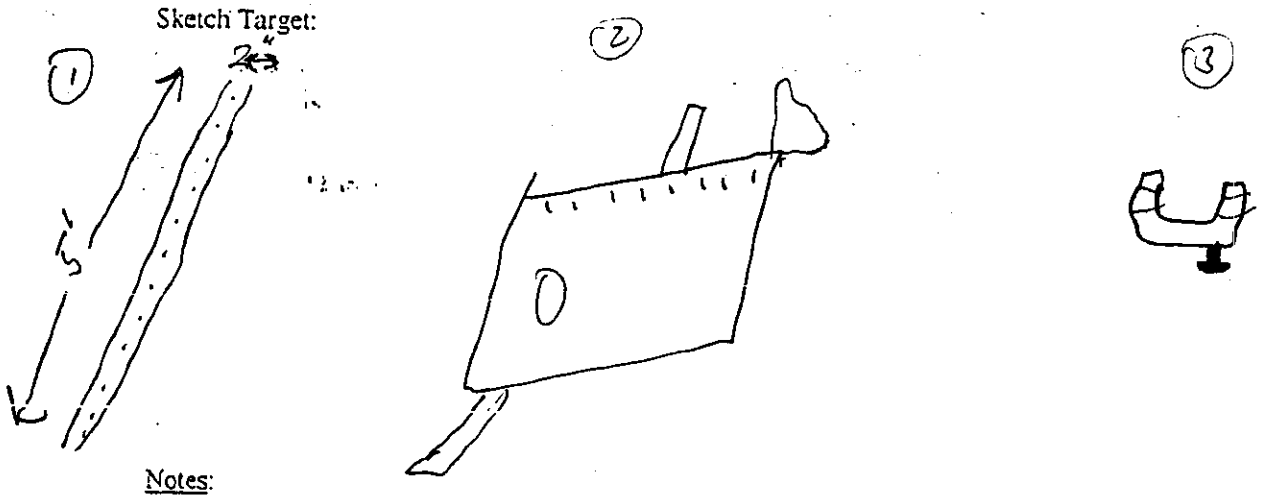
Condition: Bent
(Fire Damage/Darkened Areas/Soot/Insulation Missing/Bent)

Describe Target: 3 Pieces of debris Found

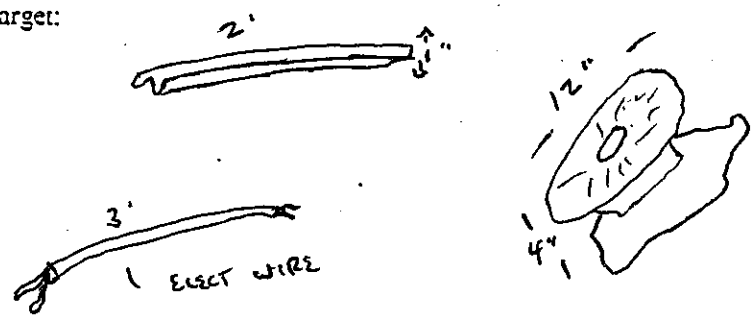
Describe Target: A FEW ~~MANY~~ SMALL PIECES OF WRECKAGE NONE OF WHICH WERE CLOSE ENOUGH TO THE MARK TO BE CONSIDERED THE TARGET. BELIEVE ALL PIECES WITHIN VASCINITY OF MARK TO BE RECOVERED.

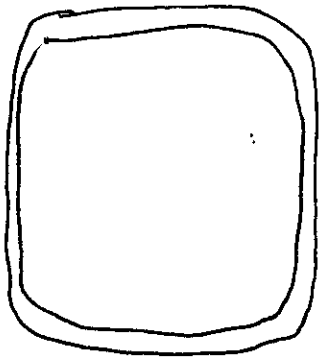
Describe Target: WINDOW FRAME

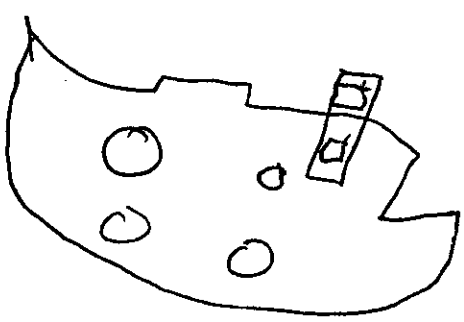
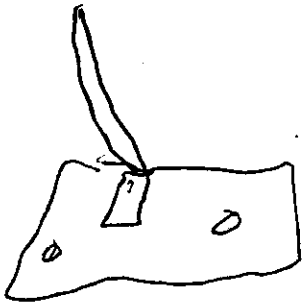
Describe Target: BENT METAL STRUCTURE PIECES

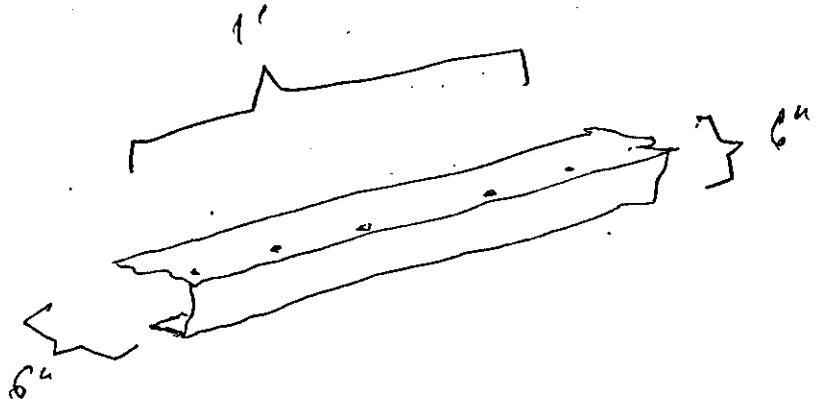
Describe Target: SMALL piece of ALUM. STRUCTURE ABOUT 1' Long.

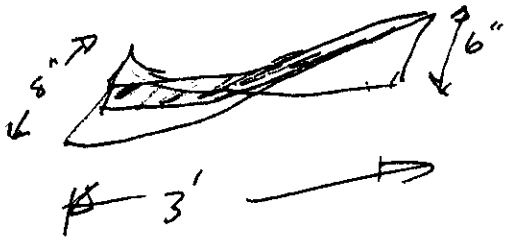
Describe Target: TWISTED PIECE OF METAL STRUCTURE.

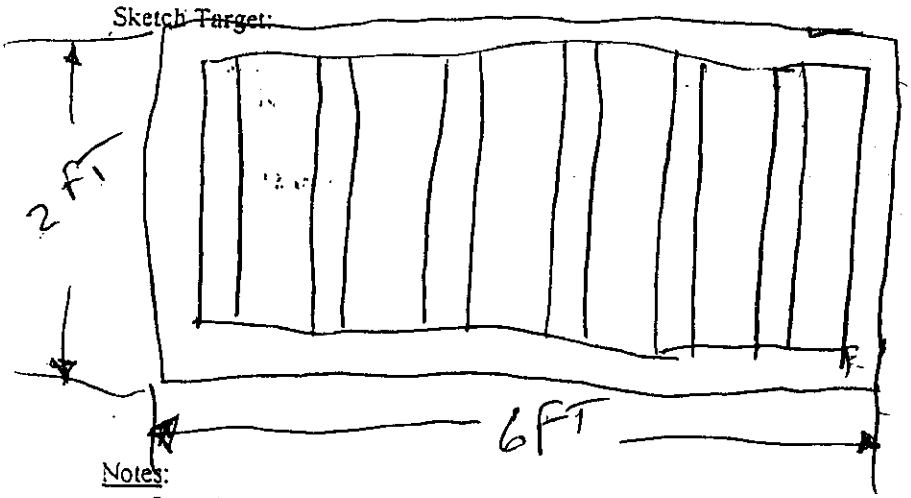
Describe Target: Conducted ZA SEARCH LOCATED TWO 2FT SECTIONS OF REBAR AND 1 6FT BY 2FT METAL GRATE. ITEM WAS NOT PART OF AIRCRAFT

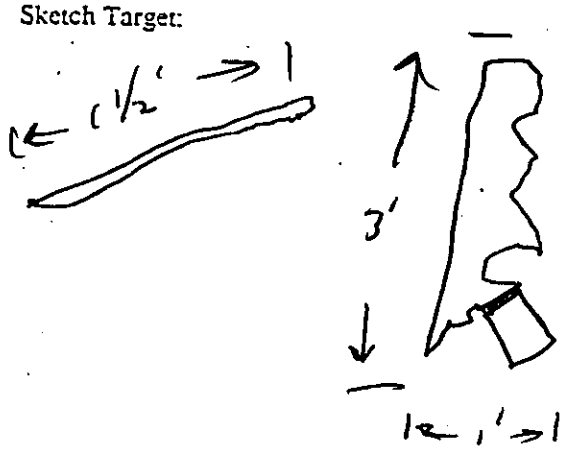
Describe Target: SMALL PIECES OF METAL DEBRIS FM 1 FOOT LENGTH TO 3'

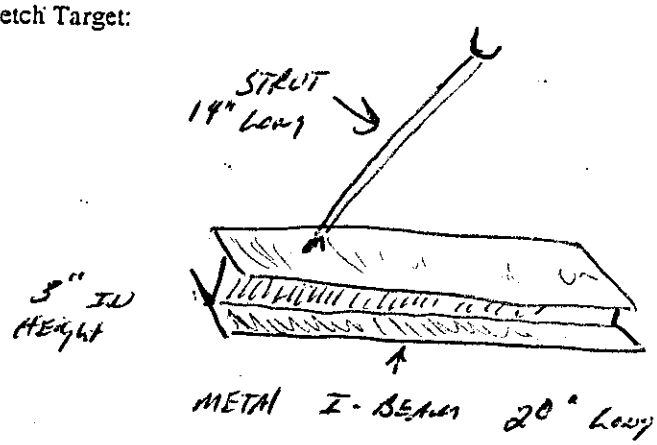
Describe Target: DIVERS RECOVERED ONE METAL I-BEAM 20" Long HAVING 14" STRUT, ONE HYDRALIC METAL And RUBBER HOSE APPROX 4' LONG, ONE SMALL PIECE OF METAL (NO NUMBERS), ONE NYLON STRAP HAVING ANCHORING DEVICES ON ENDS (APPROX 3' Long)

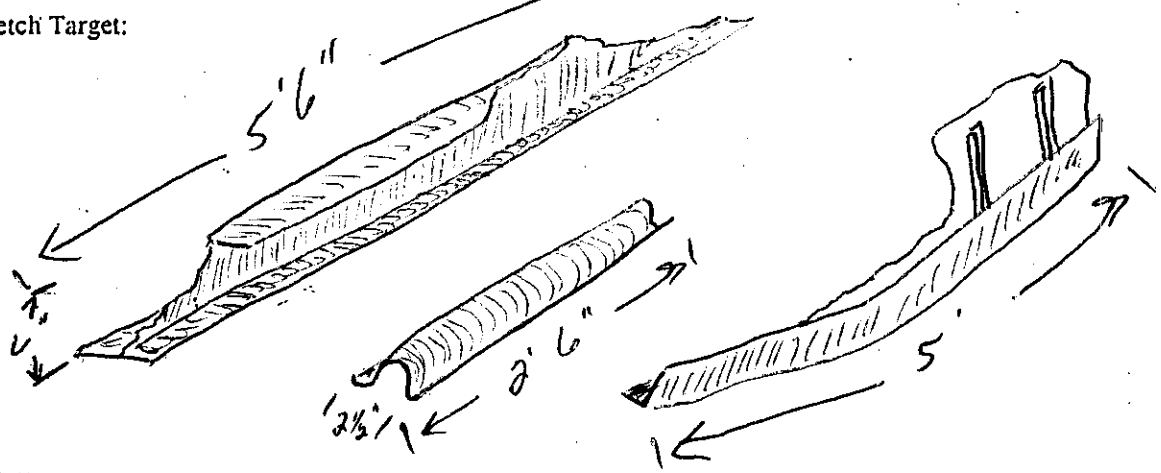
Describe Target: ONE ALUMINUM BEAM 5'6"
ONE ANGLE ALUMINUM W/ SHEET METAL 5' LONG (color GREEN & WHITE)
ONE ALUMINUM BEAM COLOR GREEN 2'6" LONG
(1) BOTTOM OF T-BEAM 14" LONG (TORN OFF)
ONE SMALL PIECE OF METAL

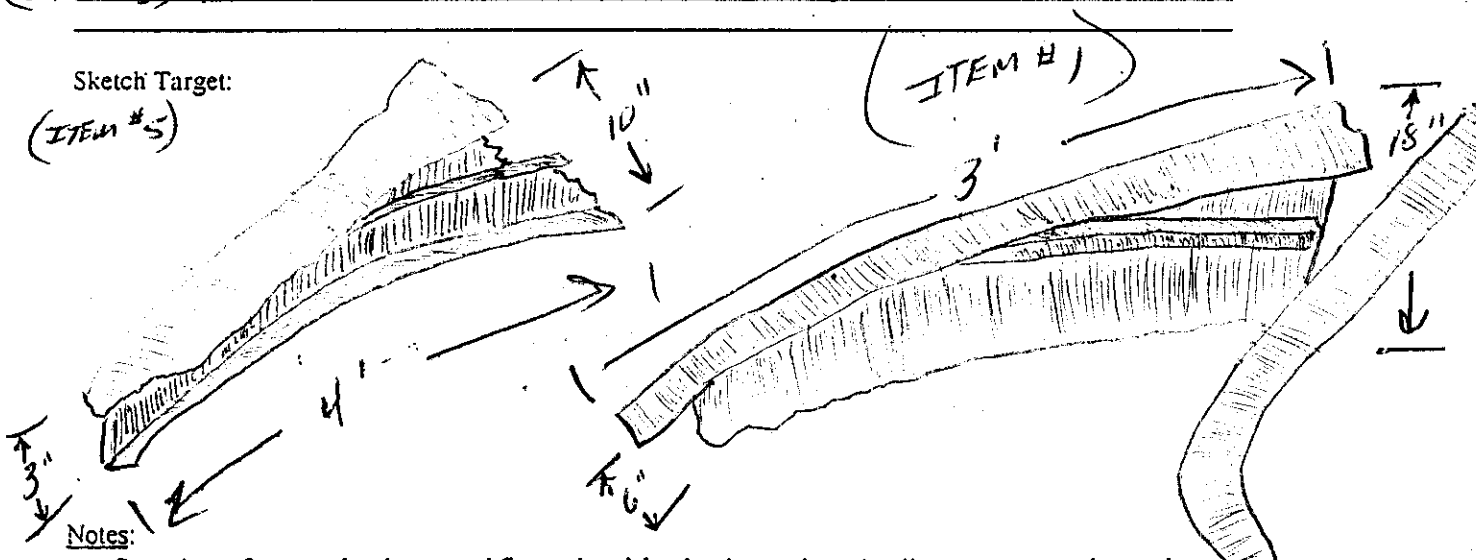
Describe Target: (ITEM #1) FIBERGLASS and METAL I-BEAM STRUCTURE 3' X 18" X 2".
(ITEM #2) METAL and FIBERGLASS STRUCTURE HAVING TWO (2) LATCHES (15" X 3" X 1/2")
(ITEM #3) "T" SHAPED FIBERGLASS TORN ON ONE SIDE 2' X 2" X 2" WHITE in COLOR
(ITEM #4) METAL "T" SHAPED BEAM (COLOR GREEN) 3' X 3" X 2"
(ITEM #5) FIBERGLASS I-BEAM 4' X 10" X 5")

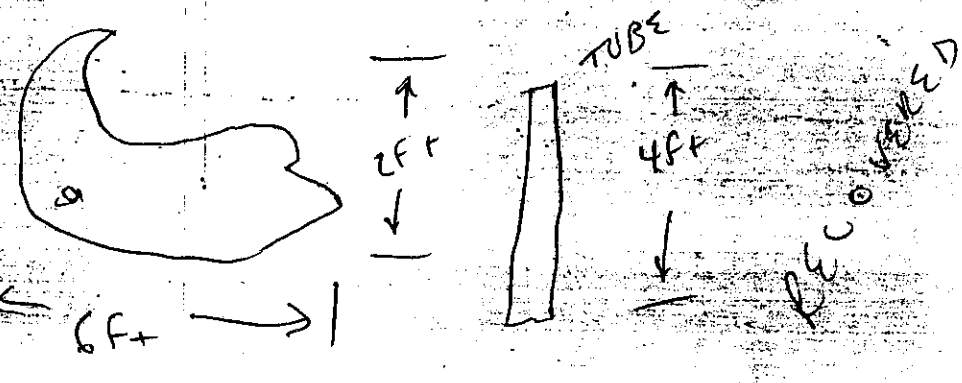
Describe Target: FUSELAGE + FIBERGLASS TUBE

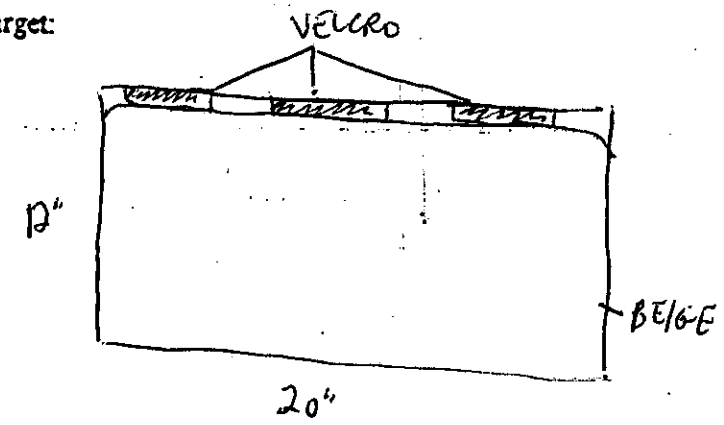
Describe Target: PLASTIC SEAT BACK

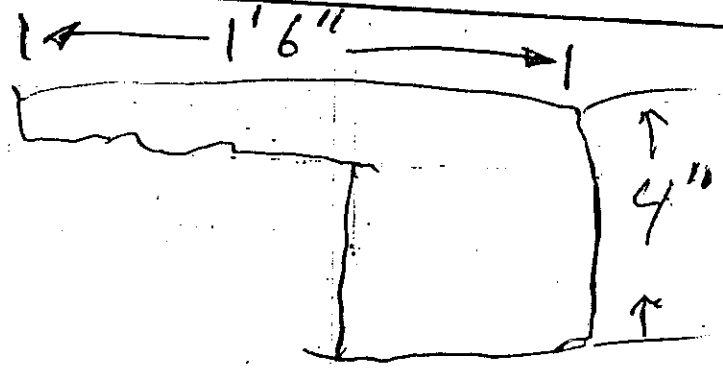
Describe Target: Honey Comb -

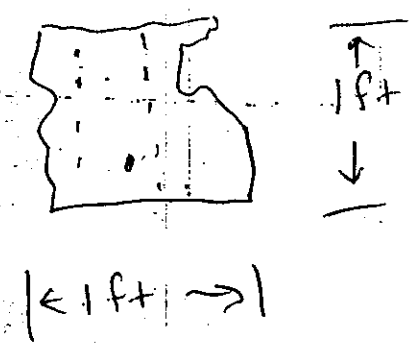
Condition: BENT
(Fire Damage/Darkened Areas/Soot/Insulation Missing/Bent)

Describe Target: PIECE of FUSALAGE

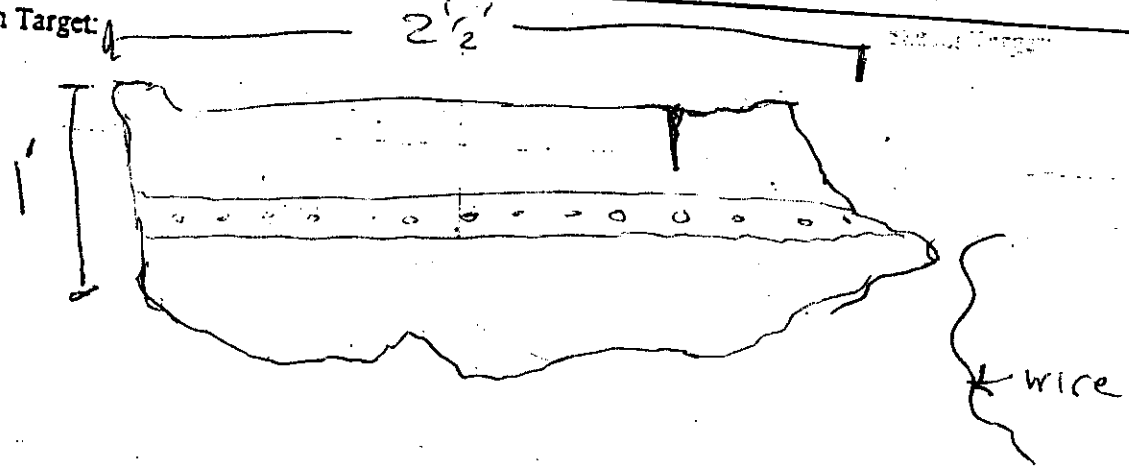
Condition: BENT
(Fire Damage/Darkened Areas/Soot/Insulation Missing/Bent)

Describe Target:
damaged section of fuselage

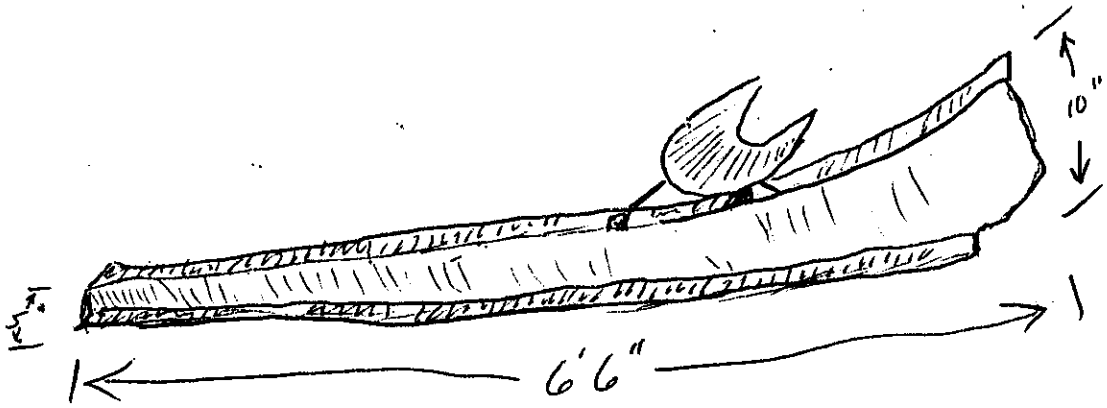
Condition: TORN
(Fire Damage/Darkened Areas/Soot/Insulation Missing/Bent)

Describe Target: FIBERGLASS I-BEAM CONSTRUCTION, CURVED HAVING 1/2 CIRCLE FIBERGLASS TUBULAR STRUCTURE ATTACHED
ALSO RECOVERED TWO (2) SMALL PIECES OF WHITE PLASTIC

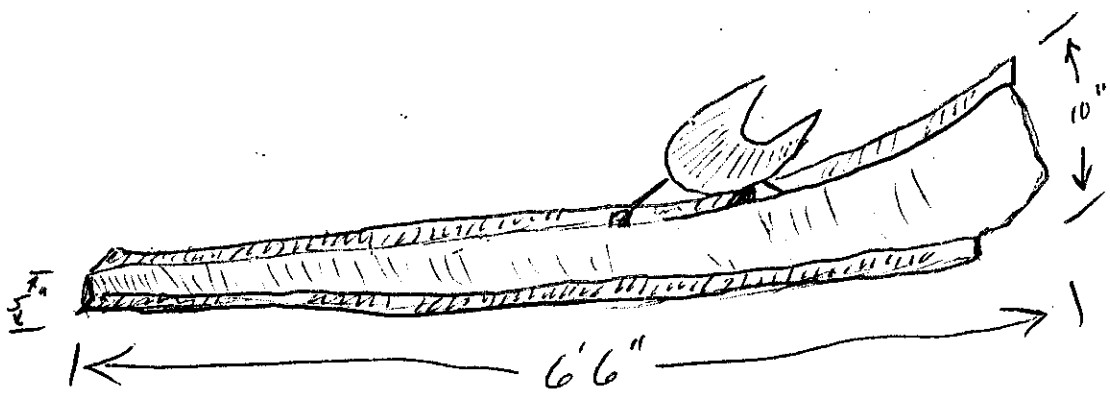
Describe Target: FIBERGLASS I-BEAM CONSTRUCTION, CURVED HAVING 1/2 CIRCLE FIBERGLASS TUBULAR STRUCTURE ATTACHED ALSO RECOVERED TWO (2) SMALL PIECES OF WHITE PLASTIC

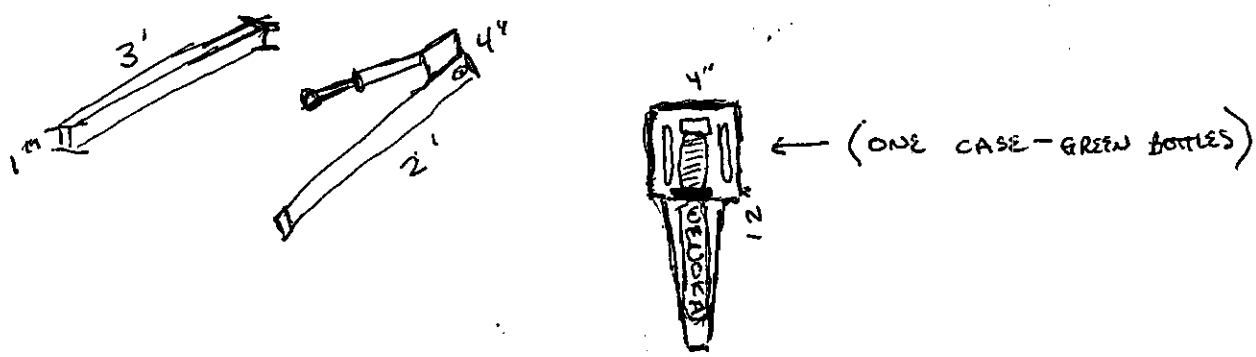
Condition: BROKEN
(Fire Damage/Darkened Areas/Soot/Insulation Missing/Bent)

Describe Target: VARIOUS SMALL CONTACTS

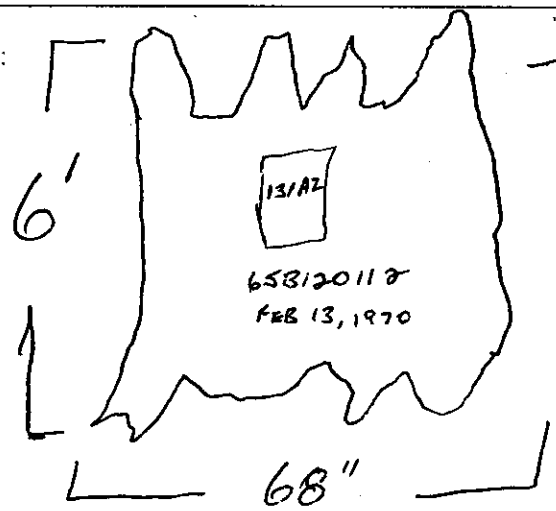
METAL SKIN WITH 6 METAL SUPPORTING RIBS ALONG BACK

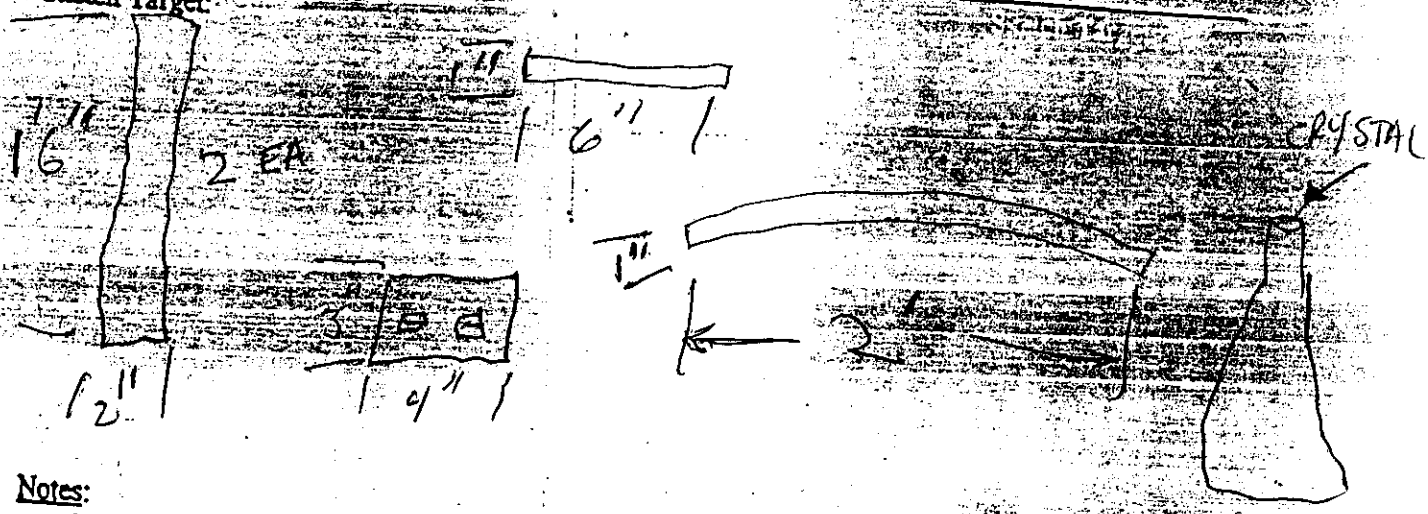
Condition: Bent
(Fire Damage/Darkened Areas/Soot/Insulation Missing/Bent)

Describe Target: 5 pieces of wreckage ONE [illegible]

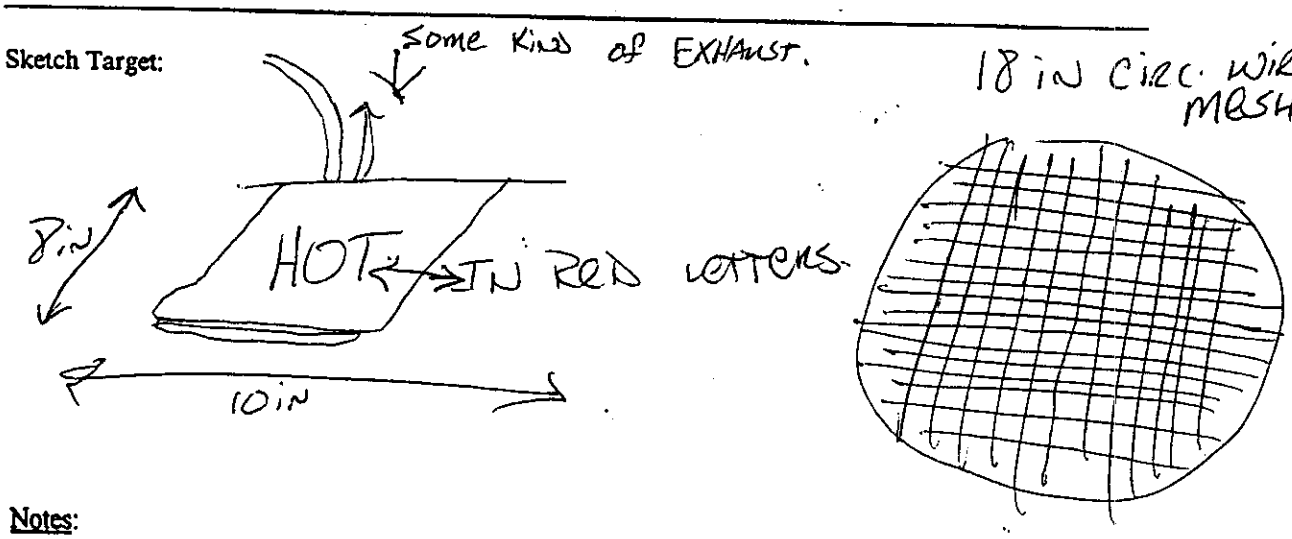
Describe Target: FOUND 2 ITEMS DESCRIBED BELOW.

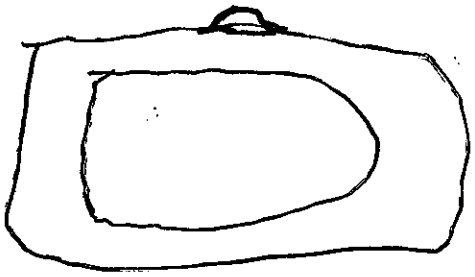
Condition: EMPTY / DAMAGED
(Fire Damage/Darkened Areas/Soot/Insulation Missing/Bent)

Describe Target: LUGGAGE (EMPTY)
ITEM RECOVERED

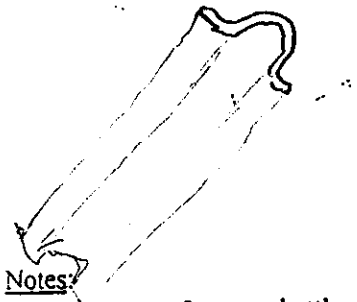
Describe Target: SMALL GREEN METAL PIECE

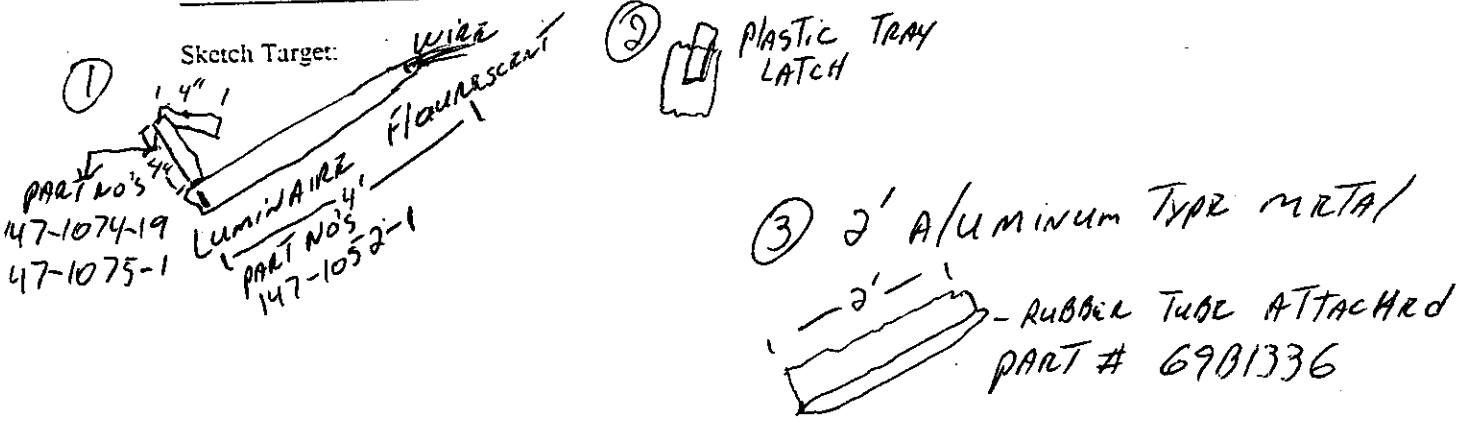
Condition: Twisted and Torn
(Fire Damage/Darkened Areas/Soot/Insulation Missing/Bent)

Describe Target: (1) Flourescent Light Fixture / (2). Plastic Tray Latch
(3). 2' Aluminum Type Metal with Rubber Tube Attached

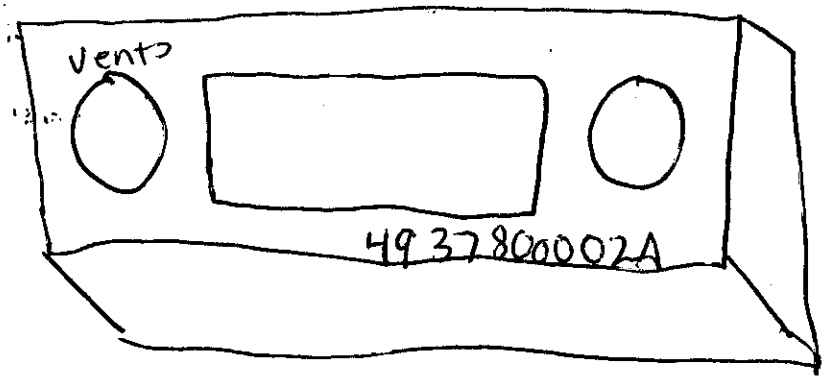
Condition: Cracked / Broken.
(Fire Damage/Darkened Areas/Soot/Insulation Missing/Bent)

Target Removed / Tagged

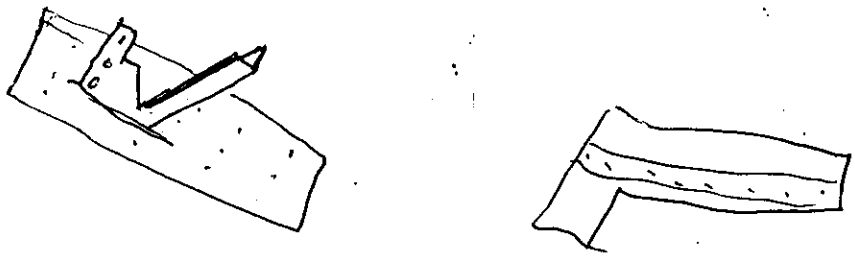
Condition: Bent, Broken
(Fire Damage/Darkened Areas/Soot/Insulation Missing/Bent)

Describe Target: 2 Items recovered. Metal skin.

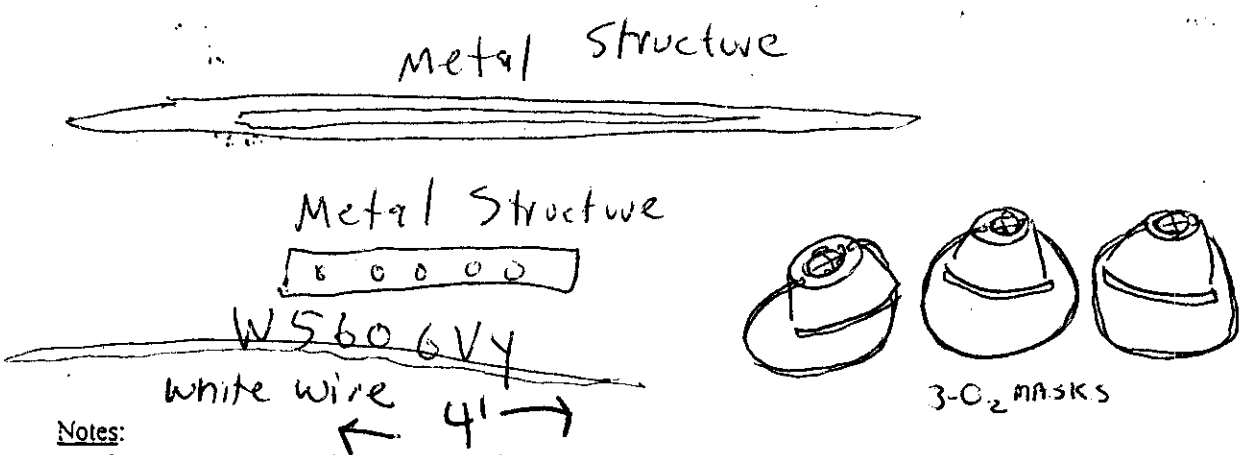
Condition: Damaged
(Fire Damage/Darkened Areas/Soot/Insulation Missing/Bent)

Describe Target: Target removed + Tagged
wire 4' lenght

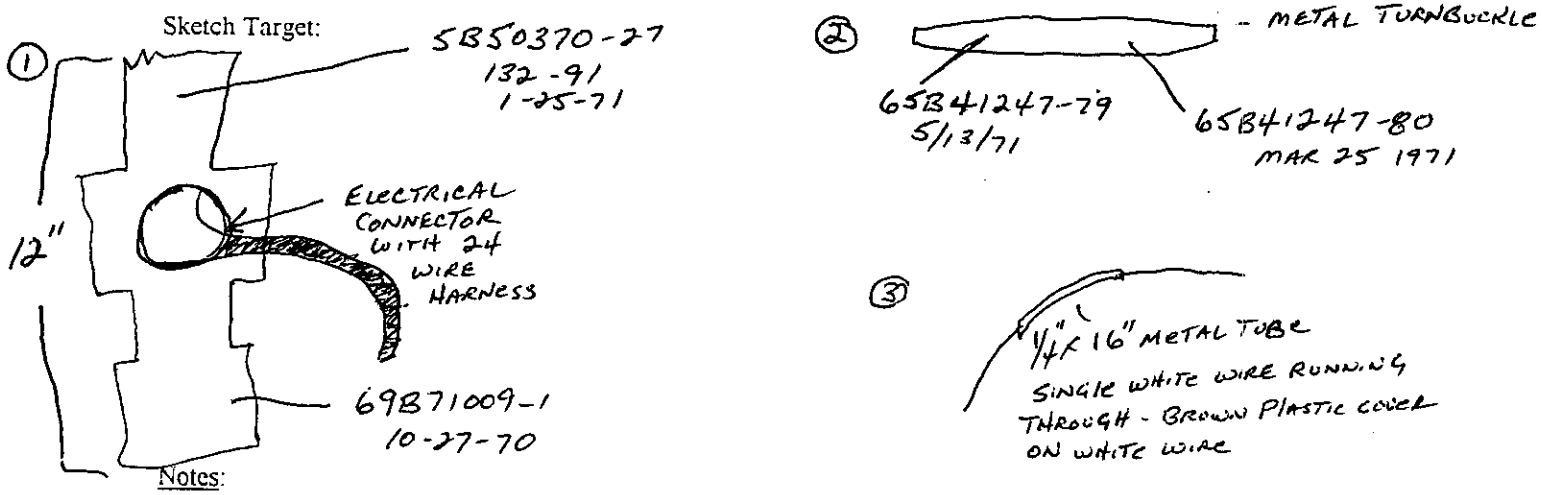
Condition: DAMAGED
(Fire Damage/Darkened Areas/Soot/Insulation Missing/Bent)

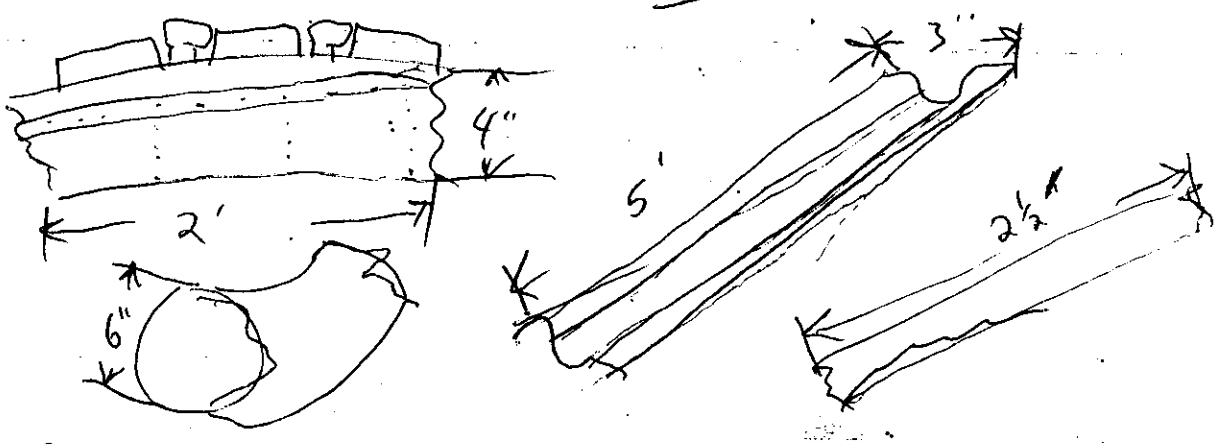
Describe Target: RUBBER SEAL, POSSIBLE FROM WINDOW AND TWO SMALL BROKEN UP PIECES WITH HONEY COMB BACKING RECOVERED

Condition: Bent
(Fire Damage/Darkened Areas/Soot/Insulation Missing/Bent)

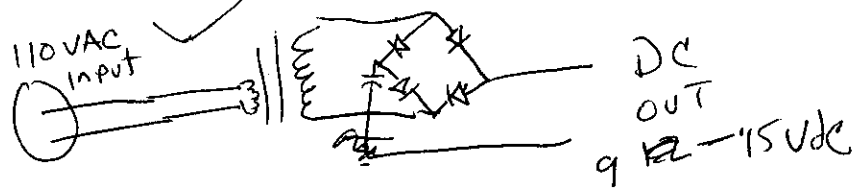
RECOVERY TAG #: A683

DESCRIPTION: JVC pwr Supply TARGET # NONE

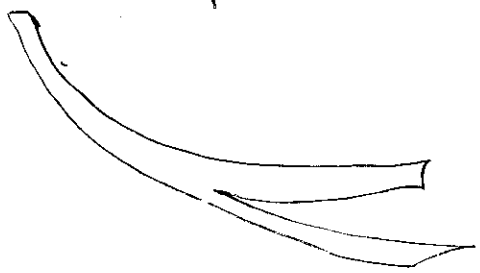
RECOVERY TAG #: A689

APPROX 3 FT LONG
V SHAPE ON 1 END

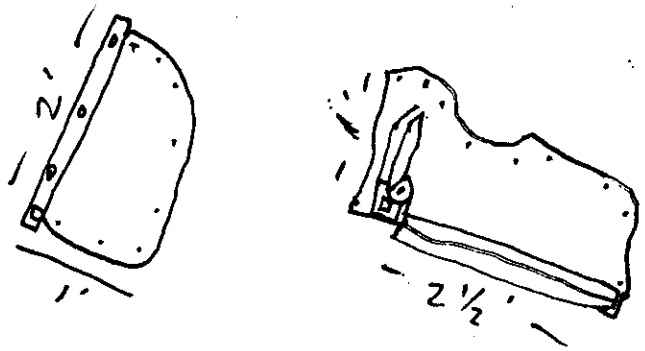
Condition: BENT / BROKEN
(Fire Damage/Darkened Areas/Soot/Insulation Missing/Bent)

Describe Target: SMALL PIECES OF WRECKAGE / WEAK SONAR CONTACTS AND PARTIALLY BURIED.

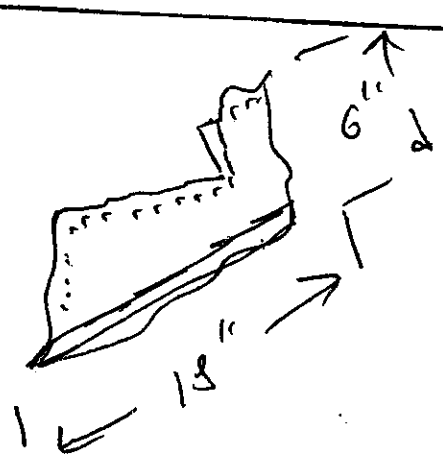
Describe Target: SMALL PIECE OF AL SKIN WITH PIECE OF ANGLE IRON ON IT.

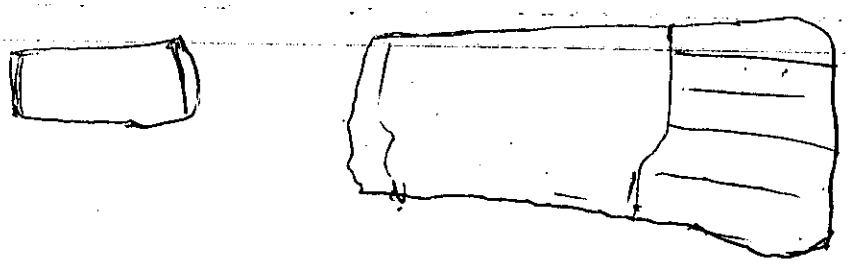
Describe Target: AIRCRAFT ENGINE W/ STRUT DAMAGED AND BENT, SMALL OIL FILTER SHAPED COMPONET,

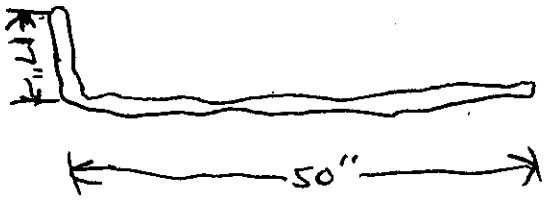
Condition: Torn or snapped
(Fire Damage/Darkened Areas/Soot/Insulation Missing/Bent)

Describe Target: METAL CURVED TYPE ROD APPROXIMATELY 50" W/ A BEND OF 17" (APPROX.) AFTER BEND.

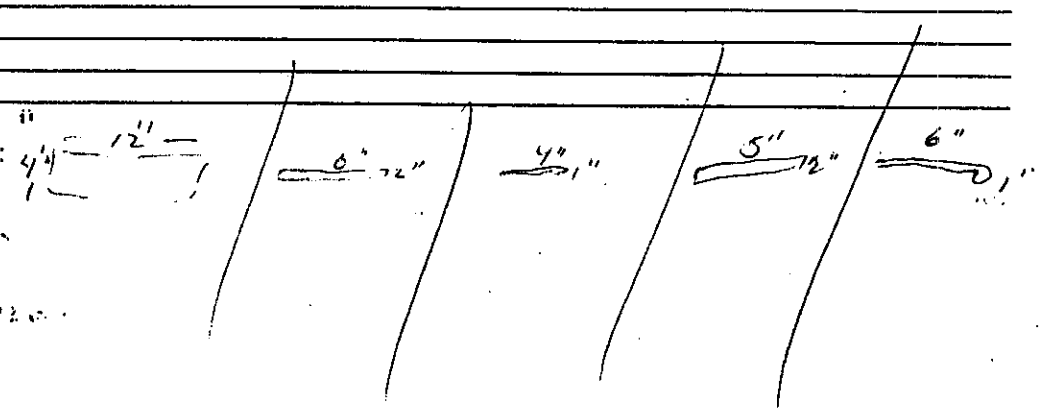
Describe Target: ASSORTED SMALL Debris (5) NO PIECES LARGER THAN 12" IN Length -

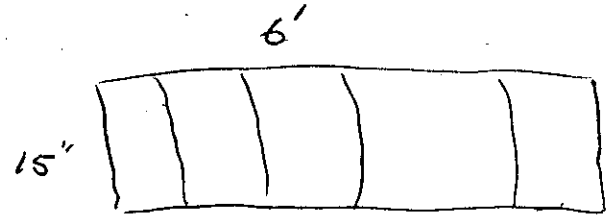
Section similar to others found. Item rectangular and flat

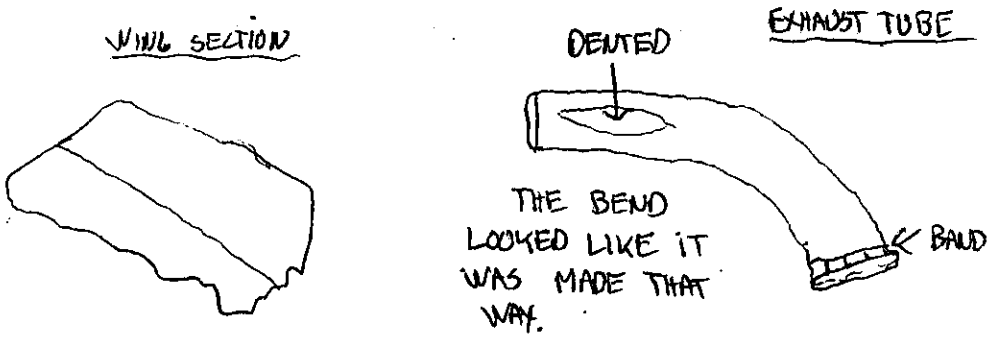
Describe Target: ACQUIRED 1ST TARGET WITH 2A BADLY DAMAGED WING SECTION. MADE MULTIPLE SMALL TARGETS, THEN CAME ACROSS THE EXHAUST / AIR TUBE, DARK IN COLOR, LOOKED LIKE AN EXHAUST BELOWGE OF THE SOOTY APPEARANCE.

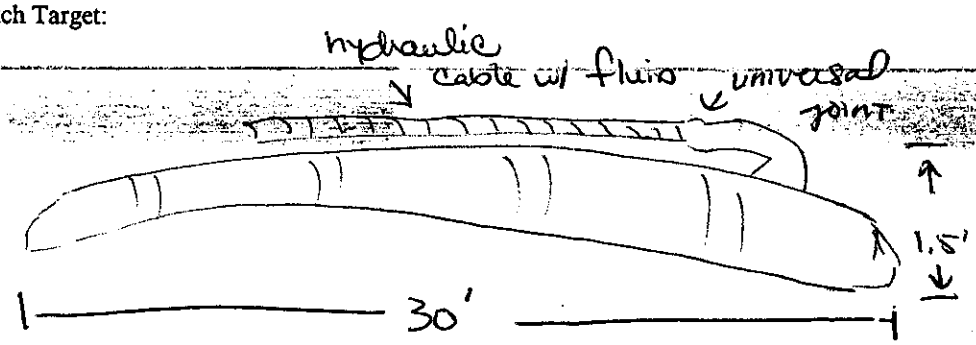
Describe Target: Long metal structure first thought to be An engine strut. Once onbd SLWT, tech rep thought it was controller for wing flaps.

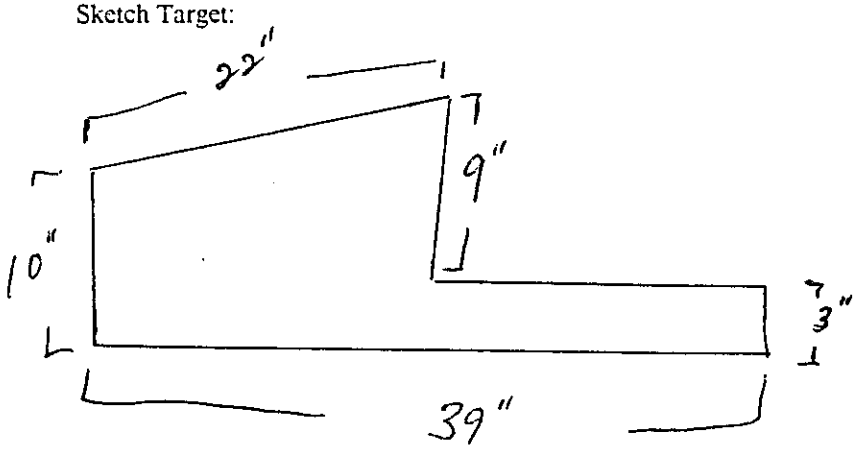
Condition: DAMAGED.
(Fire Damage/Darkened Areas/Soot/Insulation Missing/Bent)

Describe Target: SECTION OF METAL RIB STRUCTURE

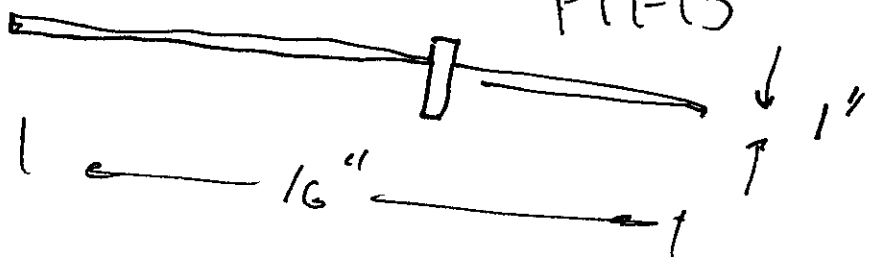
DESCRIPTION: WIRES ALL KINDS of LOOSE AND HANGING TOGETHER.
