DIVER/ROV TARGET LOGS

TWA 800
Oceaneering Data Center

DAILY DIVE SITREP

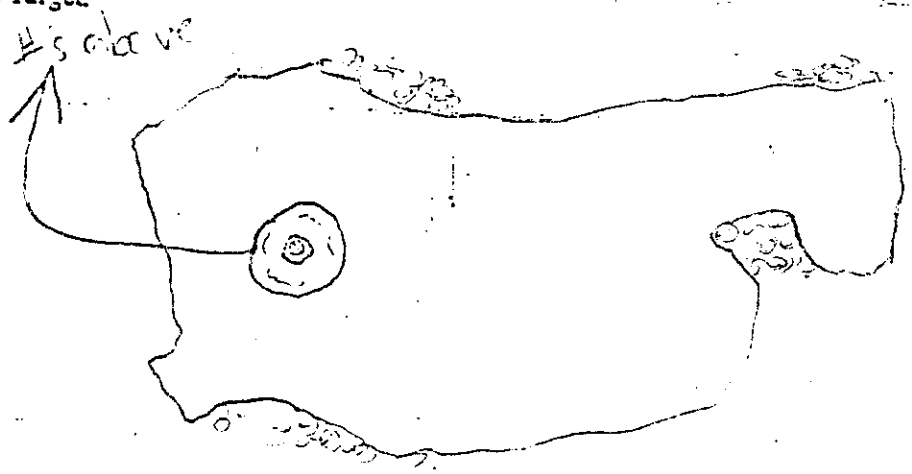
Condition: torn
(Fire Damage/Darkened Areas/Soot/Insulation Missing/Bent)

Describe Target: Wall/bulkhead covering w/ attached

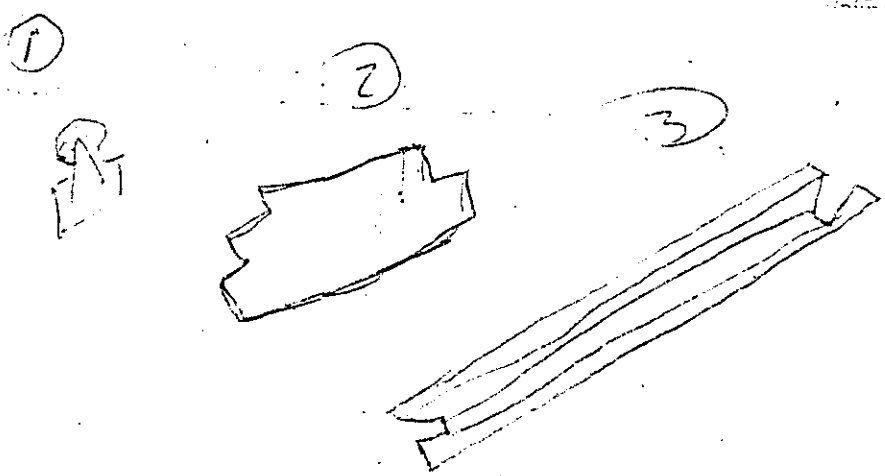
Condition: 1,2,3 Bent torn
(Fire Damage/Darkened Areas/Soot/Insulation Missing/Bent)

Describe Target: ① Metal square with a small roller
② TORN SHEET Metal
③ LONG Reinforcement Bar

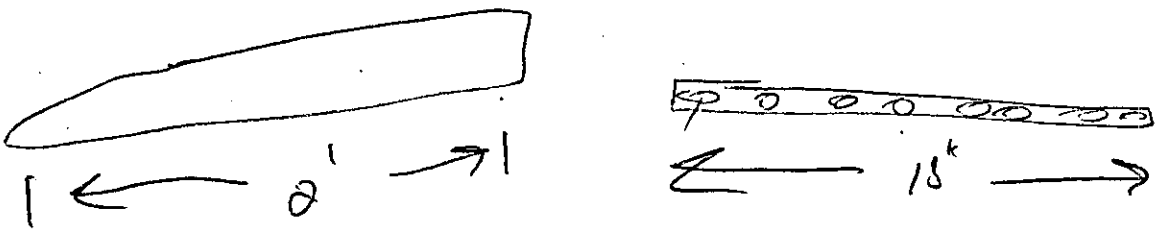
Describe Target: CLEAR BOTTOM WITH 2 PIECES OF METAL FRAME.

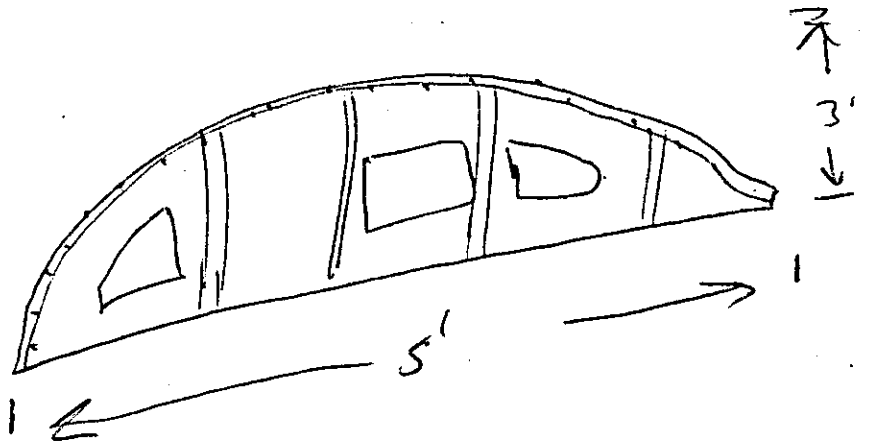
Condition: TWISTED / BROKEN / BURNED
(Fire Damage/Darkened Areas/Soot/Insulation Missing/Bent)

Describe Target: WING RIB

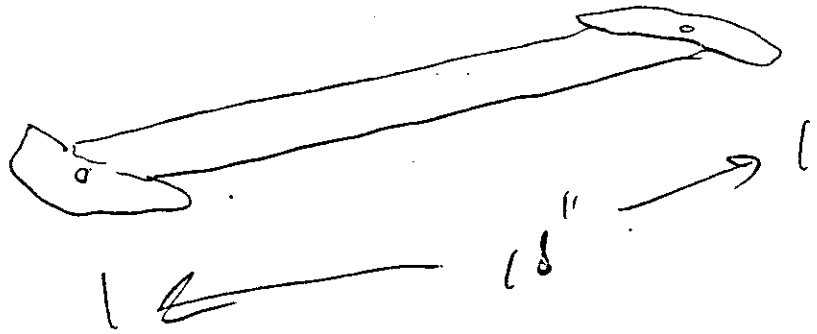
Condition: Broken Bent
(Fire Damage/Darkened Areas/Soot/Insulation Missing/Bent)

Describe Target: Thin STRIP of Green painted Aluminum
