Runway Side Excursion During Attempted Takeoff in Strong
and Gusty Crosswind Conditions
Continental Airlines Flight 1404
Boeing 737-500, N18611
Denver, Colorado
December 20, 2008

NTSB/AAR-10/04
PB2010-910404

Aviation Accident Report

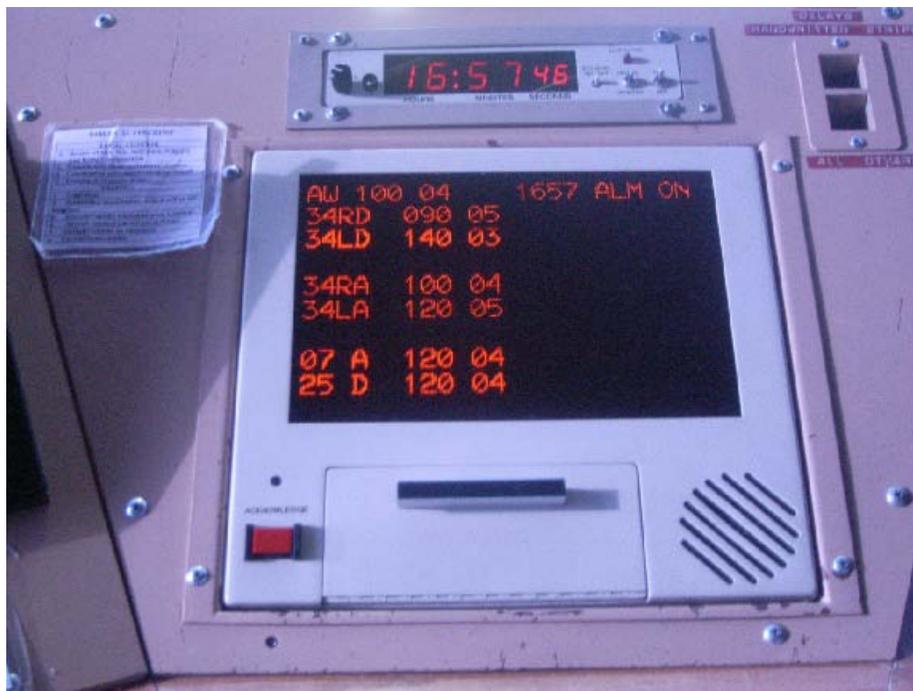
Figure 5. An exemplar photograph of a DEN ATCT RBDT wind display set up to show arrival and departure wind information for runways 34R, 34L, and 07/25. On the display, the runway 34R departure wind information is on the second line, identified as “34RD.” The AW is displayed directly above the runway 34RD information. Note: the wind directions and speeds displayed in this photograph do not represent the winds on the night of the accident.

On the night of the accident, the DEN ATCT local controller who issued the accident flight's takeoff clearance was responsible for departures from runways 34L, 34R, and 25. His RBDT displayed runway 34R departure wind information generated by LLWAS sensor #3 (winds from 270° at 27 knots), which he issued to the accident pilots with their takeoff clearance.

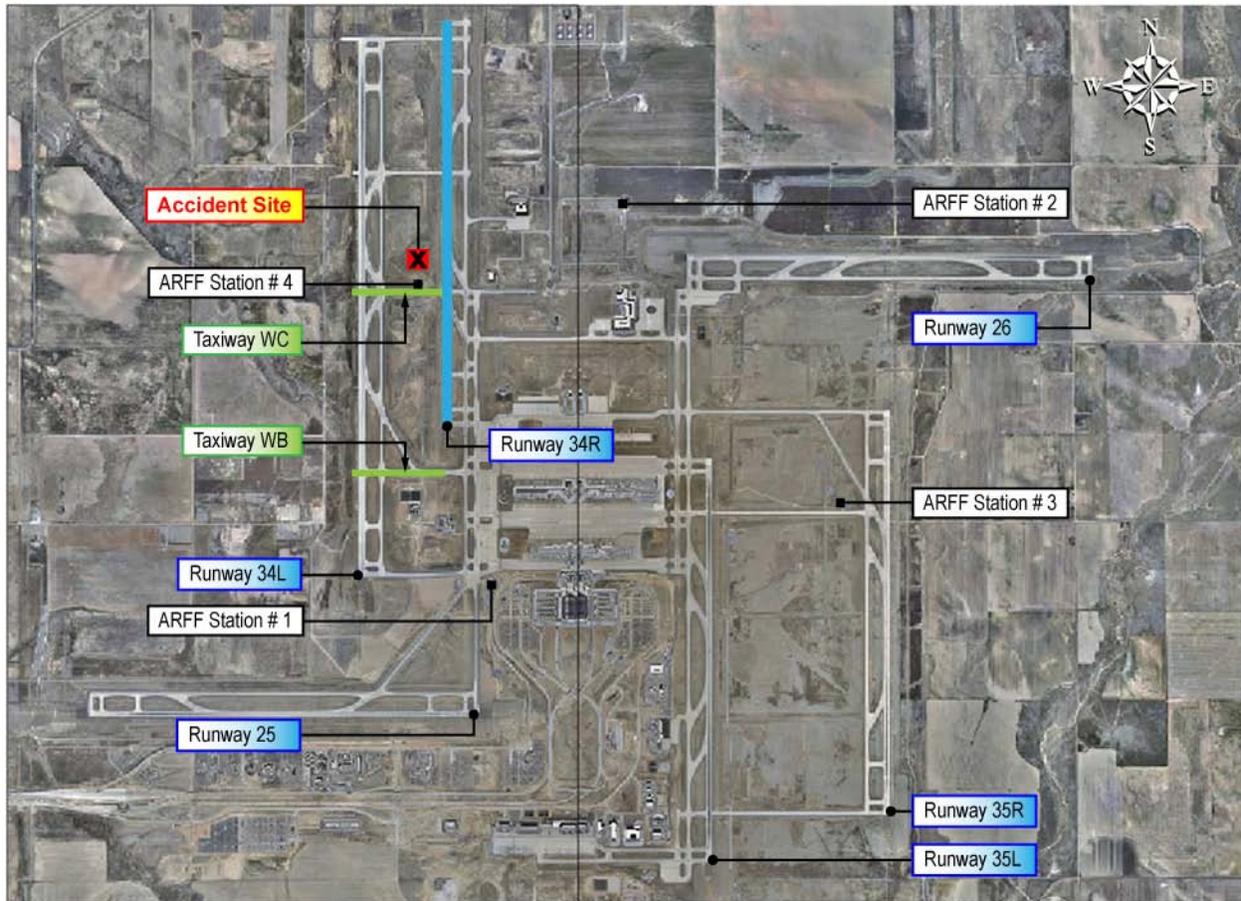
an incorrect accident location (“off of runway 34R at [WB]”)⁶⁰; however, he subsequently relayed the correct accident location to DEN airport ground operations personnel. Additionally, at 1819:50, the DEN ATCT local controller contacted airport ground operations personnel on the local control frequency and advised them “...aircraft departure...off 34R, exited the runway at WC, appears to be on fire immediately adjacent to the firehouse.” DEN ATCT repeated the accident location information to DEN airport ground operations again about 15 seconds later, and DEN airport ground operations relayed the revised information to the ARFF crews. Figure 8 is an aerial photograph of the DEN airport with the runways, relevant taxiways, ARFF stations, and accident location identified.

Figure 8. Aerial photograph of the DEN airport with the runways, relevant taxiways, ARFF stations, and accident location identified.
