NATIONAL TRANSPORTATION SAFETY BOARD

SAFETY STUDY

CRASHWORTHINESS OF LARGE POSTSTANDARD SCHOOLBUSES

NTSB/SS-87/01

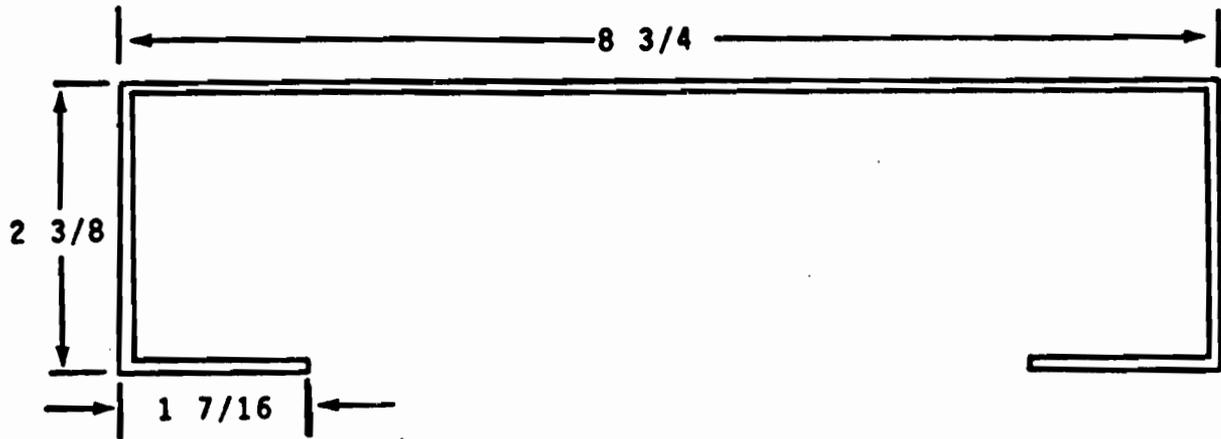
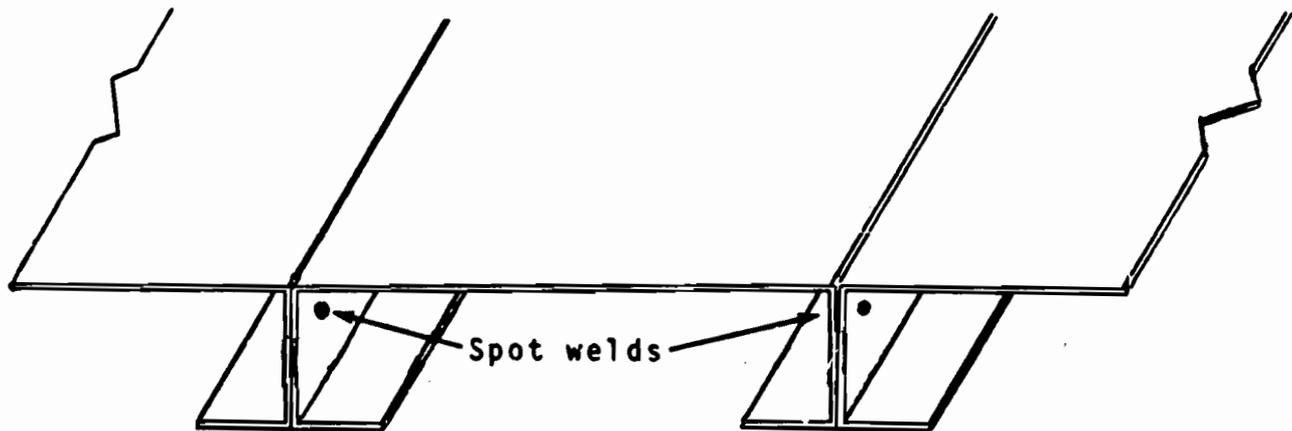
The schoolbus floor consisted of 0.075-inch-thick steel bent into C-shaped channels. The channels were joined together by an exterior steel "cap" around the outside perimeter of the floor, by welds along the flanges at each end, by welds on the underside of the floor structure, and by spot welds near the center of the flanges on each channel. (See figure 20.) The collision separated two of these floor channel sections at the floor joint near the seat legs of the fourth row of bench seats in front of the schoolbus drive axle. The floor separation created a triangular opening across the schoolbus floor which measured about 45 inches wide at the left sidewall. (See figure 21.)

Figure 20.—Schoolbus floor construction in the
Snow Hill, North Carolina, accident bus (case 14).

Strengthen the floor panel joints of all newly-manufactured schoolbuses to ensure that they comply with the requirements of Federal Motor Vehicle Safety Standard 221.

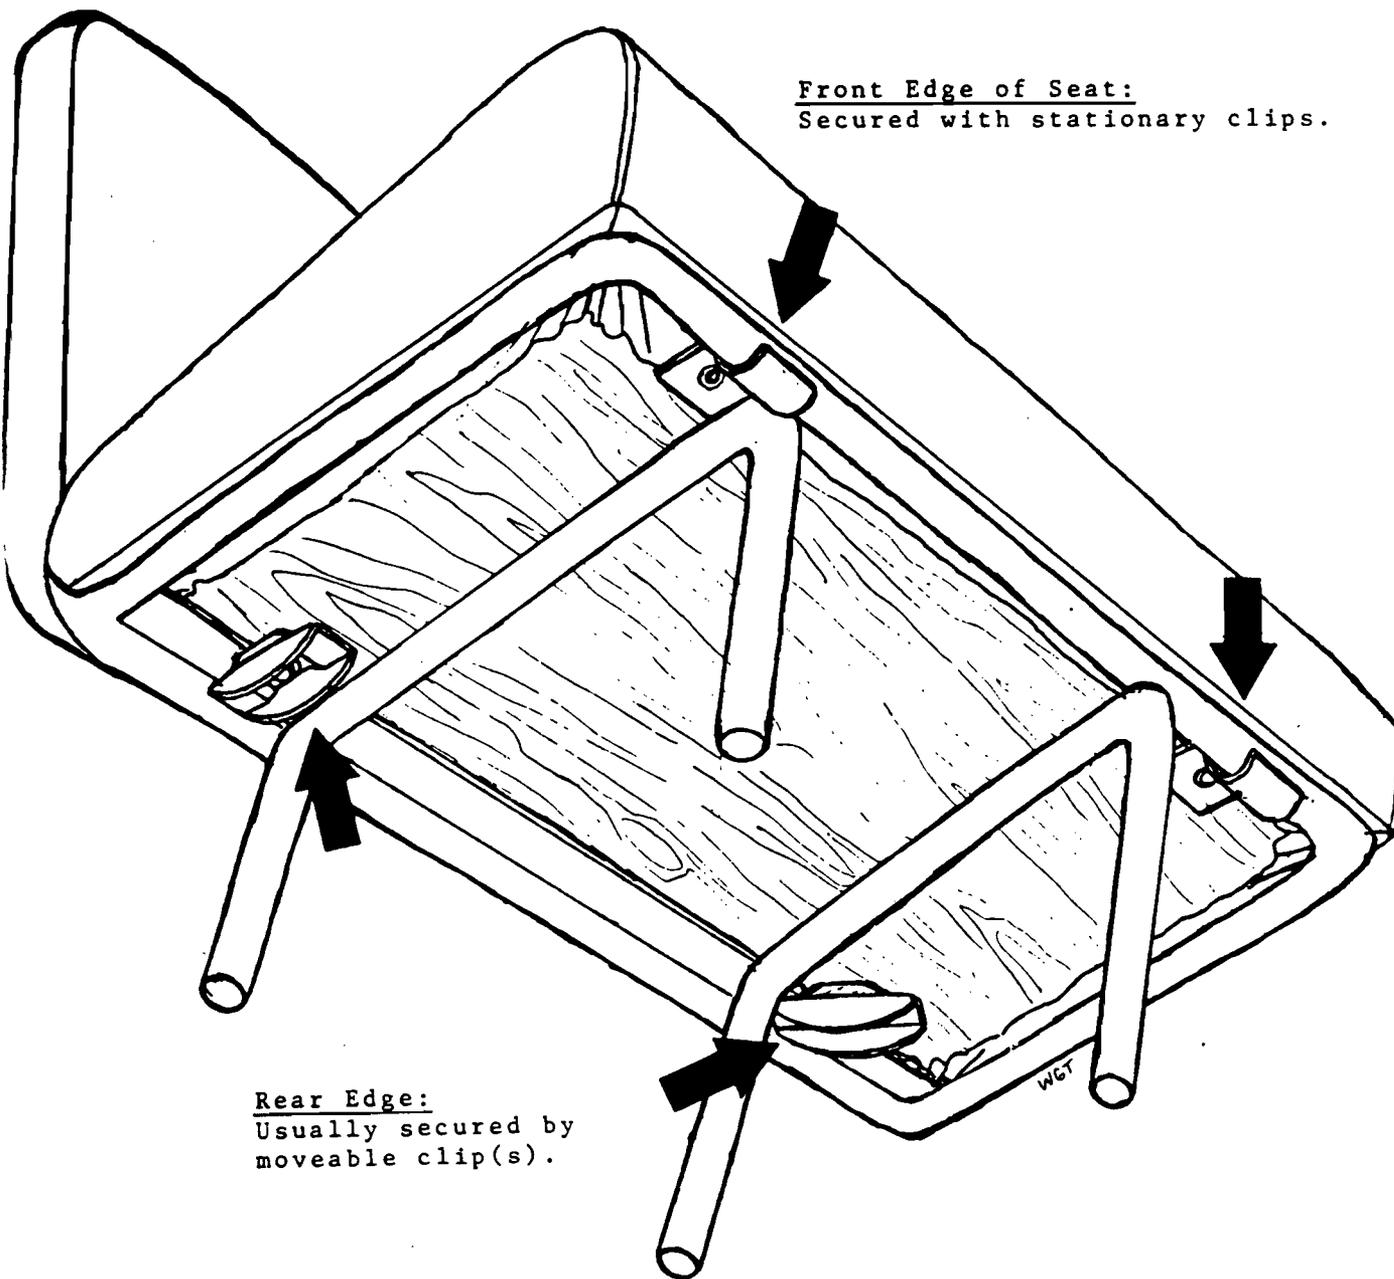
The problem of unsecured seat cushions is confined to the bottom cushion. The top cushions are permanently secured to the seat frame, whereas most of the bottom cushions can be flipped up or removed to facilitate bus cleaning and other types of maintenance. (See figure 22.)

Figure 22.—Bottom cushion as viewed from the floor.

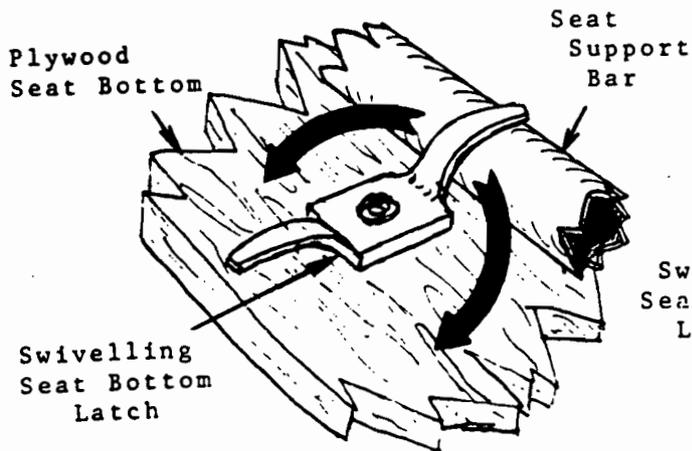
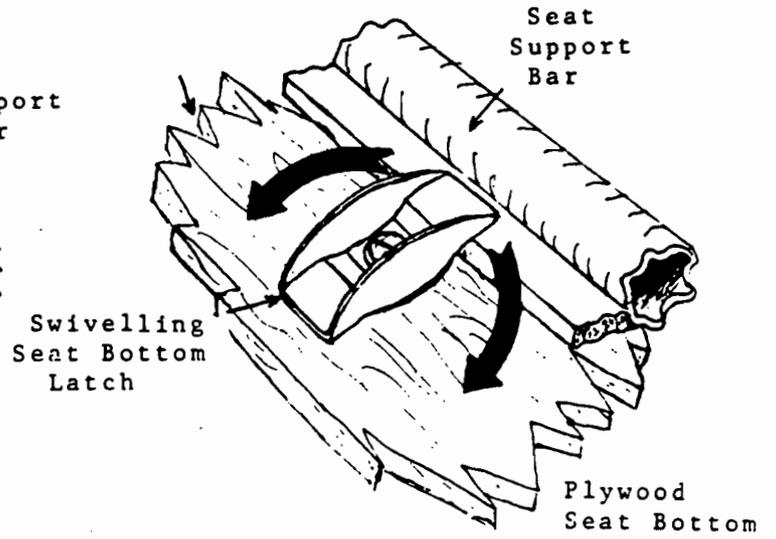
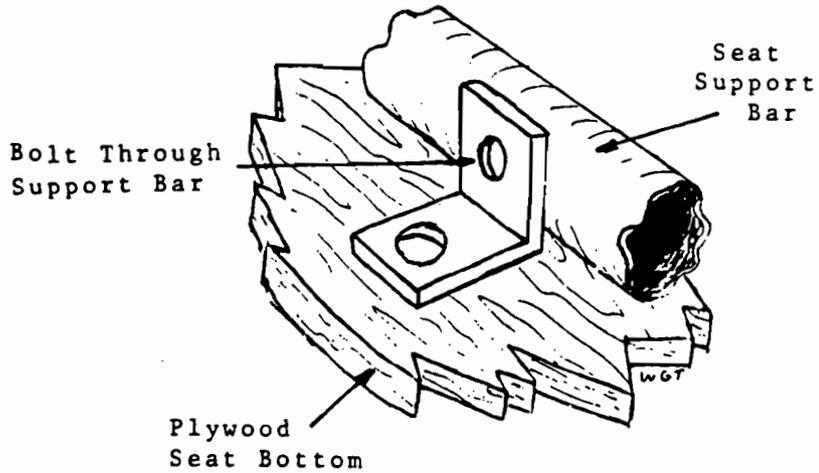
Three types of hardware used to secure the rear of the seat cushion to the seat frame were seen in the cases investigated by the Safety Board. (See figure 25.) The first two used rotating clips which could be turned to fasten or unfasten the cushion. The clips differed in design: one used a single, two-pronged piece of thin metal which clipped over the tubular seat frame; the other used a pair of swivel type clips of a more rigid design to attach the bottom cushion to the seat. In some instances, the latter type may have failed to secure the seat cushion because the clips were not secured tightly and they swivelled to the open position. The third type of hardware was a nonswivelling clip bolted to the seat frame.

Moveable Prong Clip:

A single clip secures the rear of the cushion.

Formed Metal Swivelling Clip:

Two clips secure the rear of the seat cushion.

Stationary Clip:

Two clips secure the seat cushion.

Figure 25.—Types of clips used to secure rear of seat cushion to frame.
