**National
Transportation
Safety Board**

Technologically Advanced Aircraft Accident Case Studies

Allison Diaz, ASI
Eastern Region – Aviation

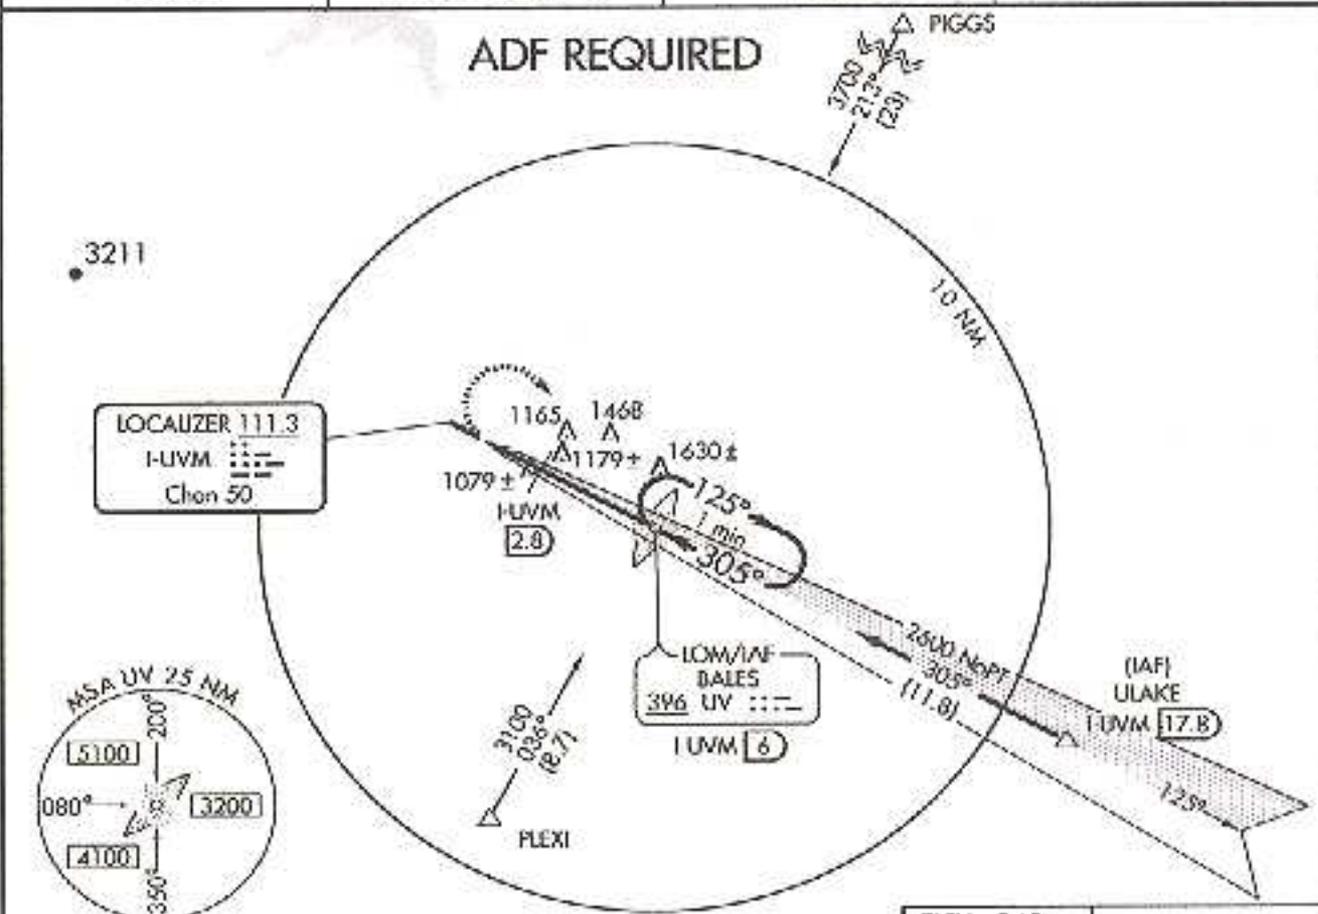
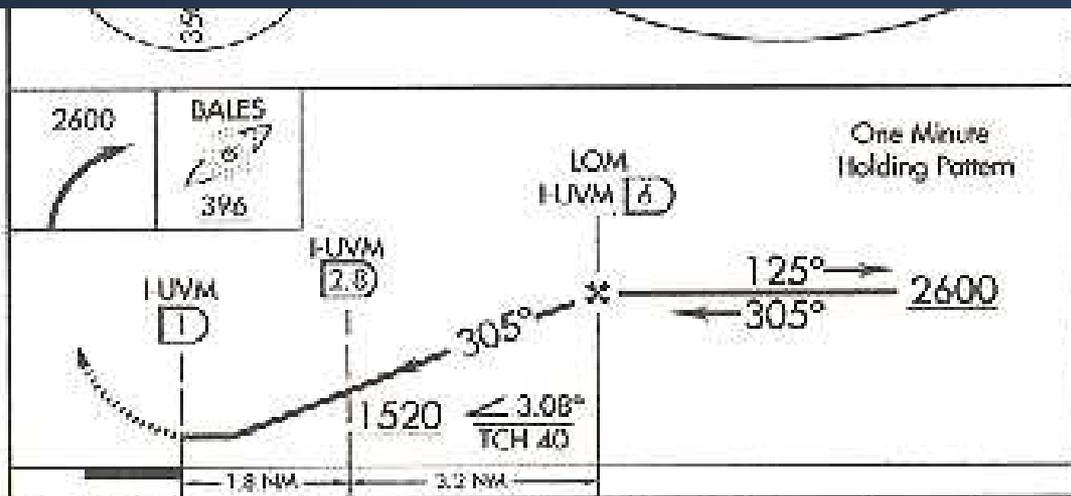
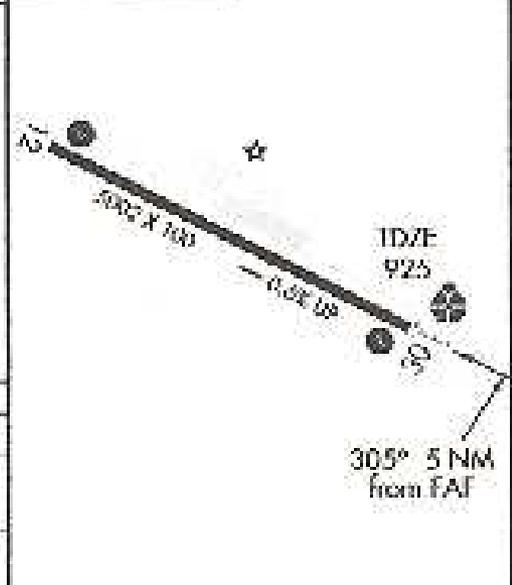
LOC RWY 30

- Departed Concord, NC
- Destination: Martinsville, VA
- IMC prevailed
- MTV non-towered

- No CVR
- Navigated to BALES
- Failed to notice autosequence to MTV
- Did not cross-check
- Did not execute published MAP

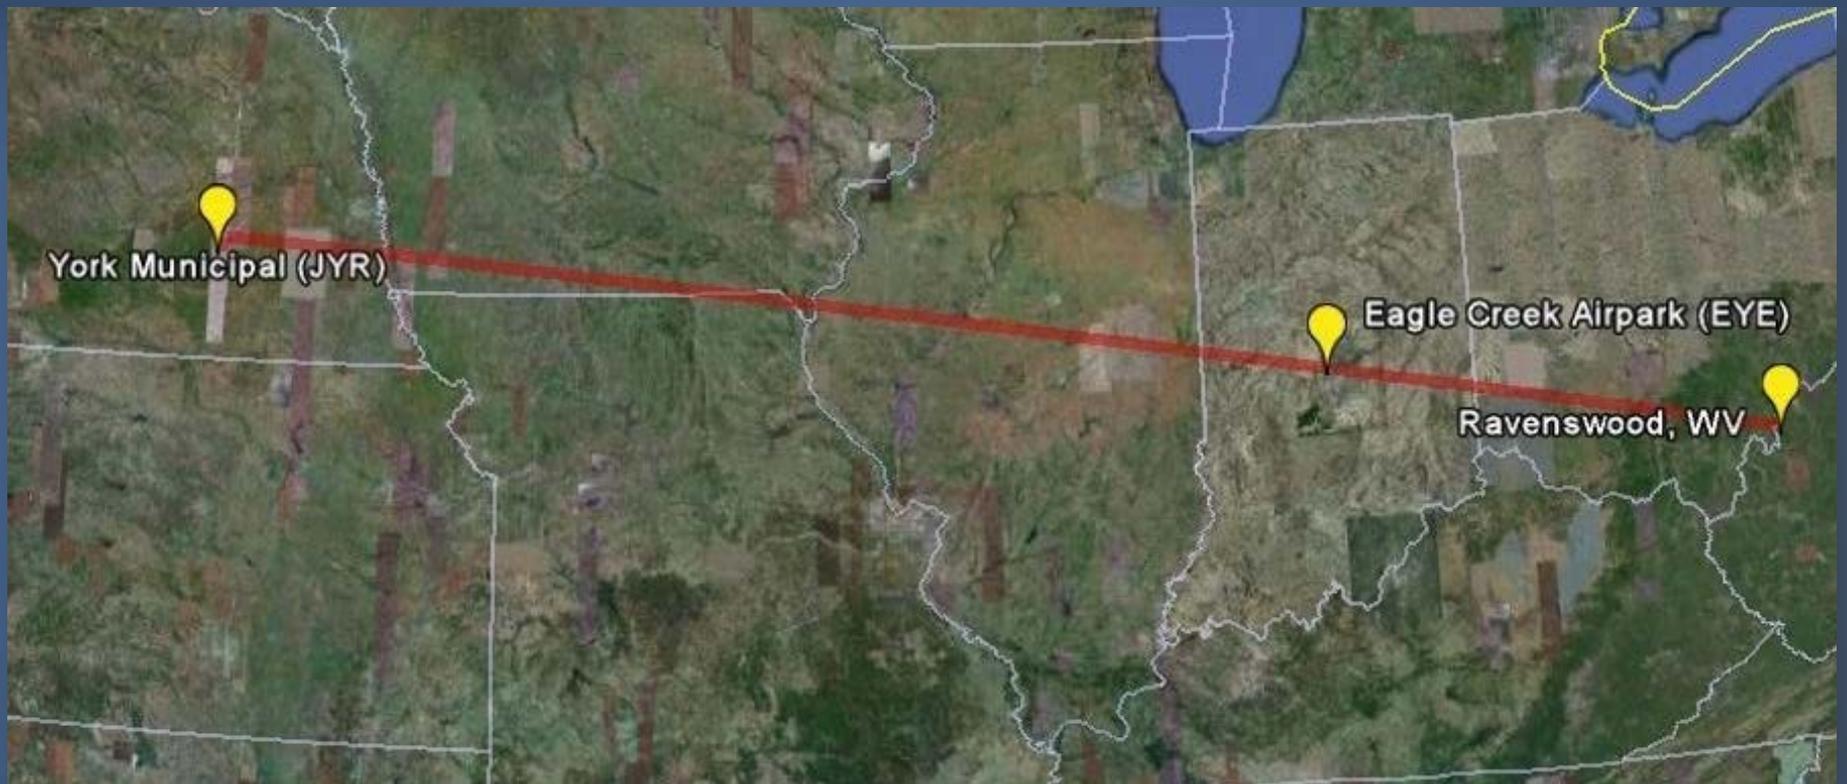
- 1937: “labored breathing”
- Ohio ANG F-16s launched
- “An unresponsive individual who appeared to be unconscious.”

York Municipal (JYR)

Eagle Creek Airpark (EYE)

Ravenswood, WV

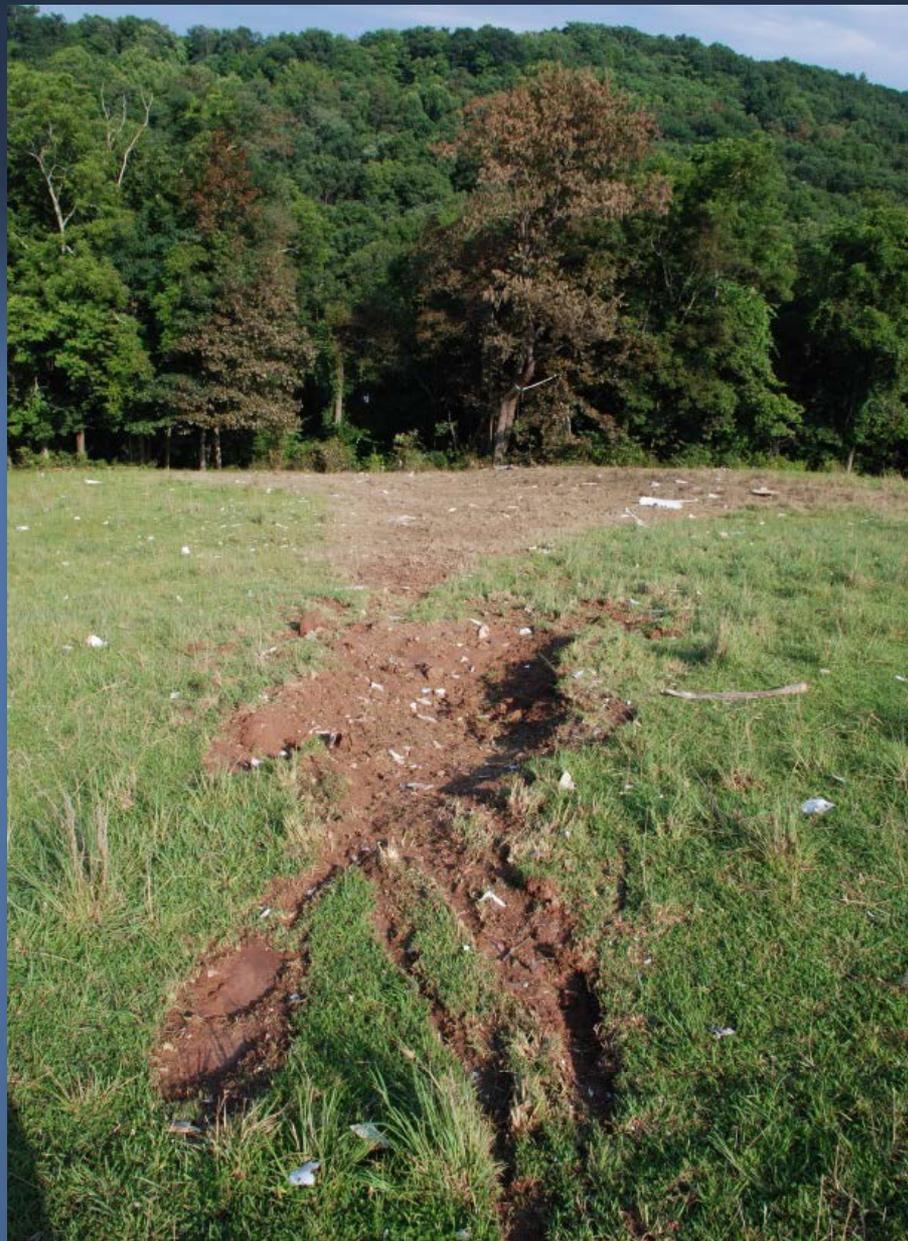
- 2051: overflew EYE at FL250
- Maintained altitude and heading
- 2146: loss of power
