National Transportation Safety Board Aviation Accident Preliminary Report

Location:	Blair, NE	Accident Number:	CEN19LA269
Date & Time:	08/16/2019, 0945 CDT	Registration:	N106PD
Aircraft:	Bell 206	Injuries:	2 Minor
Flight Conducted Under:	Public Aircraft

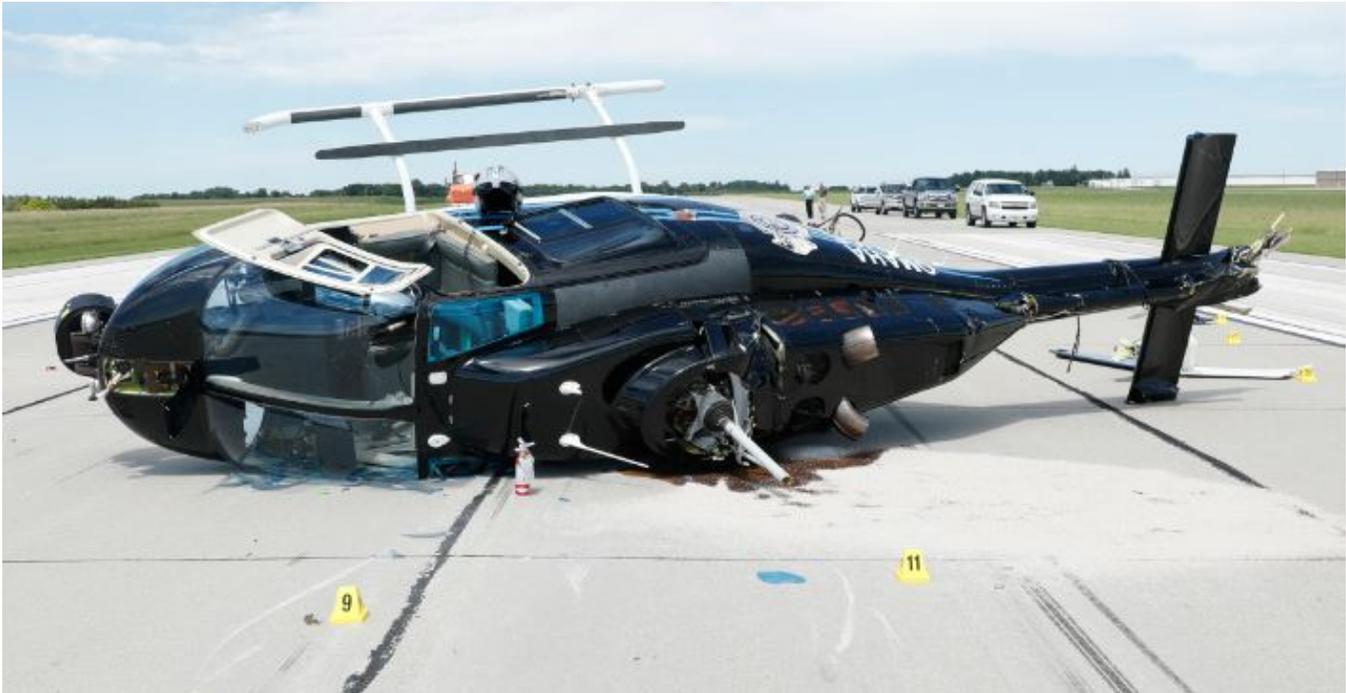
The PIC executed an emergency shutdown and both pilots egressed from the helicopter without further incident. The pilots were wearing MSA Gallet MH250 helicopter flight helmets and both flight helmets sustained impact damage the during the accident sequence. The helicopter sustained substantial damage to the main rotor system, the fuselage, the tailboom, and the tail rotor system as shown below in figure 1.

Figure 1 – View of the helicopter on runway 31 (courtesy of the OPD).

On August 23, 2019, a team of Federal Aviation Administration aviation safety inspectors from the Lincoln Flight Standards District Office traveled to BTA to examine the wreckage. During the examination, no preimpact mechanical malfunctions or failures with the airframe and engine were noted. The engine and engine accessories were removed for a future examination and test run.
